# FA report of Abnormal Display issue

JUNGLIM G140HAB01.2 VLD

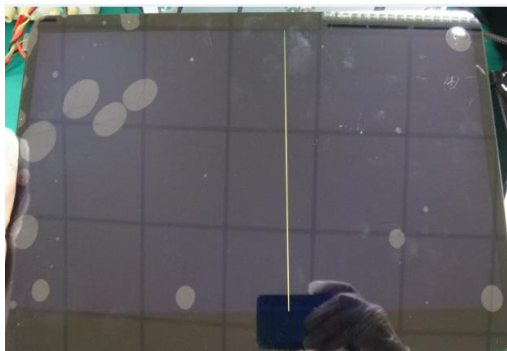
1. V-line defect observed at customer side.

1. A vertical line (V-line) is visible after display activation.
2. The defect location is identified at approximately  $X = 1090$ .
