# FA report of TP NG issue

JUNGLIM G140HAB01.2

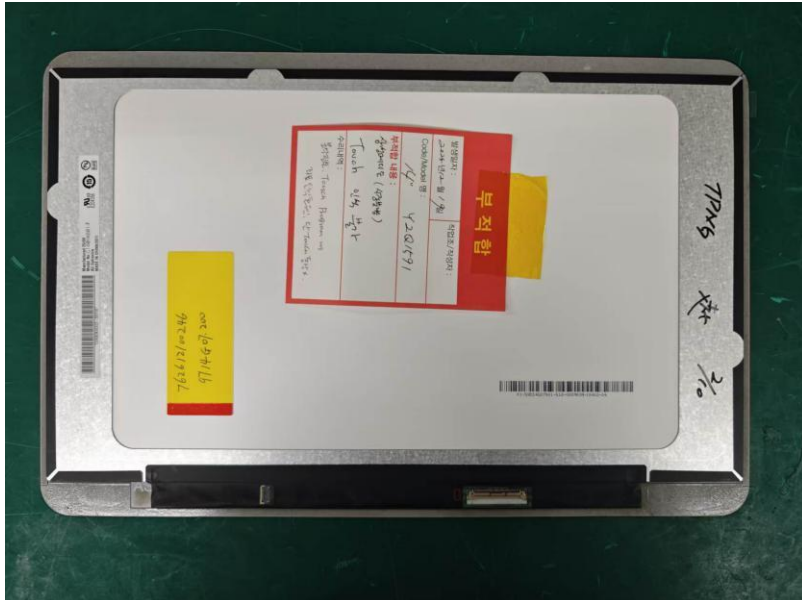
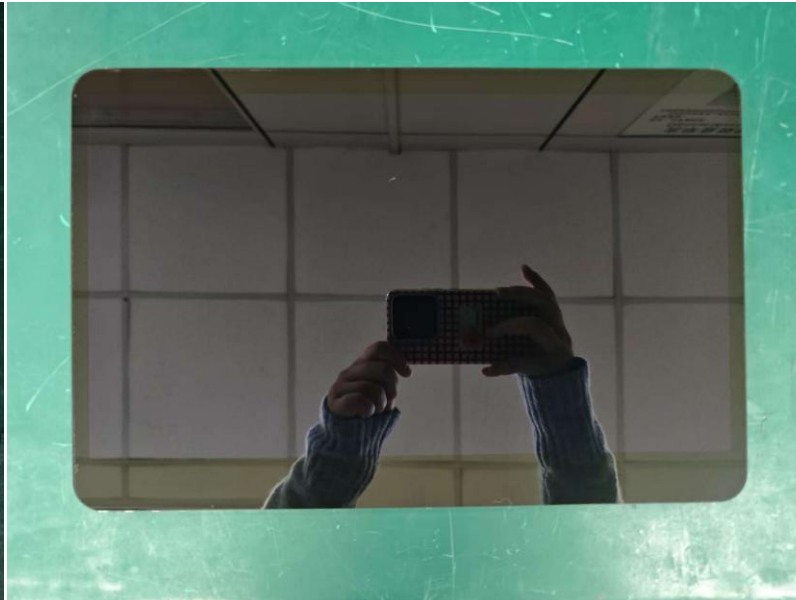
- Step 1: Visual Inspection:

No abnormality was found on the panel appearance  
No cosmetic defect, damage, or contamination was observed on either front or back side

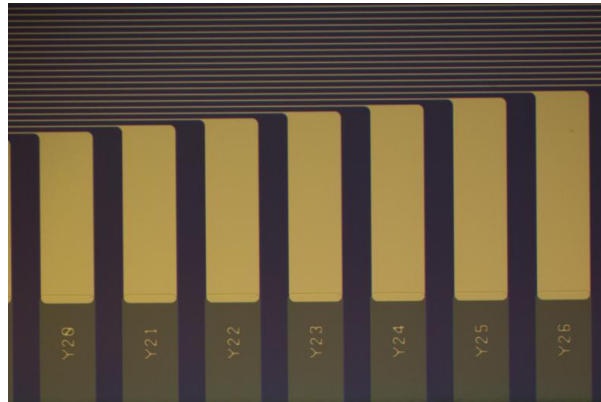
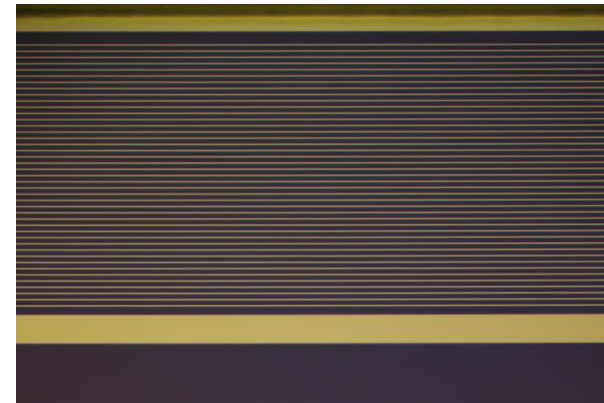
## Step 5: TP Circuit Inspection (OM)

- Optical microscopy inspection was performed on TP routing lines
- No abnormality was observed in the circuit pattern
- No open, short, breakage, or deformation was identified;

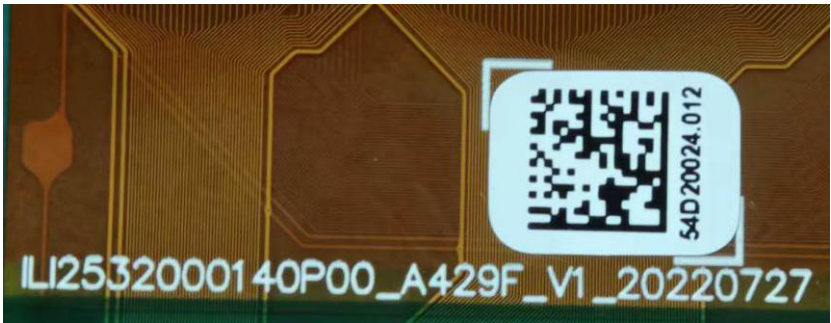
- 1.The TP NG issue reported by customer was confirmed by AUO re-test, showing failure at Y23 channel in Open & Short Test
  - 2.Based on the analysis results, no abnormality was found in panel, bonding, or TP circuit routing
  - 3. The issue is initially considered to be related to TP FPCa
- ADP(AUO) request our supplier Ichia to do further analysis

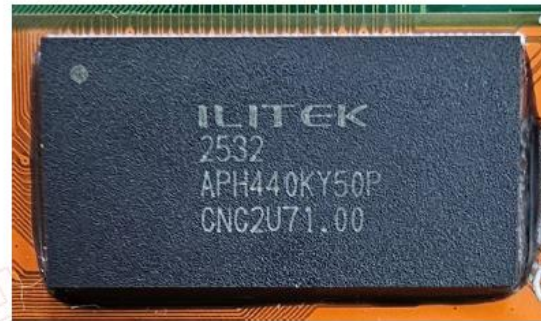
## Analysis - Appearance inspection

- Based on ILITEK analysis, no abnormality was observed on IC appearance during visual inspection
- No damage, contamination, or abnormal marking was identified on the IC surface
- The IC physical condition is confirmed to be normal

- No obvious abnormalities were found during visual inspection.
