# FA FMA Analysis Report

Junglim-G154EVN01.0 Sandy Mura

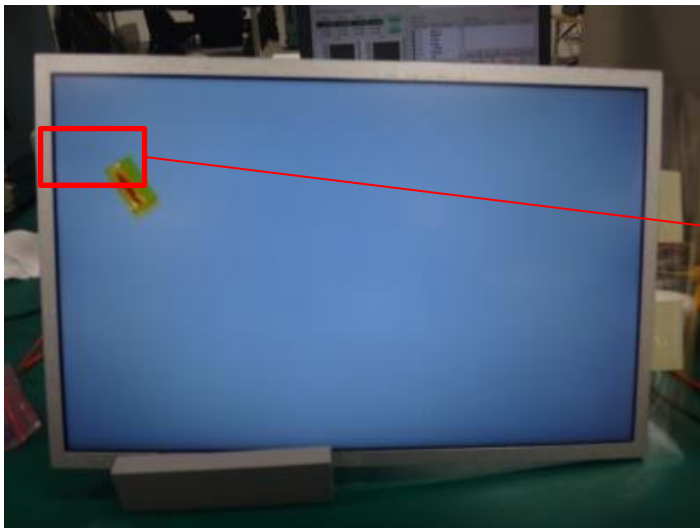
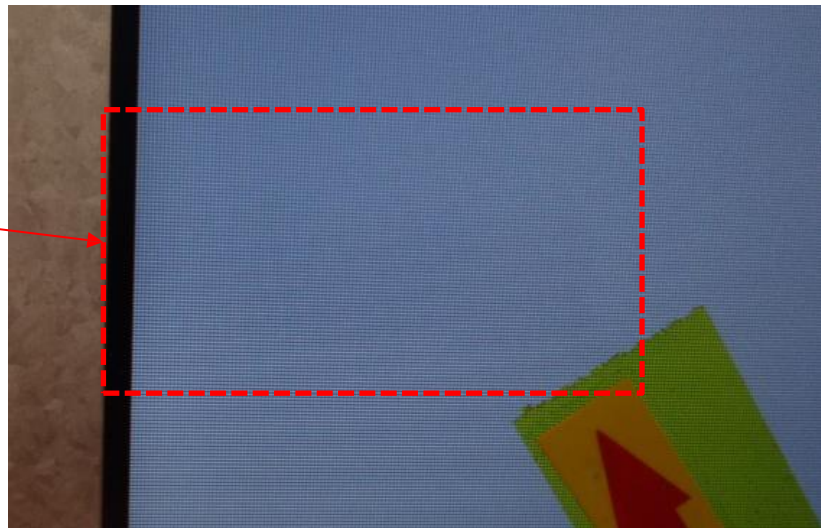
1) Customer reported defect: Sandy mura. °

- Defect Phenomenon

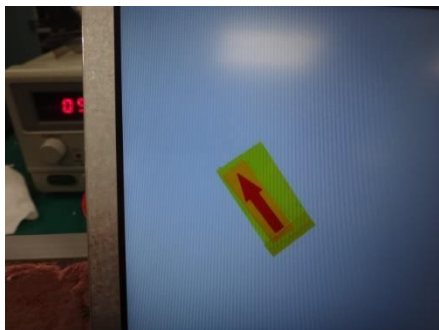
VCOM adjustment cannot eliminate the phenomenon, therefore cell issue can be ruled out.

Varying VCOM does not change the Mura

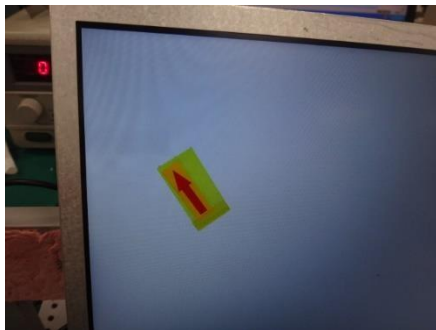
No indication of TFT off-state / leakage-related issue.

Varying VGL shows no visible change the Mura

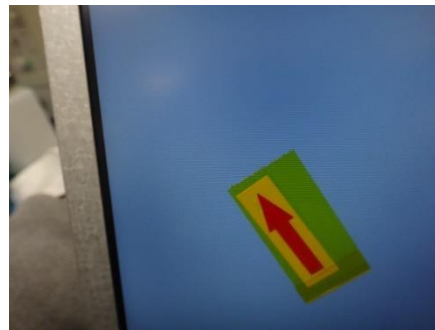
Lowering VGH makes the mura more noticeable; increasing VGH makes the mura lighter.

Lowering VGH makes the mura more noticeable;  
increasing VGH makes the mura lighter.

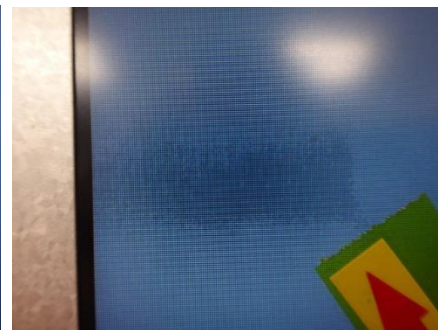
- **Varying VGH affects the mura severity**

| Voltage tune | VCOM | VGL | VGH |
| Higher | No Change | No Change | lighter |
| Lower | No Change | No Change | more noticeable |

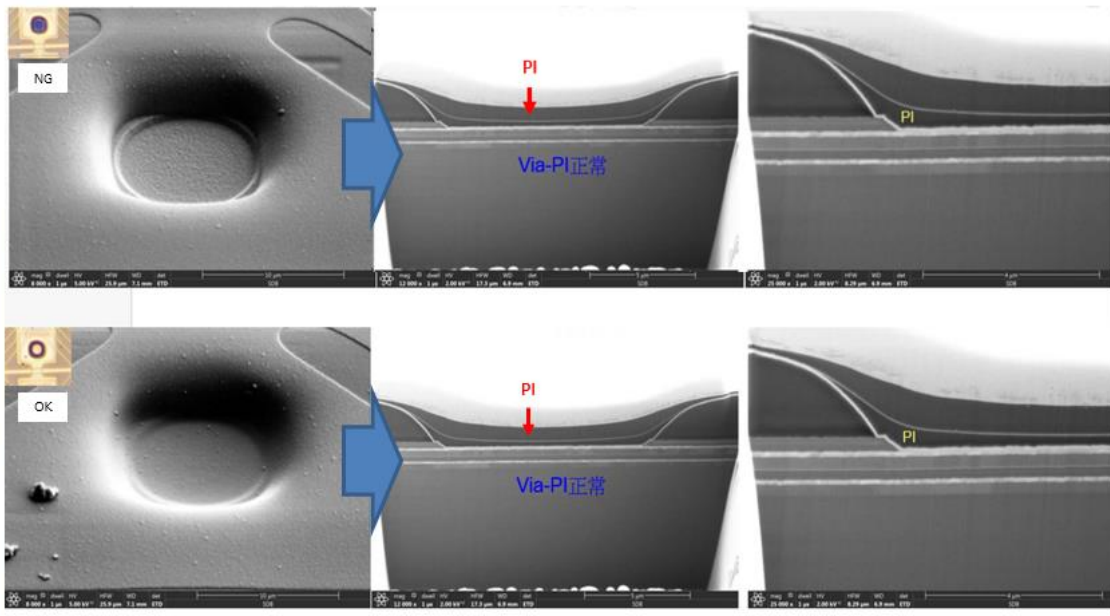
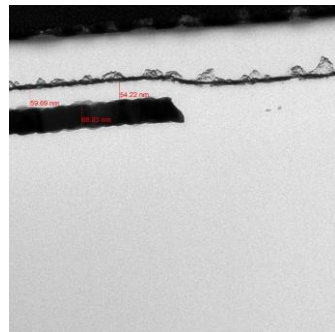
Step2: FIB check → No abnormality observed in PI / Via-PI interface
