# FA report of X-Short issue

JUNGLIM G270QAN01.4

Date 2026.04.07

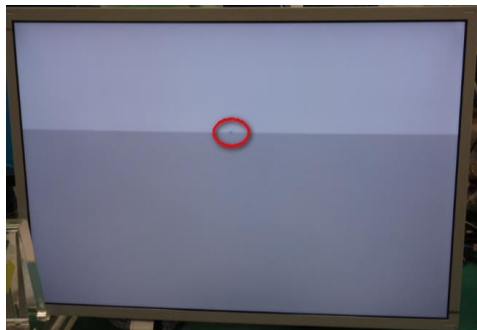
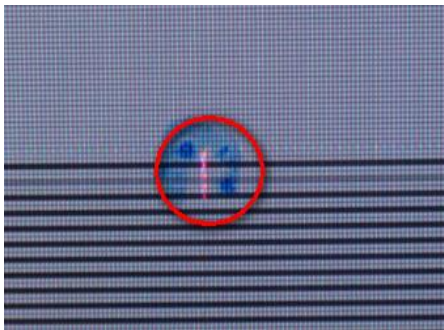
Turned on the panel, and the phenomenon same as customer's feedback and there is bright short\_line also found.  
ADP internals' defect code: X-Short
