G240HVN01.0  
BL defect

Date : June.11.'26

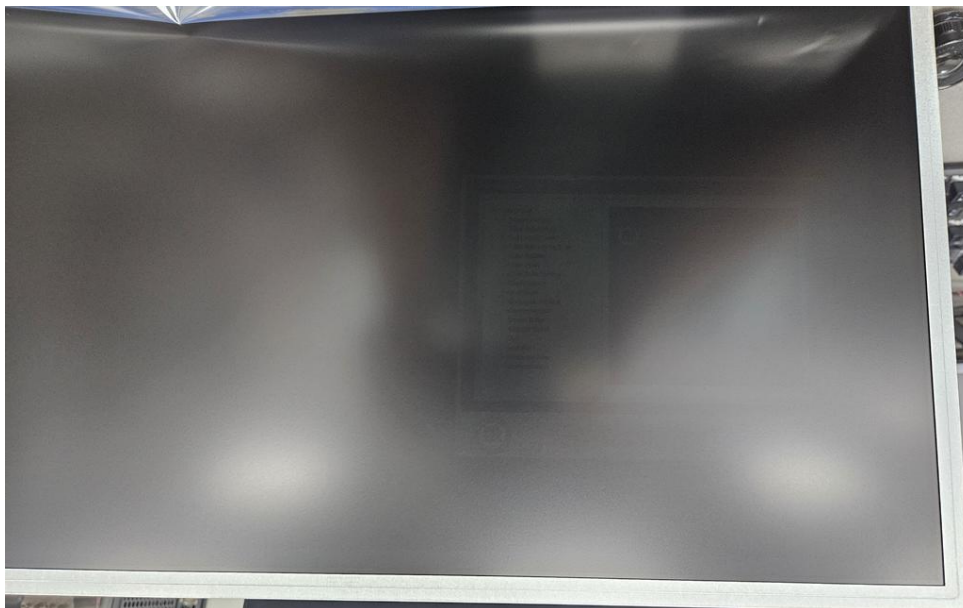
Junglim's Test picture

- \* We confirmed the issue reported by the customer regarding no image appearing when the screen is turned on.

It was determined that this issue occurred due to the backlight not operating.

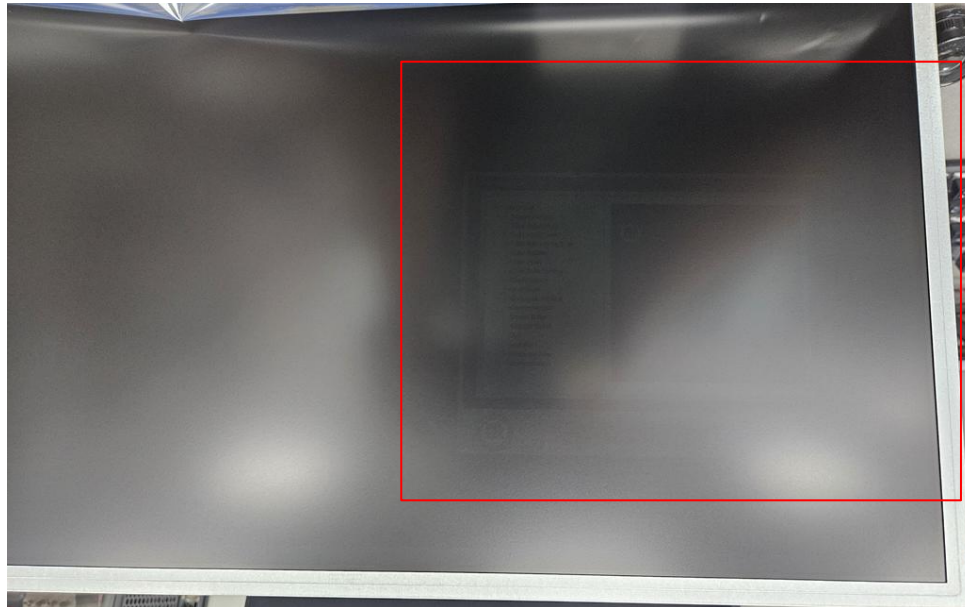
The image is displayed.

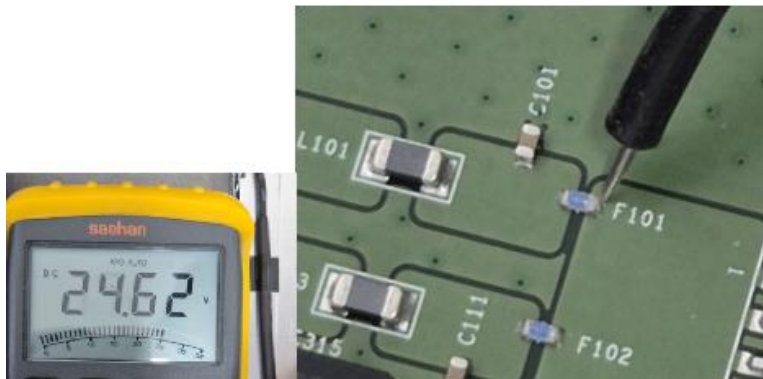
Input check (F102)

- \* The backlight driver board has been checked.
- \* We confirmed that the fuse is open. (F102 & F101)

1. The fuse in the backlight circuit was confirmed to be in an open condition.
2. As a protective device, the fuse is designed to disconnect when current exceeding its rated limit flows through it.
3. Therefore, this failure is presumed to have been caused by overcurrent in the backlight driving circuit or a short-circuit condition.

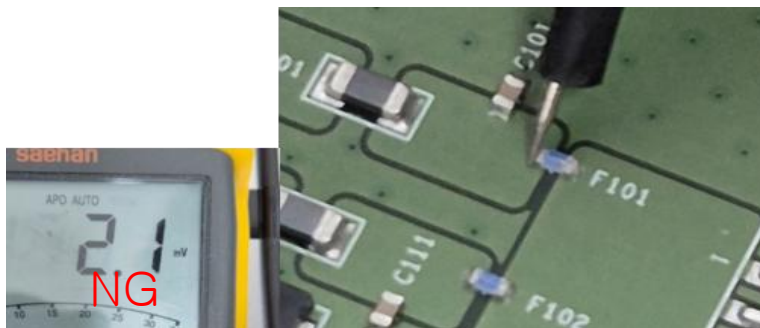
Output check

F101 (Fuse) check

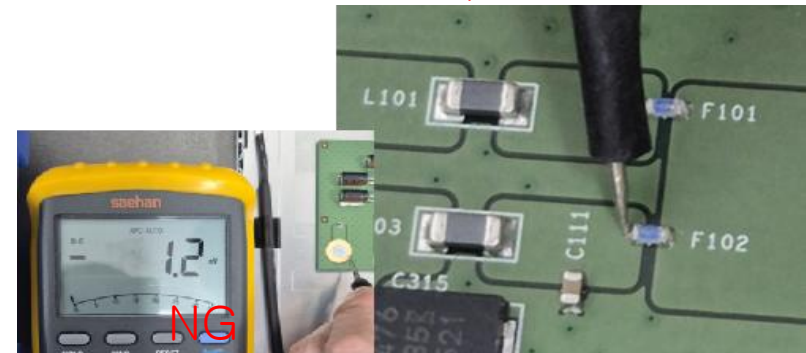
Output check

F102 (Fuse) check
