# FA report of Flicker issue

JUNGLIM\_P215HAN01.1

Date : 2026/03/23

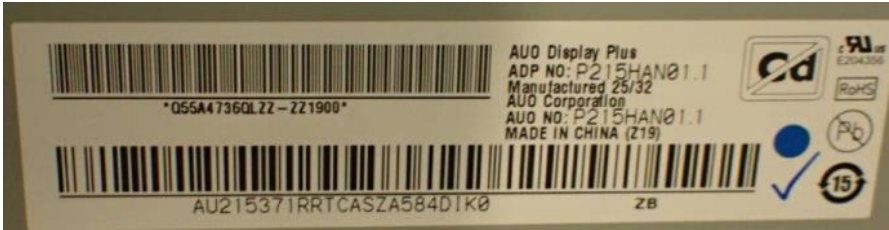
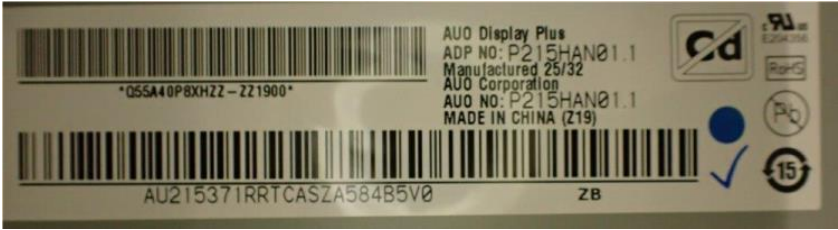
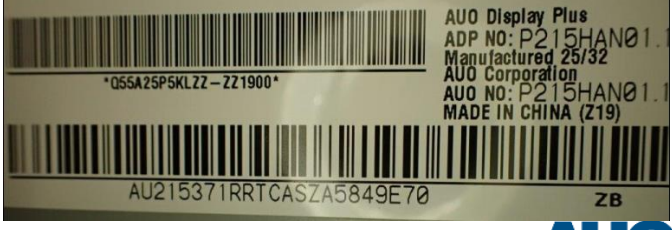
- Defect Panel S/N Picture

| AUO S/N | Q55A25P5KLZZZZ1900<br>Q55A4736QLZZZZ1900<br>Q55A40P8XHZZZZ1900 | Chip ID | A25P5KL<br>A4736QL<br>A40P8XH |

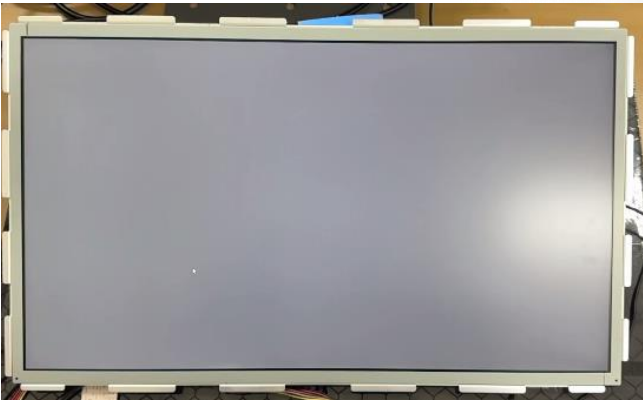
- After aging, screen flicker occurs on the gray pattern during On/Off switching.
