# FA report of JUNGGLIM GI56HAB03.2 Dark shadow MURA

Date 2026.02.12

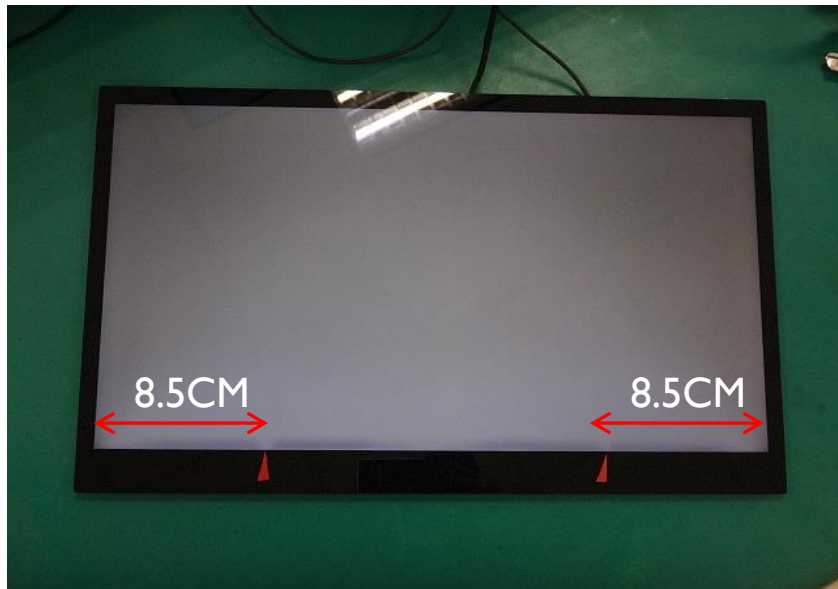
We use the defect panel from Junglim on Jan 28<sup>th</sup> to duplicate the dark shadow.

After increasing aging temperature from 50 to 60 degree , a black linear MURA appeared at the bottom—on the bottom side.

Inside the black linear MURA, there are two white notches located approximately 8.5 cm from the left and right edges of the AA area, and each notch is about 7 mm wide.

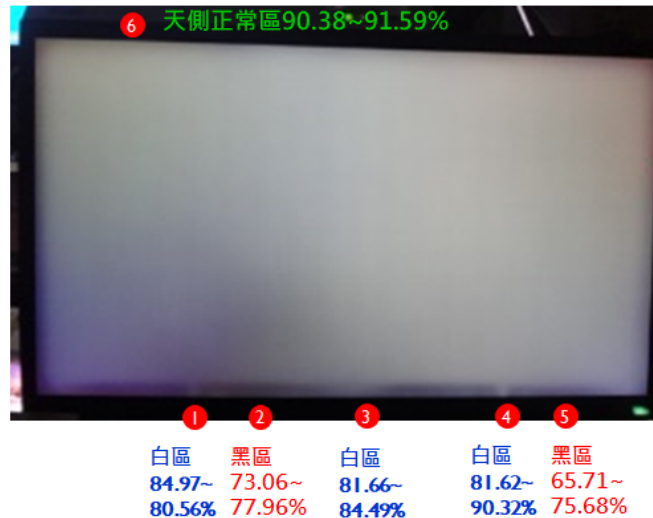
## Curing ratio

1. After verifying the curing ratio in 6 area from defect panel JL provided, the curing ratio is insufficient.
2. The curing ratio of mura area (2&5) is under 80%. The curing ratio of area (1&3&4) is over 80%. The curing ratio of area 6 is over 90%. (Target : > 90%)
3. The main reason of mura is insufficient curing ratio.

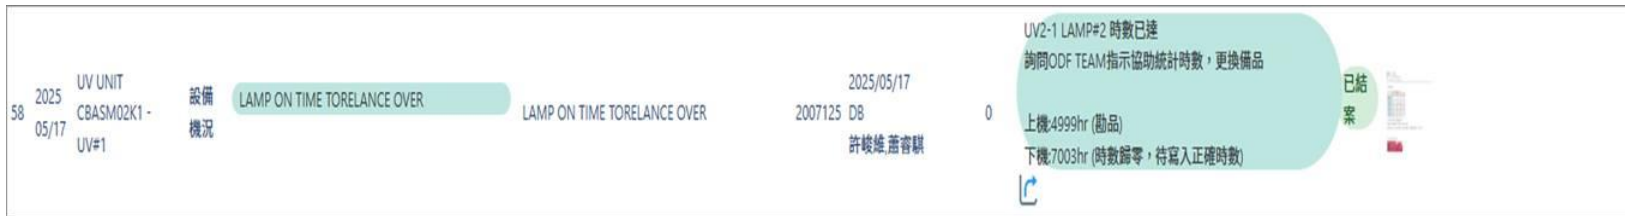
## Assembly Process :

1. Used removed lamp on May 17<sup>th</sup> : From assembly process, AUO found fab use UV lamp which is removed lamp due to original lamp over 7000 hours.
2. The rule should not be allowed to use the removed lamp. But AUO fab didn't follow it.
3. Follow up: Modify the SOP. Feb. 26<sup>th</sup>.
