**P320HVN02.3**  
**No display**

MQABB0

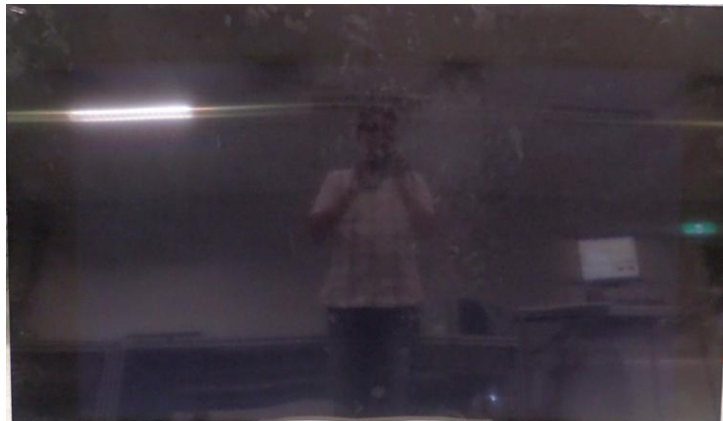
After turning on the defect panels, we found the symptom was ND as customer complaint.

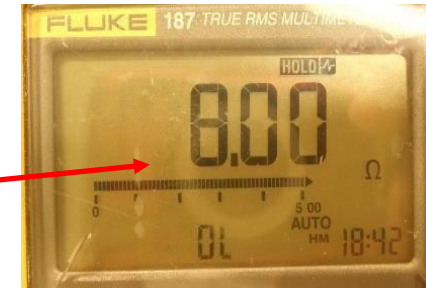
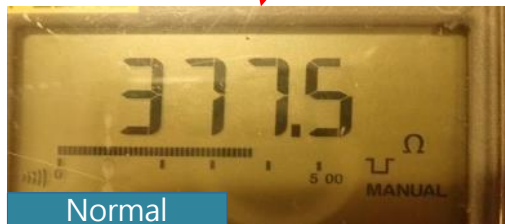
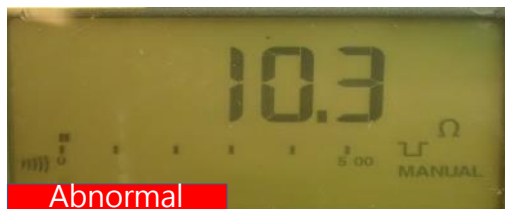
## ■ Root cause : 3B5F6FF3KRZZZS1300 (25/33)

- Turn on the panel, the no display failure was duplicated as customer complained.
- To measure V12, it was found short to GND.
- Check D113 function fail.
