# FA report of Greenish display (NDF)

JUNGLIM G133HAN01.1

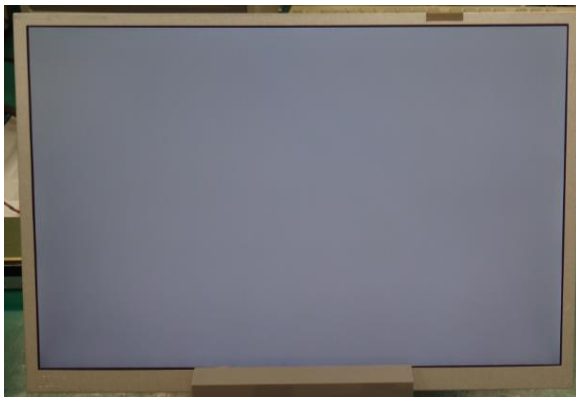
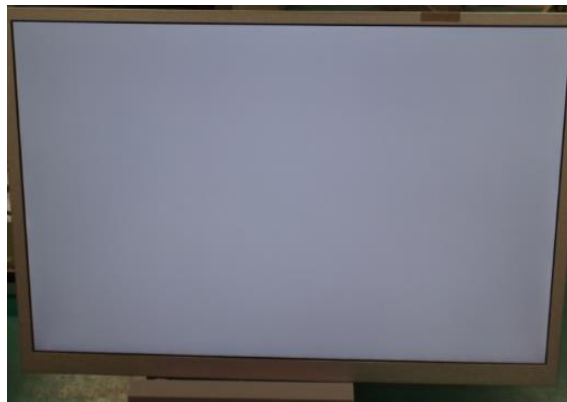
Under normal display conditions (e.g., L92 pattern), no visible abnormality is observed. The panel appears uniform, and no greenish display is detected under this condition.

no abnormality

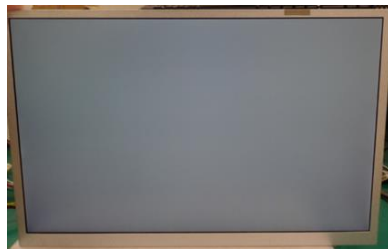
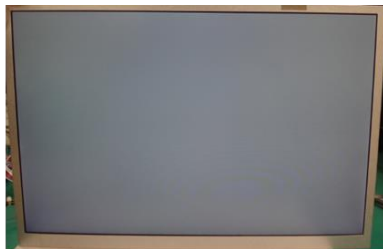
L64

- The panel was evaluated under the **L64 pattern** and **gray-scale (gradient)** patterns.
- No visible abnormality or greenish phenomenon was observed during these tests.
- The display appearance remained uniform across the panel under both test conditions.

The **L64 pattern** applied in this evaluation is a tightened inspection condition that was established based on a similar phenomenon observed previously, in agreement with the customer.

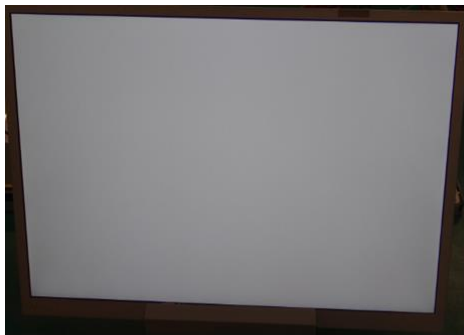
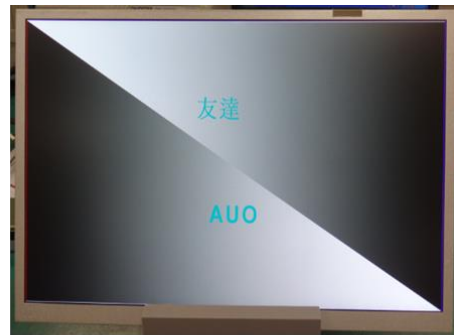
- The panel was evaluated under the L128 pattern.
- No visible abnormality or greenish phenomenon was observed during this test.
- The display appearance remained uniform across the panel.

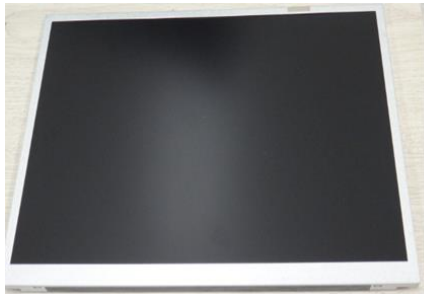
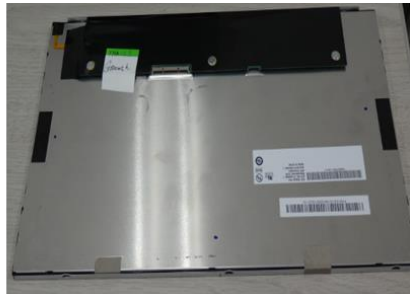
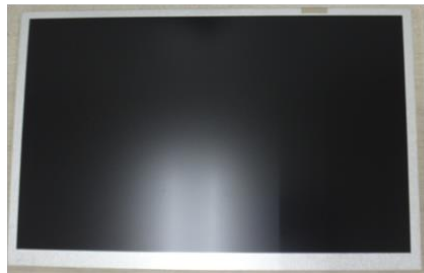
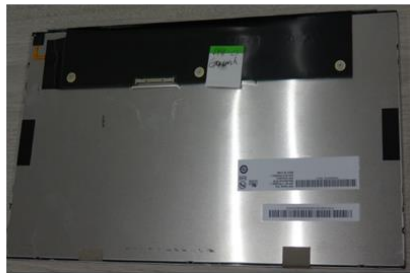
- The panel appearance was visually inspected on both the front and rear side.
- No obvious abnormality, contamination, or defect was identified during the inspection.

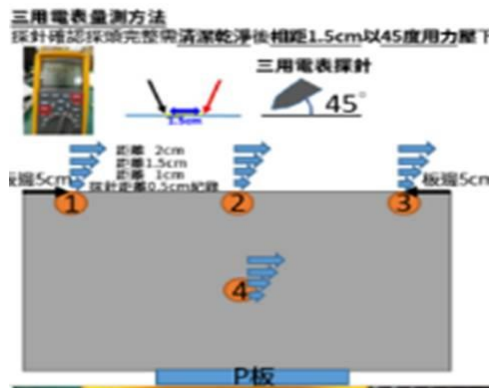
- ITO sheet resistance (RS) measurements were performed on two sampling locations (#1 and #3) for each returned unit. Max., Min., and Avg. values were recorded at different probe distances.
- The measurement results show that the RS values are within a consistent range across different positions and distances, with no significant variation observed.
