# FA report of TP glass chipping issue

JUNGLIM G140HAB01.2

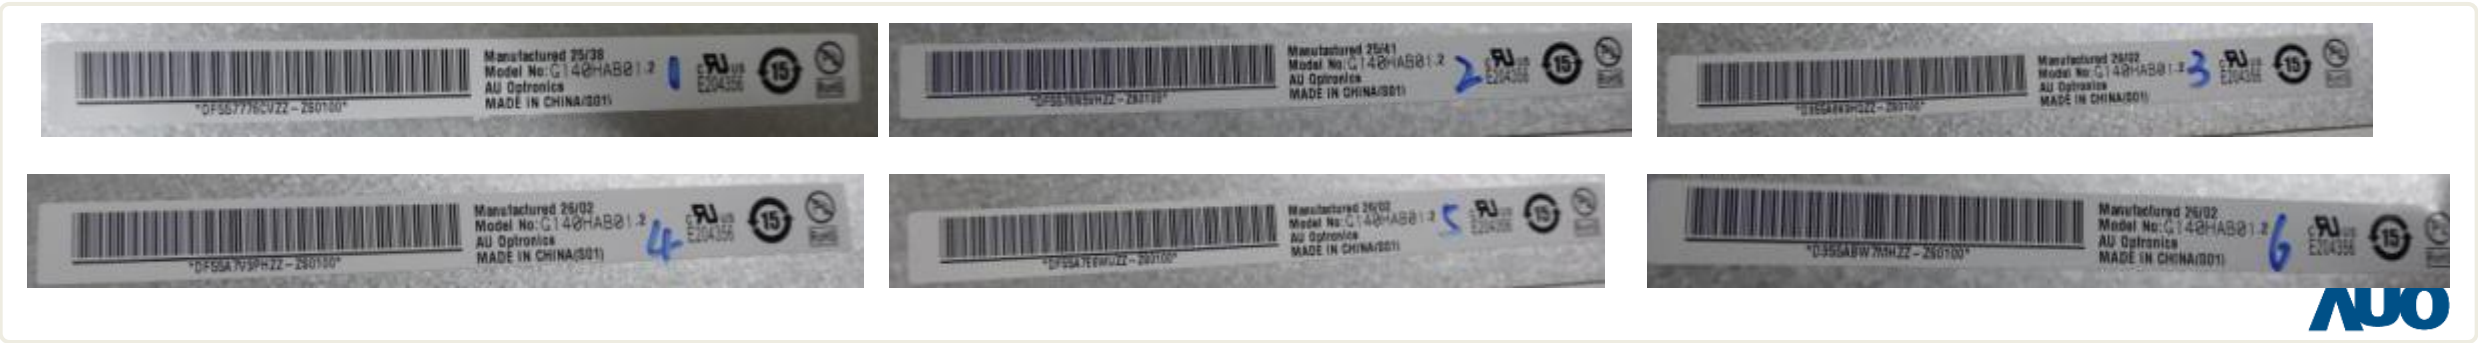
- Defect Panel S/N Picture

- 1) JUNGLIM identified 6 pieces of G140HAB01.2 panels exhibiting TP glass chipping.
- 2) After verification, the same TP glass chipping phenomenon is also observable at AUO during inspection.

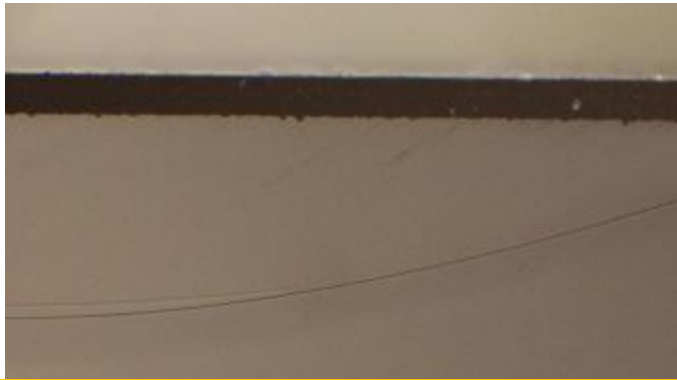
Panel-1 Fine crack-like chipping was observed along the edge of the cover lens.

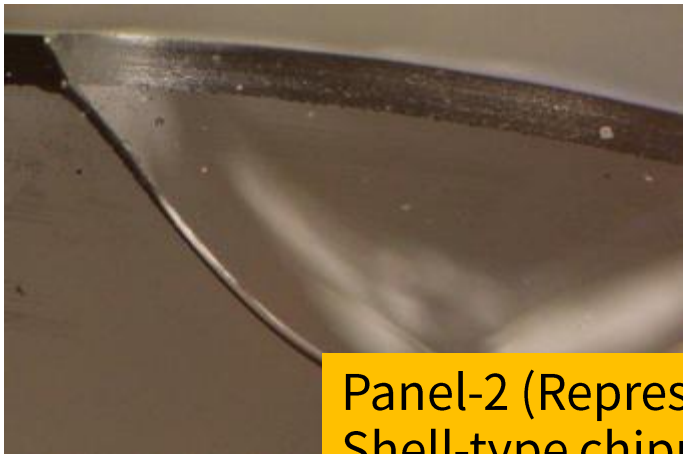
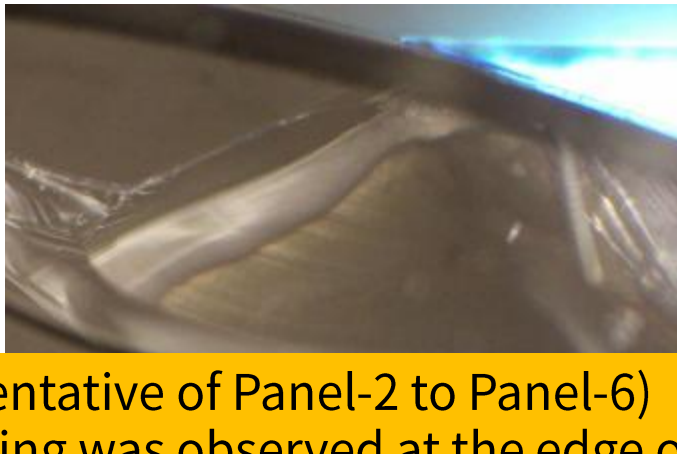
Panel-2 (Representative of Panel-2 to Panel-6)  
Shell-type chipping was observed at the edge of the cover lens.

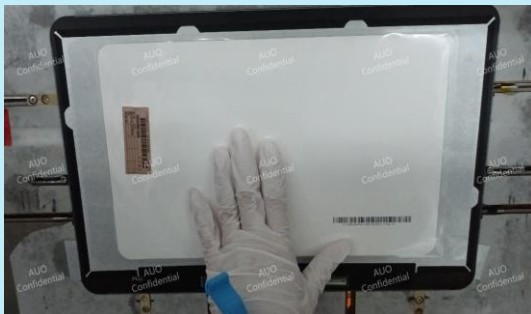
### DB bonding

- Short edges fixed by clamp, no direct contact.
  - Long edge contacts positioning pin (anti-scratch material).
  - Distance to C/L OD: 40 mm.
- Not mapping with customer defect position.

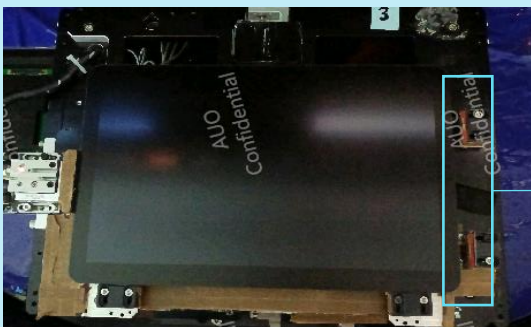
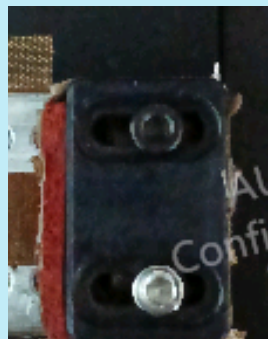
### TPI AOI

- Two side positions directly contact C/L via pins with pushing motion.
  - Distance to C/L OD: 23 mm.
  - Pins protected with buffer material(since 2024).
- Defect positions not concentrated and different from previous feedback

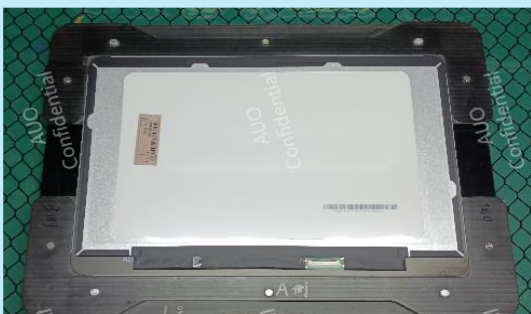
### DSA

- Positioning posts may be contacted during manual pick & place.
  - Distance to C/L OD: 23 mm / 26 mm.
- Positioning posts are metal, collision may cause edge chipping.

1. Based on failure analysis, OM observation, simulation verification, and full process review, the TP glass chipping is determined to be caused by external mechanical force applied to the cover lens edge, rather than intrinsic material abnormality.
2. The defect morphology and location are consistent with edge collision during manual handling, especially when the panel edge contacts hard objects.
3. Among all reviewed processes, DSA bonding shows the highest risk correlation, due to manual operation and the use of metal positioning posts near defect-mapping distances.

Replace all jig positioning blocks with Bakelite fixtures, in order to avoid edge cracking caused by accidental collision during operator handling. **Estimated completion date: 2026.5.4**

1. All metal positioning posts have been replaced with Bakelite fixtures to mitigate edge impact risk.
2. An SOP add-on inspection step is introduced to check for white impact marks or edge chipping on all four edges after DSA tape application.
3. These countermeasures aim to eliminate external impact sources and prevent recurrence.

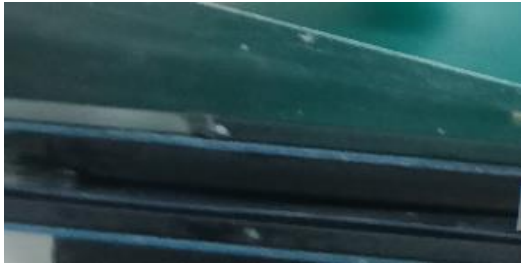
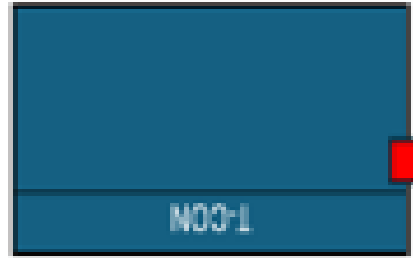
### ➤ Previous Feedback(2024) :

The phenomenon is fixed at side B, and the distance from the C/L OD edge is approximately 23 mm.

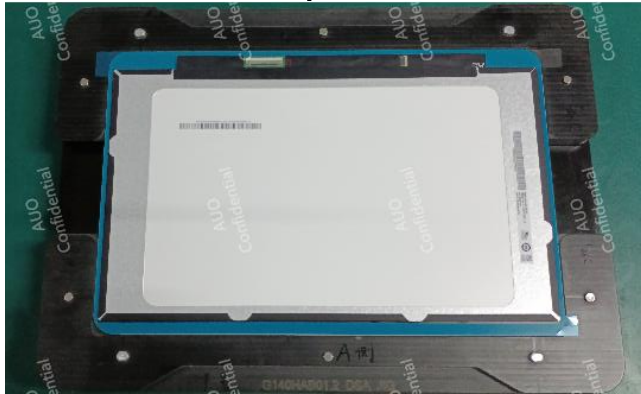
## ➤ Simulation Test

It is initially suspected that edge collision with the positioning post during panel handling (pick-up and placement by operators) leads to impact marks.

- Since the overall external contour is a symmetrical structure
- When operators place the panel into the fixture, reverse placement may occur, and during manual adjustment after pick-up, edge collision may occur
- White crack-like changes appear at the impact location
