# FA report of V Block issue(NDF)

JUNGLIM G140HAB01.2

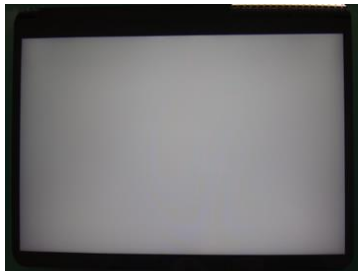
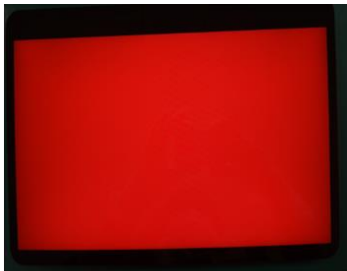
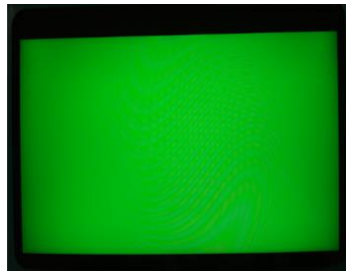
No abnormality is observed under dot/on-screen pattern verification.

Display appears normal across inspection patterns.

1. No visible line or mura under standard pattern check.
2. The defect is not reproducible during internal display verification.
3. Phenomenon is identified as **V-block reported by customer**, but not confirmed under current test conditions.

Display normal

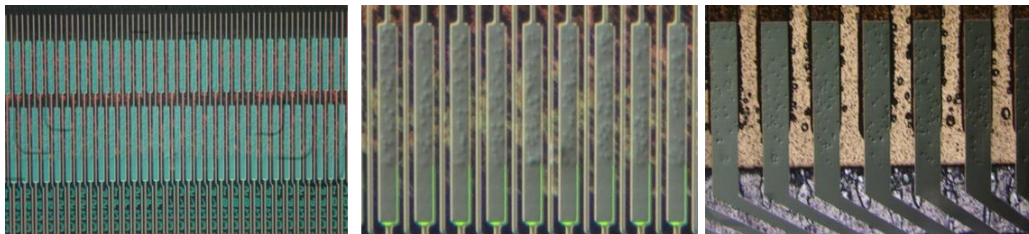
1. Conductive particle distribution at the IC bonding area is normal and uniform.
2. No abnormality is observed in bonding quality.
3. Signal routing/traces are confirmed to be intact and continuous.

Conductive particle(IC Bonding) normal

Signal routing/traces normal

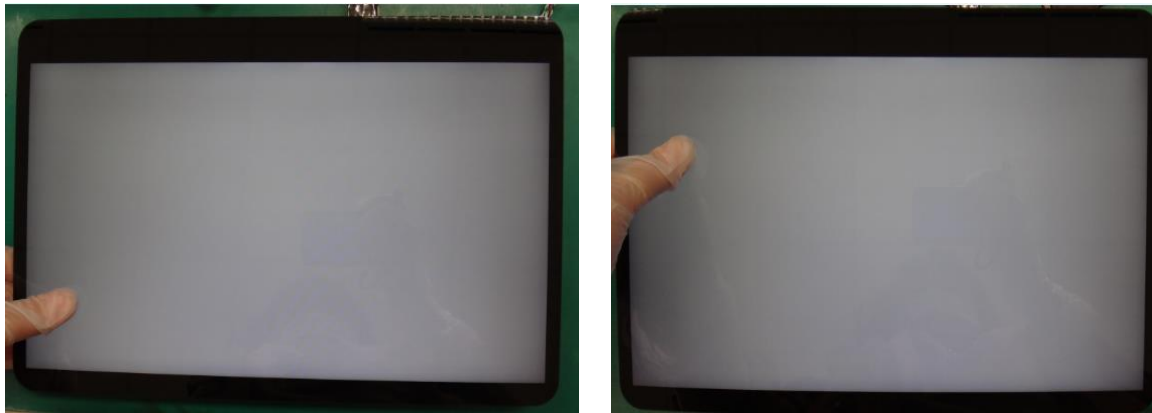
1. No abnormality is observed during the pressing test.
2. The display remains stable without any V-block or image distortion under applied pressure.

No abnormality is observed during the pressing test

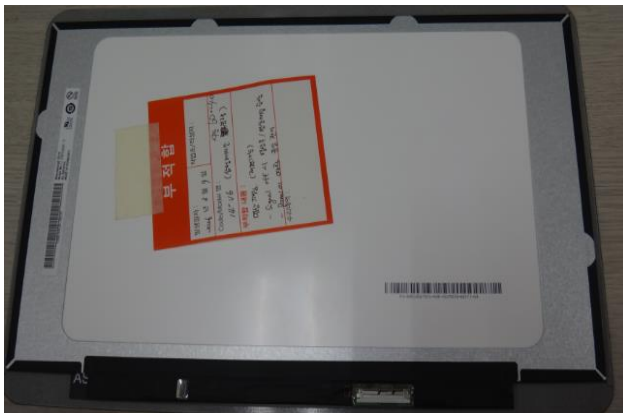
1. No abnormality is observed in the external appearance.
2. No visible damage, contamination, or mechanical defect is found.

Appearance normal
