# Florida Inspection Associates Nationwide

vehicle  
report #342620

**Vehicle** : 2017 CHEV CAMARO

**Customer Complaint** : Guest states tapping noise from engine when in gear since last oil change.

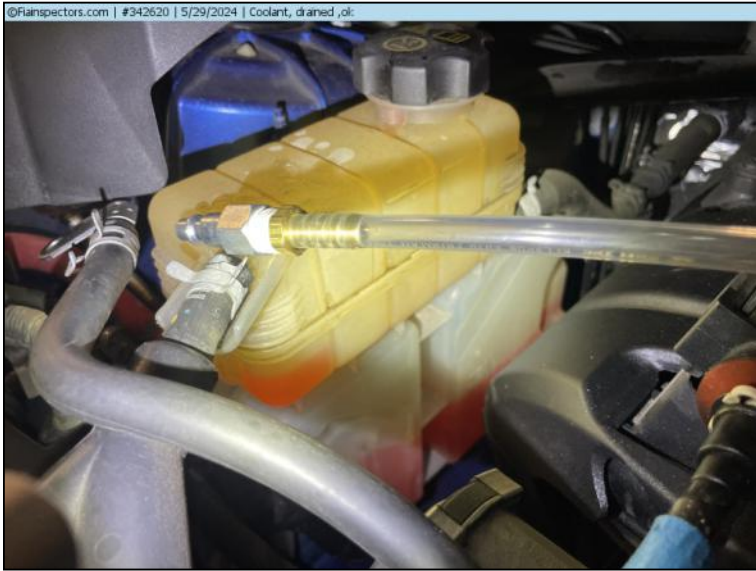
©Flanspectors.com | #342620 | 5/29/2024 | Coolant, drained, ok.

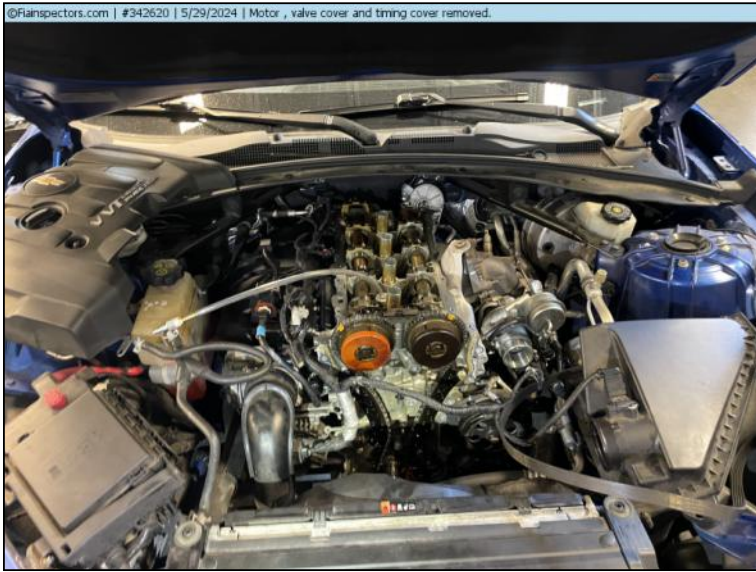
**Inspectors Report** : Yes, the valve cover and front timing cover were removed.

©Flanspectors.com | #342620 | 5/29/2024 | Motor, valve cover and timing cover removed.

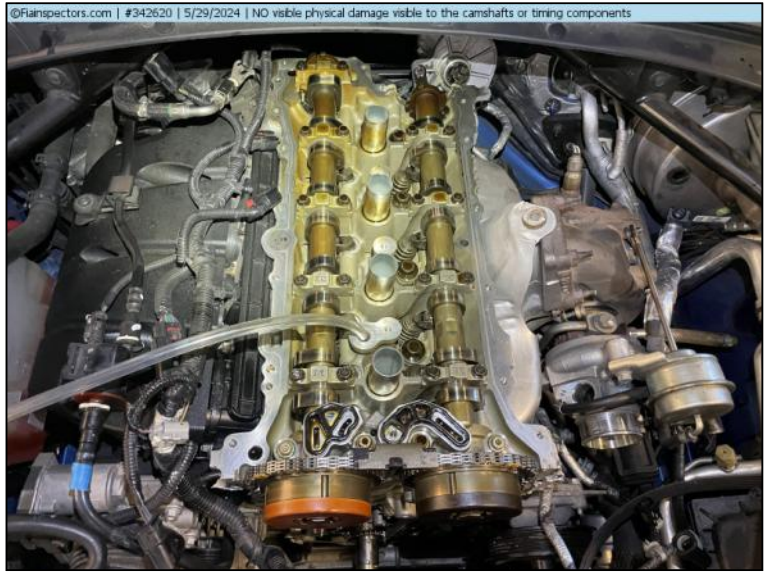
I met with the tech. He reported a noise from the motor that would stop when the Intake VVT phaser control valve connector was unplugged. He has already removed the valve cover and timing cover to inspect for damage to the camshafts and timing chain components. He found NO damage to the camshafts, timing chain, timing chain tensioner, or guides. The tech reported that the intake VVT phaser has an internal failure and is the source of the noise. All other sources of noise in the front of the motor have been excluded. The motor oil was drained but the condition of the pooled oil on the front timing cover was good, no slugging or lubrication concerns were found.

**Inspector's opinion of cause:** Suspected internal failure of the intake VVT phaser due to normal long-term use and wear.

©Flanspectors.com | #342620 | 5/29/2024 | NO visible physical damage visible to the camshafts or timing components

**Corrective Action Needed** : Replace the intake VVT phaser and retest for noise.

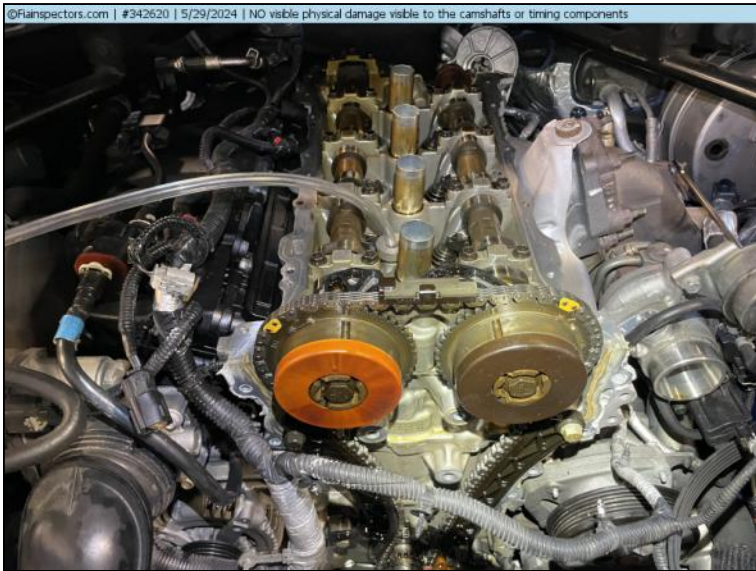
©Flanspectors.com | #342620 | 5/29/2024 | NO visible physical damage visible to the camshafts or timing components

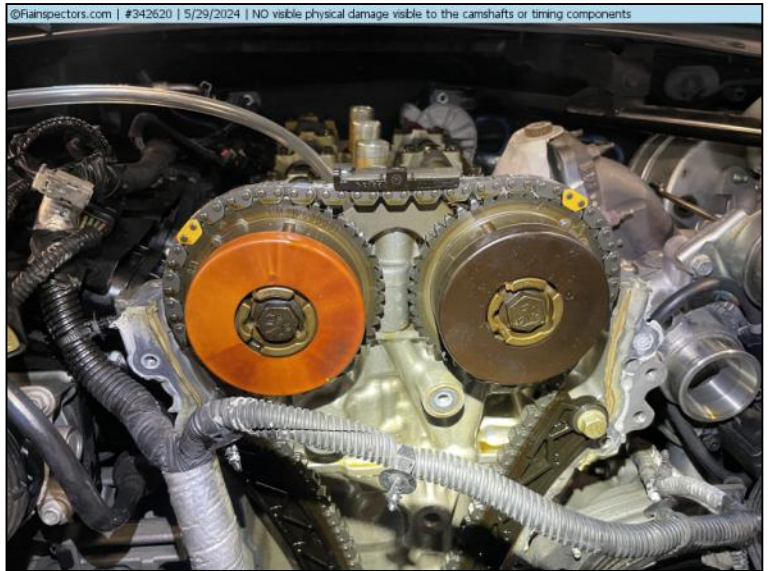
©Flanspectors.com | #342620 | 5/29/2024 | NO visible physical damage visible to the camshafts or timing components

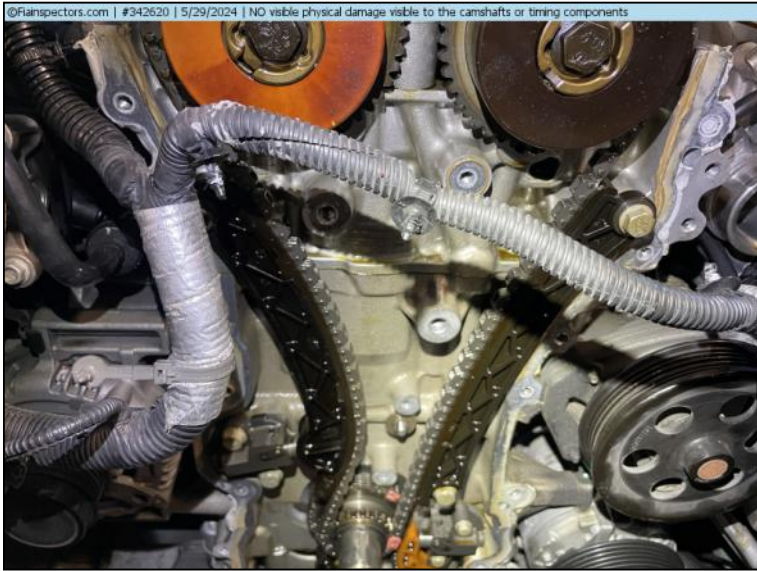
©Flanspectors.com | #342620 | 5/29/2024 | NO visible physical damage visible to the camshafts or timing components

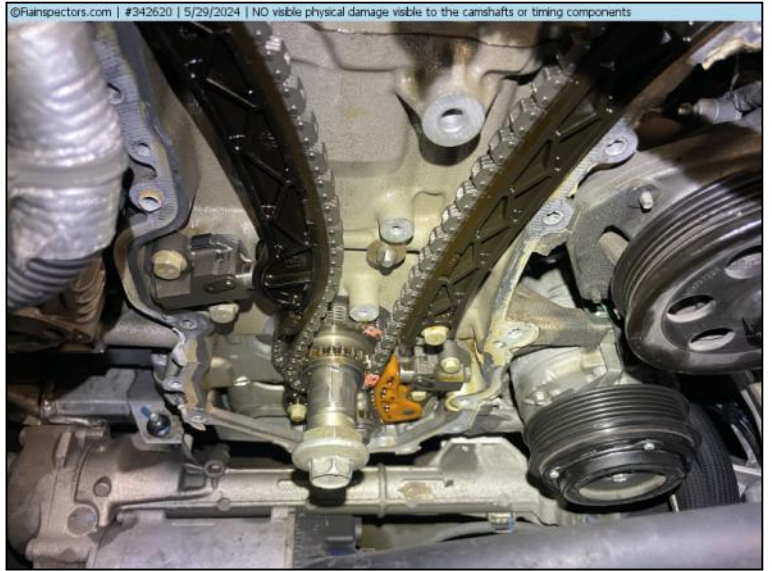
©Flanspectors.com | #342620 | 5/29/2024 | NO visible physical damage visible to the camshafts or timing components

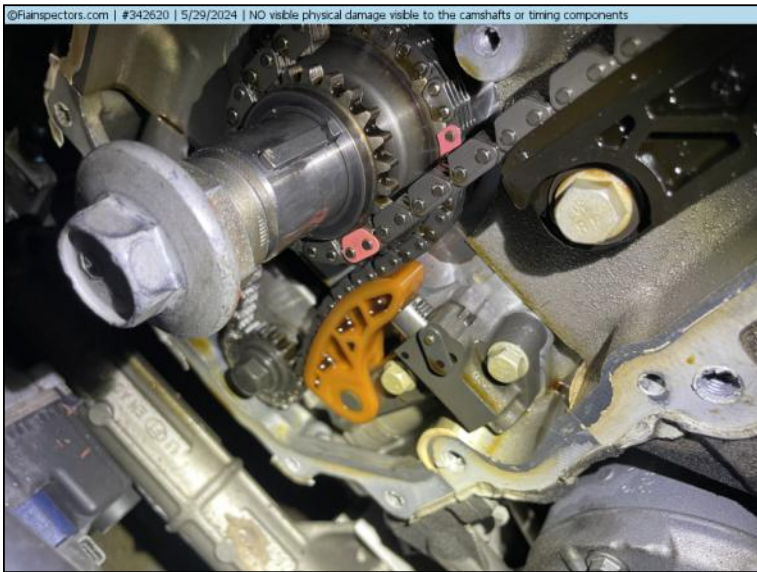
©Flanspectors.com | #342620 | 5/29/2024 | NO visible physical damage visible to the camshafts or timing components

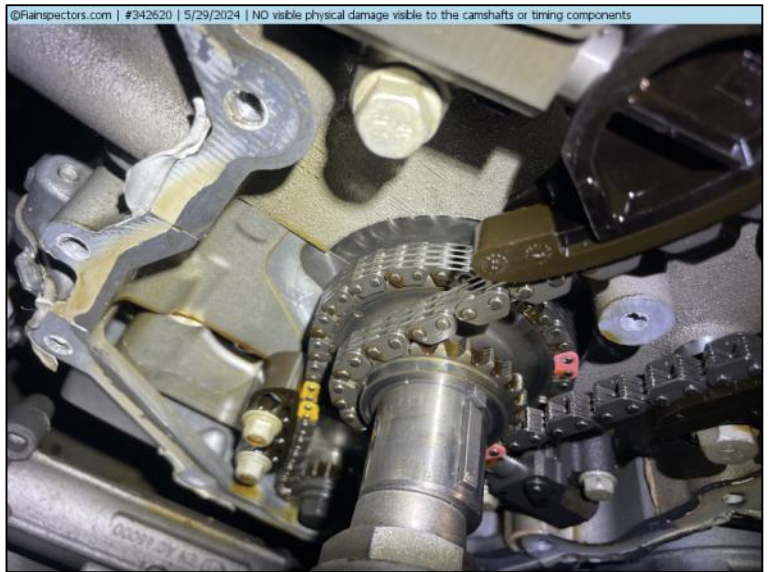
©Flanspectors.com | #342620 | 5/29/2024 | NO visible physical damage visible to the camshafts or timing components

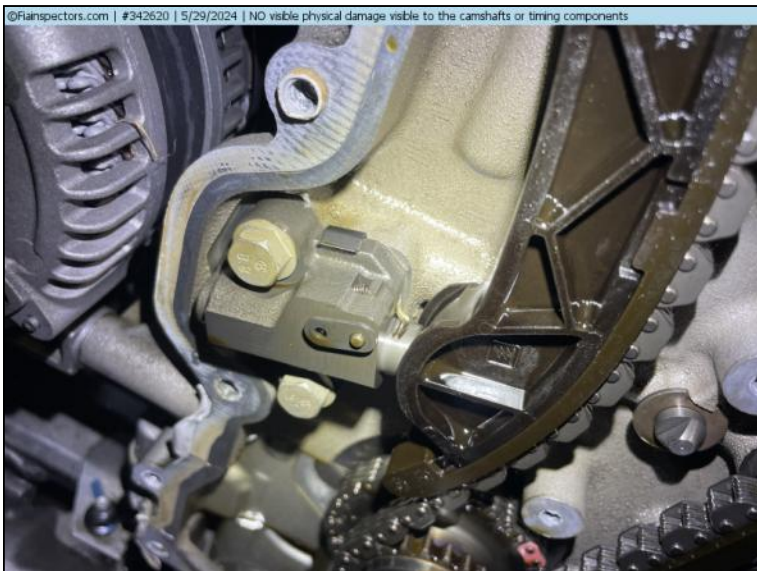
©Flanspectors.com | #342620 | 5/29/2024 | NO visible physical damage visible to the camshafts or timing components

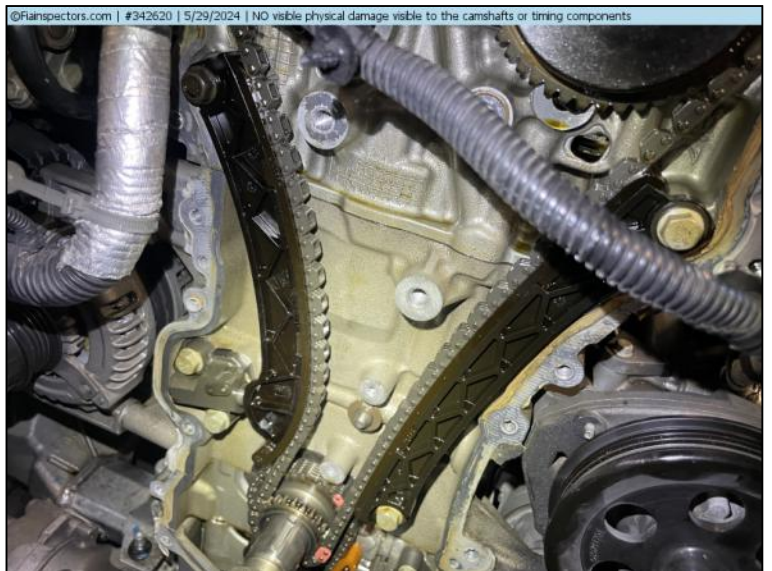
©Flanspectors.com | #342620 | 5/29/2024 | NO visible physical damage visible to the camshafts or timing components
