# Florida Inspection Associates Nationwide

vehicle  
report #342620

**Vehicle** : 2017 CHEV CAMARO

**Customer Complaint** : Guest states tapping noise from engine when in gear since last oil change.

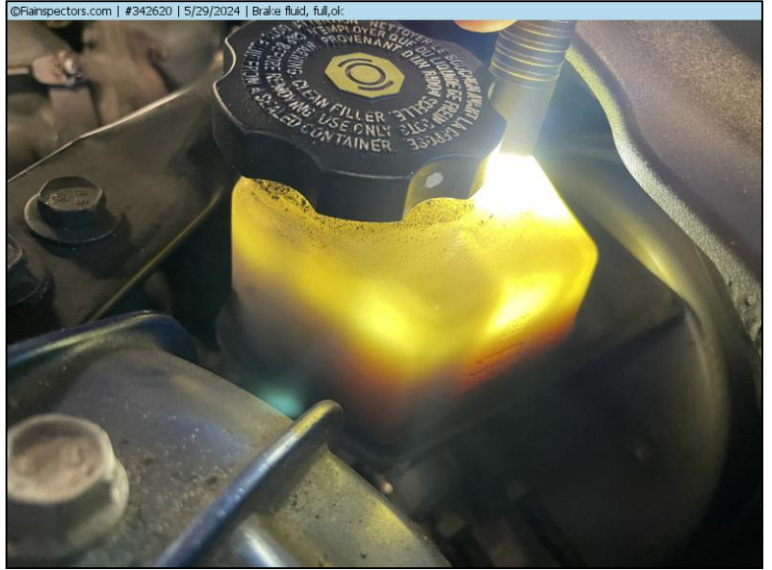
©Flainspectors.com | #342620 | 5/29/2024 | Brake fluid, full, ok

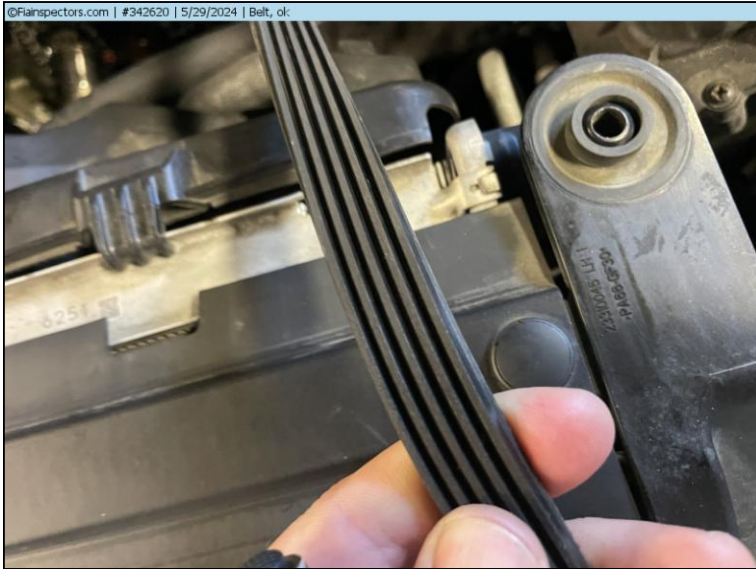
©Flainspectors.com | #342620 | 5/29/2024 | Belt, ok

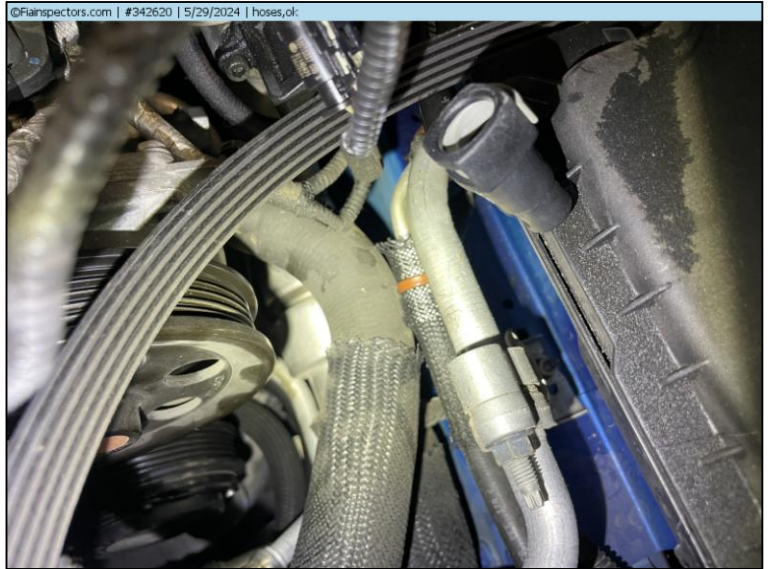
©Flainspectors.com | #342620 | 5/29/2024 | hoses, ok

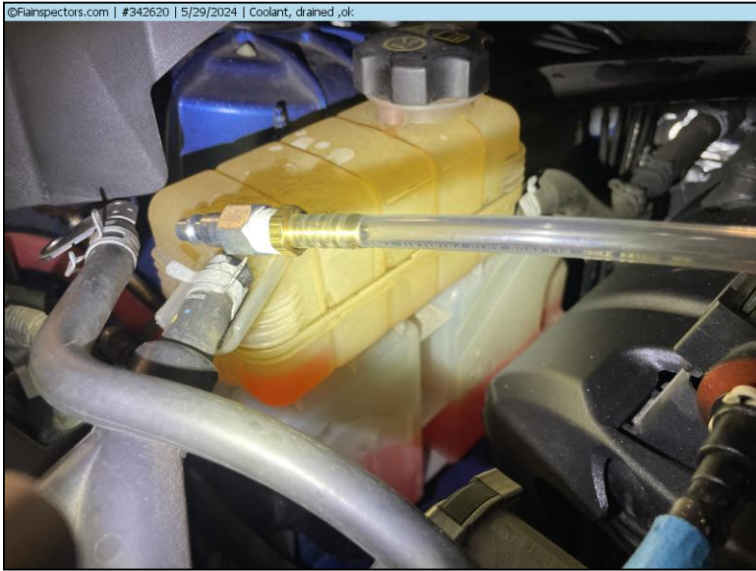
©Flanspectors.com | #342620 | 5/29/2024 | Coolant, drained ,ok:

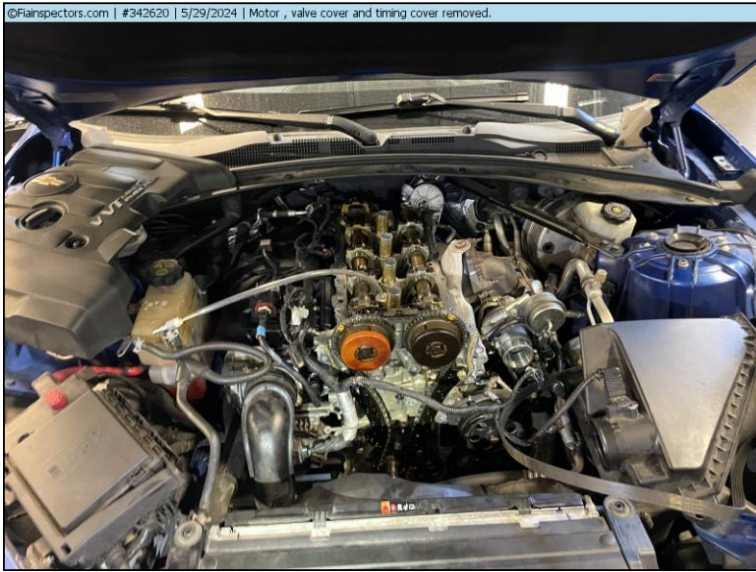
I met with the tech. He reported a noise from the motor that would stop when the Intake VVT phaser control valve connector was unplugged. He has already removed the valve cover and timing cover to inspect for damage to the camshafts and timing chain components. He found NO damage to the camshafts, timing chain, timing chain tensioner, or guides. The tech reported that the intake VVT phaser has an internal failure and is the source of the noise. All other sources of noise in the front of the motor have been excluded. The motor oil was drained but the condition of the pooled oil on the front timing cover was good, no slugging or lubrication concerns were found.

©Flanspectors.com | #342620 | 5/29/2024 | Motor , valve cover and timing cover removed.

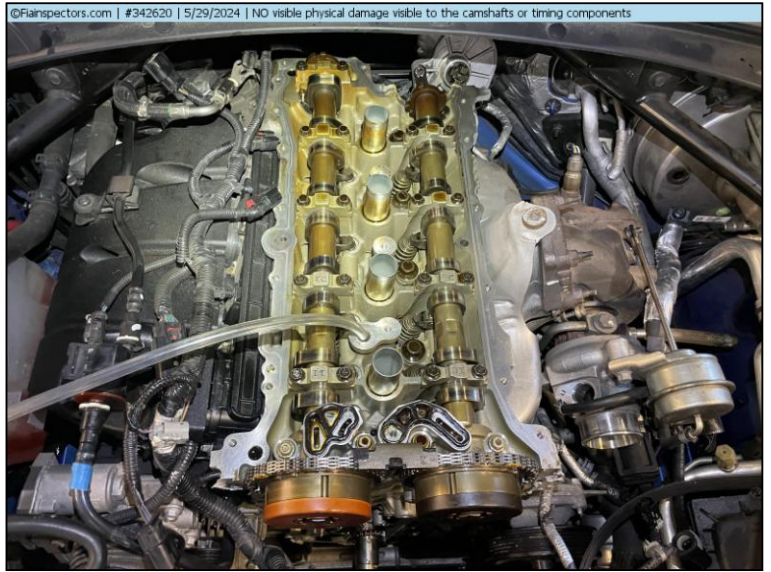
**Inspector's opinion of cause:** Suspected internal failure of the intake VVT phaser due to normal long-term use and wear.

©Flanspectors.com | #342620 | 5/29/2024 | NO visible physical damage visible to the camshafts or timing components

**Corrective Action Needed** : Replace the intake VVT phaser and retest for noise.

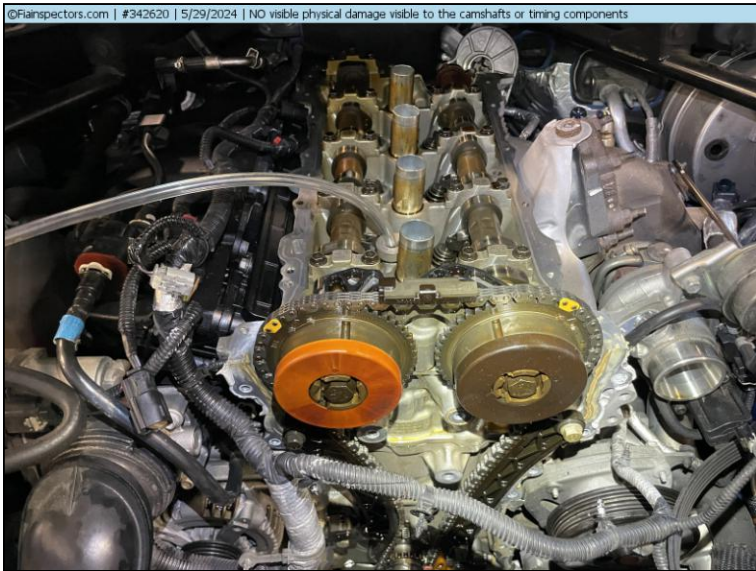
©Flanspectors.com | #342620 | 5/29/2024 | NO visible physical damage visible to the camshafts or timing components

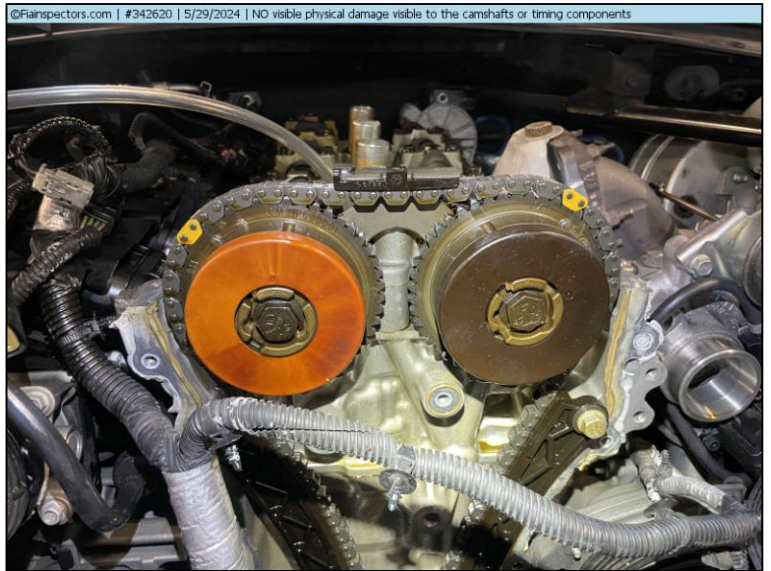
©Flanspectors.com | #342620 | 5/29/2024 | NO visible physical damage visible to the camshafts or timing components

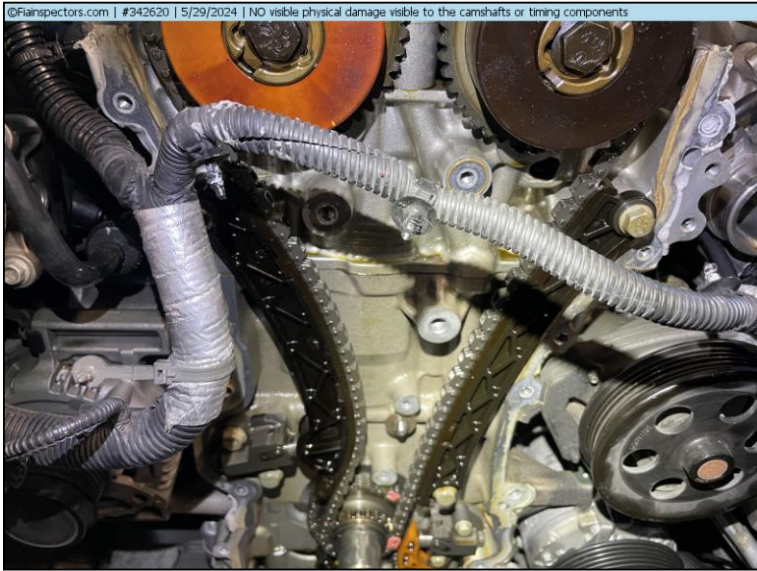
©Flanspectors.com | #342620 | 5/29/2024 | NO visible physical damage visible to the camshafts or timing components

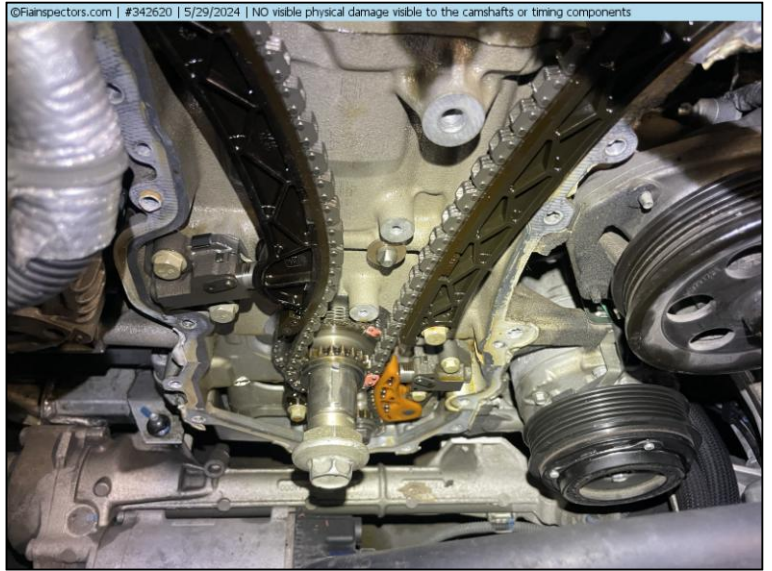
©Flanspectors.com | #342620 | 5/29/2024 | NO visible physical damage visible to the camshafts or timing components

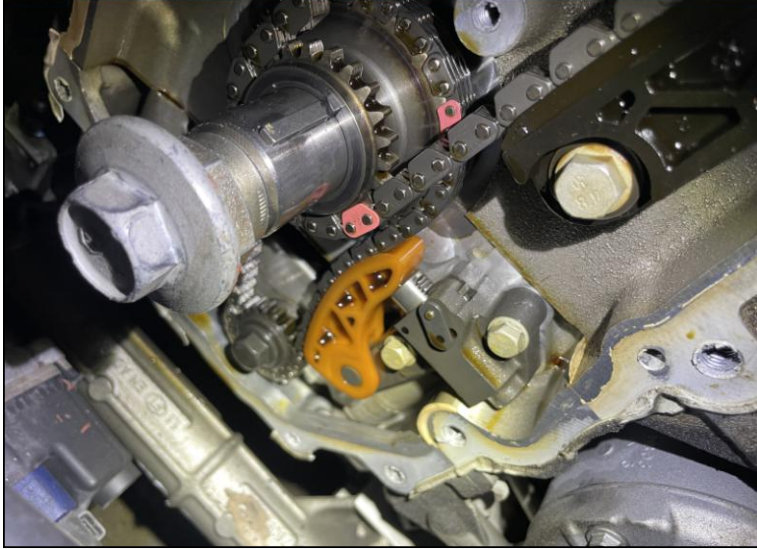
©Flanspectors.com | #342620 | 5/29/2024 | NO visible physical damage visible to the camshafts or timing components

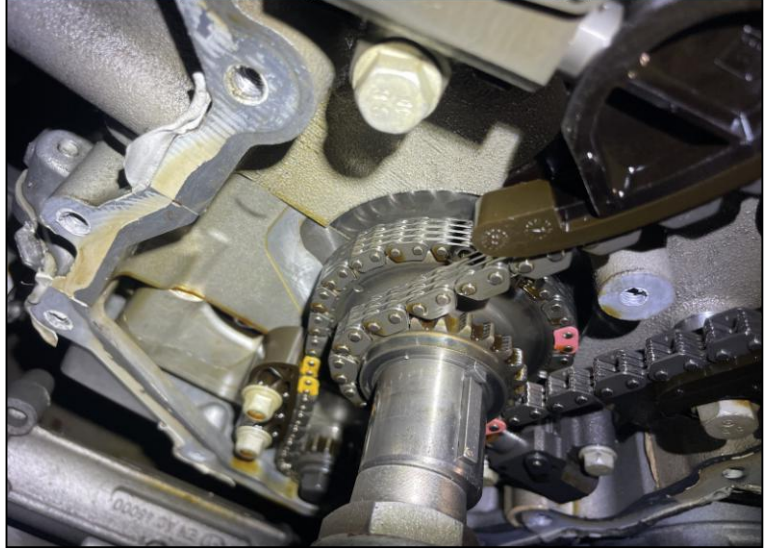
©Flanspectors.com | #342620 | 5/29/2024 | NO visible physical damage visible to the camshafts or timing components

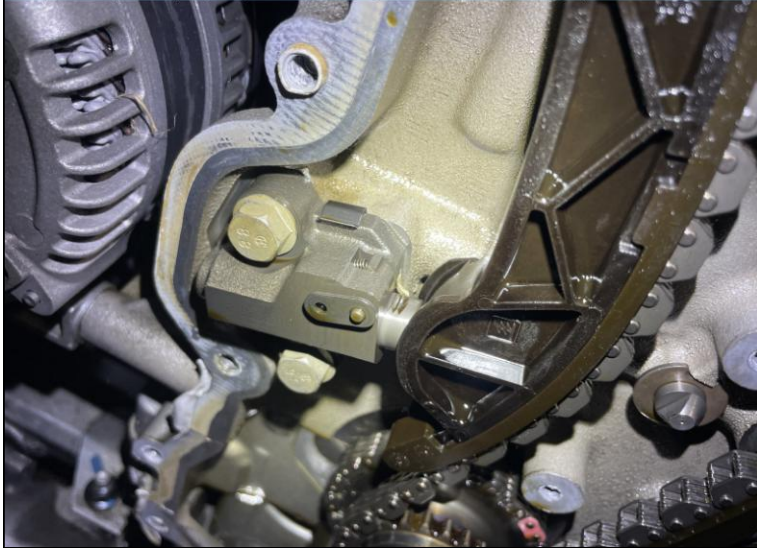
©Flanspectors.com | #342620 | 5/29/2024 | NO visible physical damage visible to the camshafts or timing components

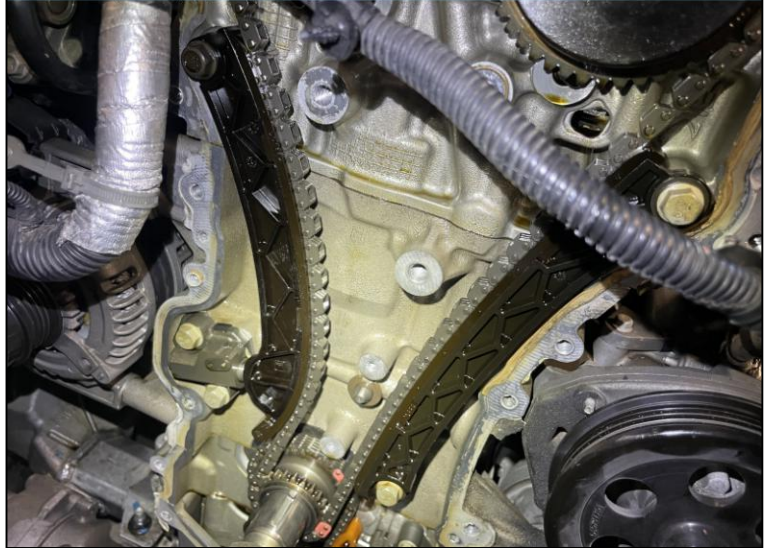
©Flanspectors.com | #342620 | 5/29/2024 | NO visible physical damage visible to the camshafts or timing components
