LEGAL METROLOGY COMPLIANCE  
INSPECTION REPORT

| Report Reference Number | report-8a292a7be4af | Generated Date / Time | 01-09-2026 15:59 UTC | Compliance Score | 30 / 100 |

| Product Name | GHEE | Manufacturer / Packer | Manufactured by: SRI SAI LAXMI KRISHNA DAIRY, Andra Prabha Colony, Pipal Road, Vijayawada - 15, (A.P) |

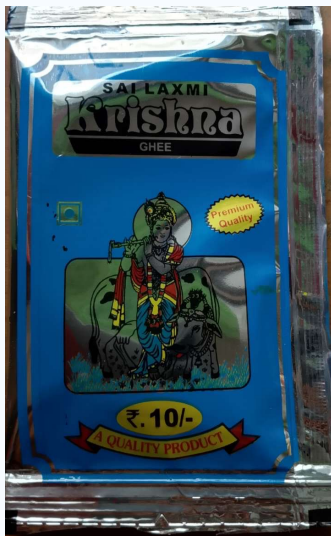
| # | Rule ID | Applicable Requirement | Observed Value / Evidence | Status | Confidence |
|---|---|---|---|---|---|
| 2 | R6_1_E | LMPC Rules, 2011, Rule 6(1)(e) | M.R.P. Rs. 10.00 (Incl. of all taxes) | VIOLATION / NON-COMPLIANT | N/A |
| 3 | R6_1_C | LMPC Rules, 2011, Rule 6(1)(c) | Field 'Net Weight .' printed on label but no value is filled. | UNABLE TO VERIFY / REQUIRES REVIEW | N/A |
| 5 | R6_1_D | LMPC Rules, 2011, Rule 6(1)(d) | Field 'Pkd. on .' printed on label but no value is filled. | UNABLE TO VERIFY / REQUIRES REVIEW | N/A |
| 6 | R6_1_DA | LMPC Rules, 2011, Rule 6(1)(da), inserted by 2017 amendment | Best before 9 months from the month of packing. | VIOLATION / NON-COMPLIANT | N/A |
