IMU 추적 QC — FR5 teleop 프로빙 블록 'probe' · chip

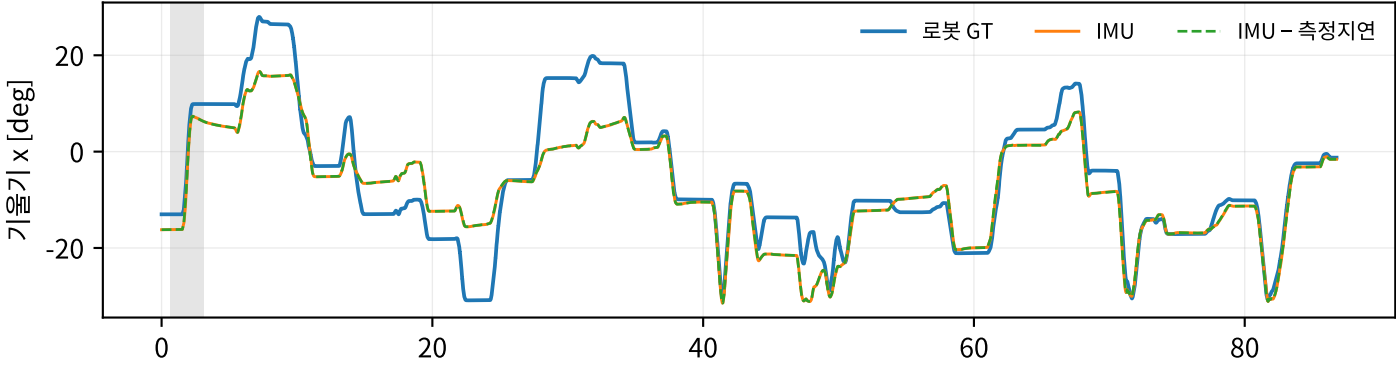
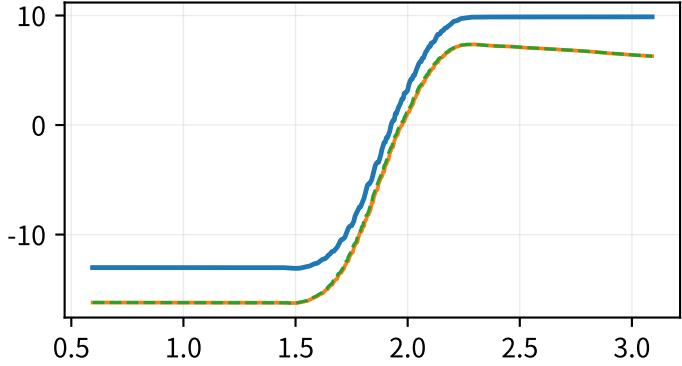
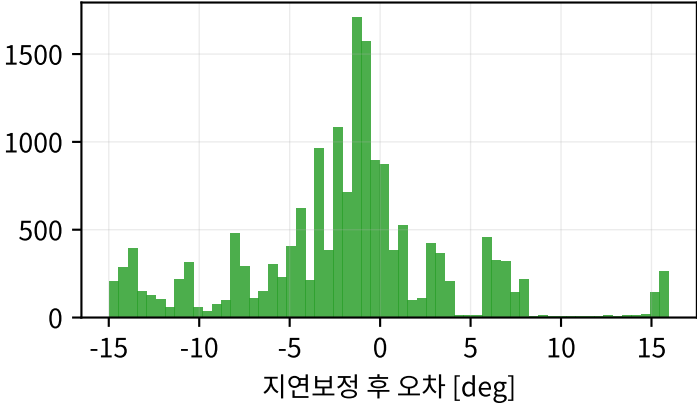
지연 6 ms 상관 0.915 보정후 RMS 6.17 deg

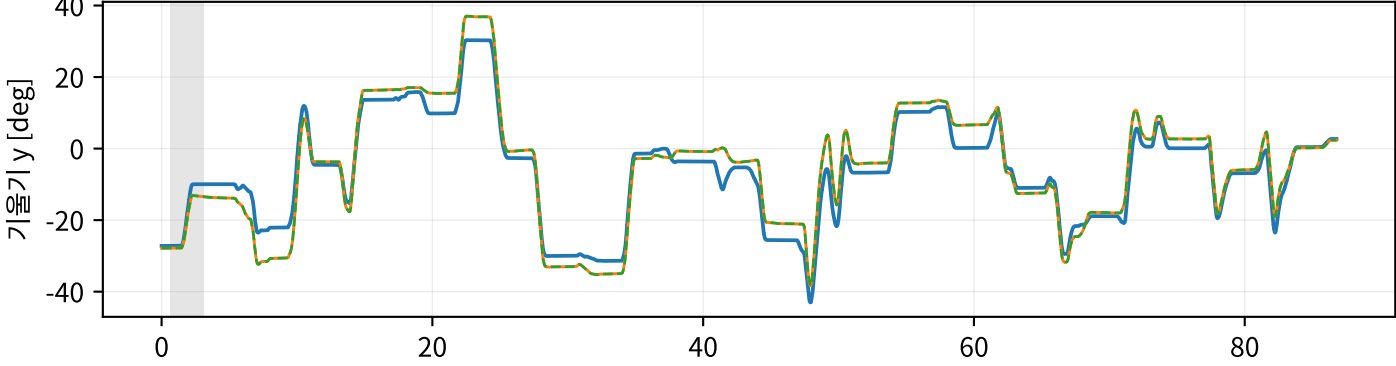
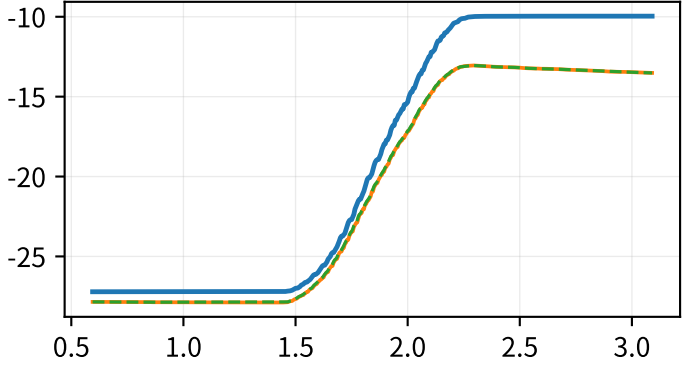
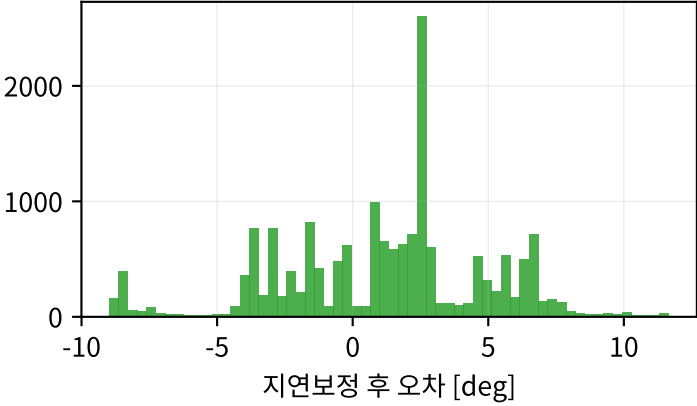
지연 3 ms 상관 0.977 보정후 RMS 3.98 deg

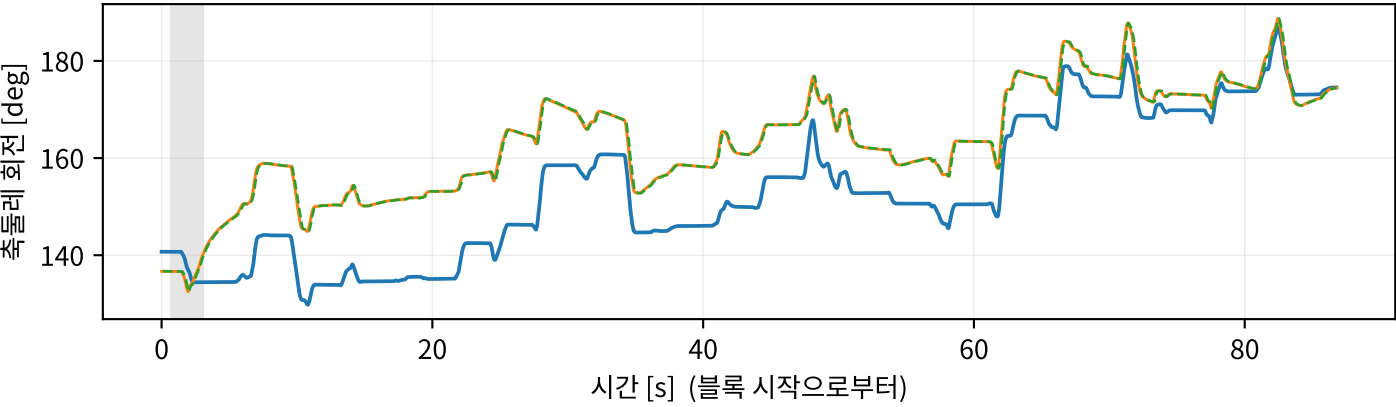
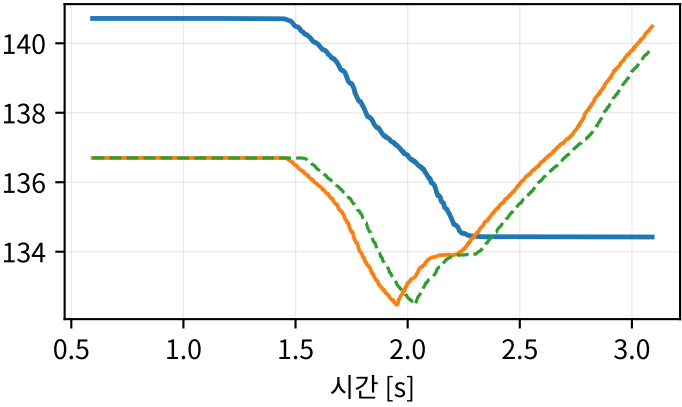
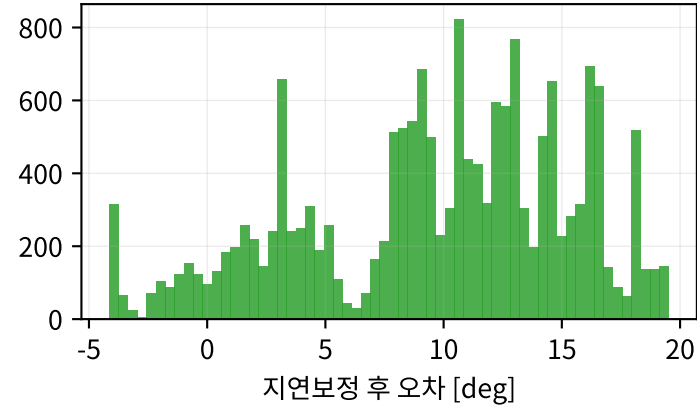
지연 -81 ms 상관 0.930 보정후 RMS 11.23 deg 기준 28 ms / 0.999

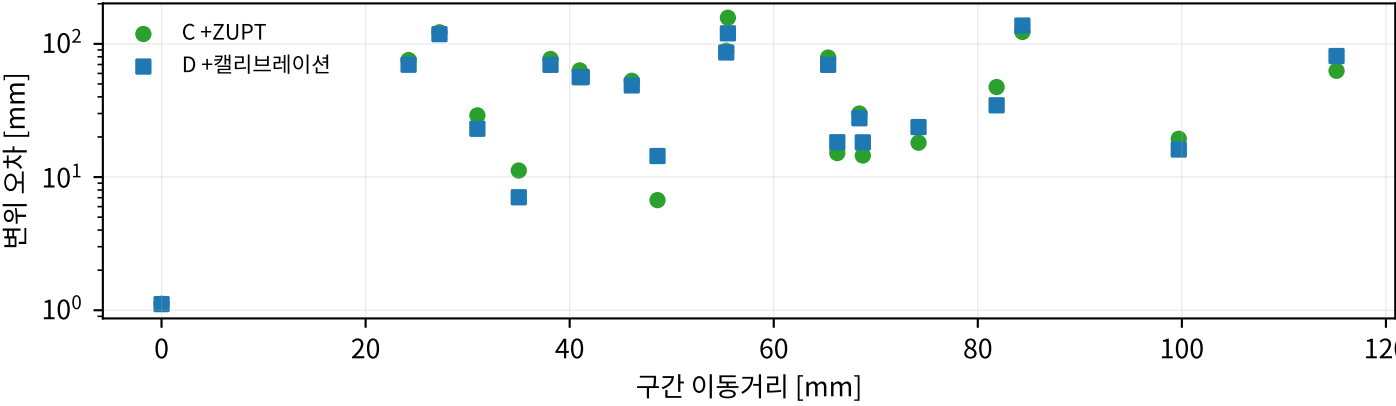
ZUPT 구간별 변위 오차 n=21
