JUBILEE ALLIANZ INSURANCE ASSESSORS REPORT

PRIVATE AND CONFIDENTIAL MOTOR ASSESSMENT REPORT

| Policy Number: | Adjuster: | Insured: | Claim Number: | | | | | |
|---|--|---|---|--|--|--|--|--|
| P/101/1002/2019/007287/01/02 | Christine | ROBERT BICHAGE MUNGA | C/101/1002/2022/000657 | | | | | |
| Registered No. | | KCC 939R | | | | | | |

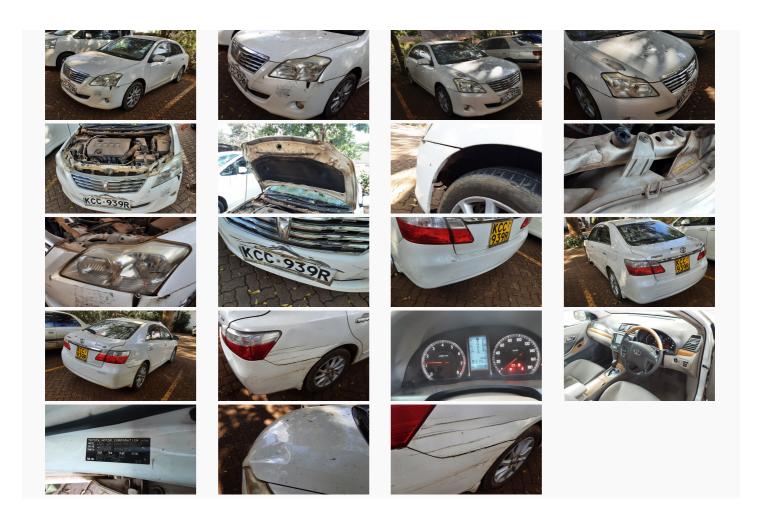
Consistent with a medium frontal impact biased at the LHS areas.

We confirm inspecting your insured's vehicle following your instructions. The veicle appears to have had a medium frontal impact which damaged the LHS areas as illustrated by photographs attached.
