Engine Mini Pack

Engine type	CFM56-3C1
Engine Serial Number	[REDACTED]
Engine TT	59928.05
Engine TC	30279
TSLSV	9555.05
CSLSV	5279
LLP Limiter	3797
As of 2025/08/08

Borescope inspection report

Engine Shop Visit Report

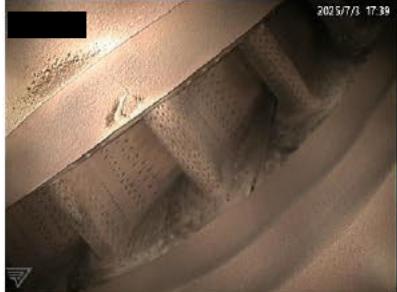
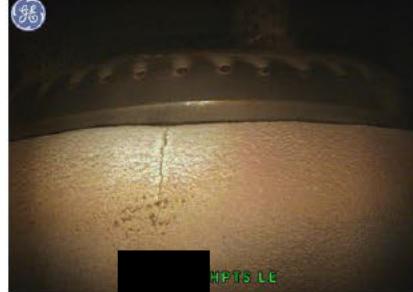
Combustion Chamber	
Inner Liner	<p>Serviceable damage</p> <p>Cracks no longer than one panel were found</p> <p>(b) Axial cracks on the inner liner(Fig.606)</p> <p>1) The conditions that follow are permitted:</p> <p>a) No maximum number of cracks that go across 1 panel or less</p>

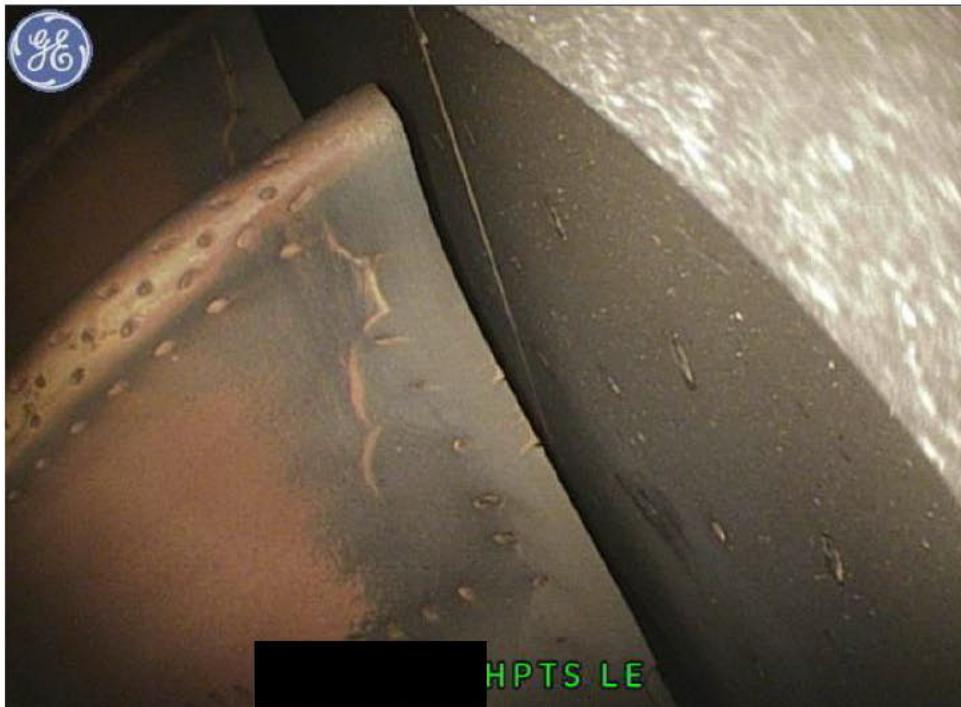
HPT Blade	
Stage 1	<p>Serviceable damage</p> <p>(c) Examine the tip area of the blades</p> <p>b) There is no limit to the quantity of damage if the internal cooling passages are not seen</p>

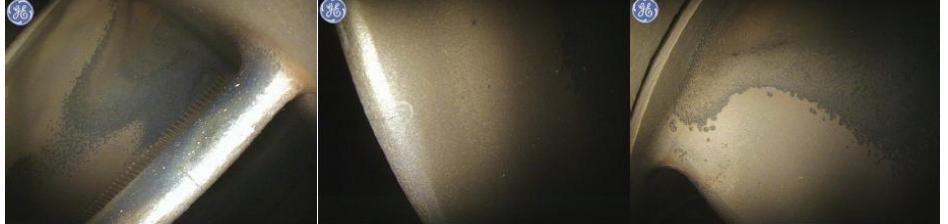
Low pressure Turbine Nozzle	
Stage 1	<p>Serviceable Damage</p> <p>1. Cracks no longer than 1/3 of the chord length were found on L/E (b) Cracks in the leading edge 1) No maximum limit to the quantity if they are less than 0.6 inch (15.2 mm) in length (1/3 of the chord length) on all the vanes of the same nozzle segment.</p>

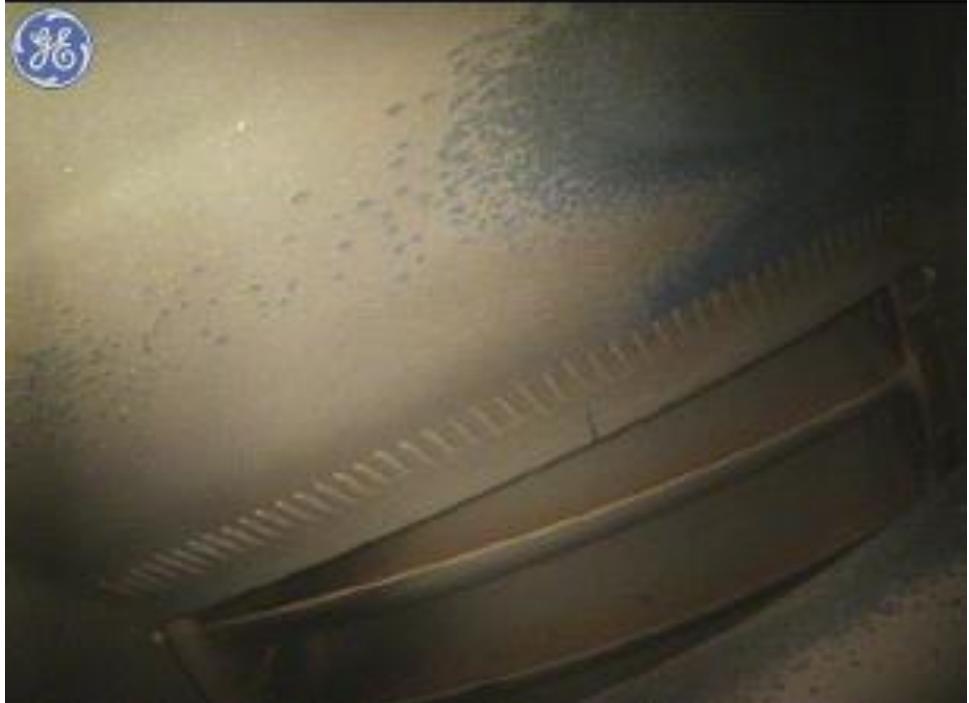
<p>2. Cracks no longer than 1/3 of the chord length were found on T/E (a) Cracks in the trailing edge 1) No maximum limit to the quantity if they are less than 0.6 inch (15.2 mm) in length (1/3 of the chord length) on all the vanes of the same nozzle segment.</p>

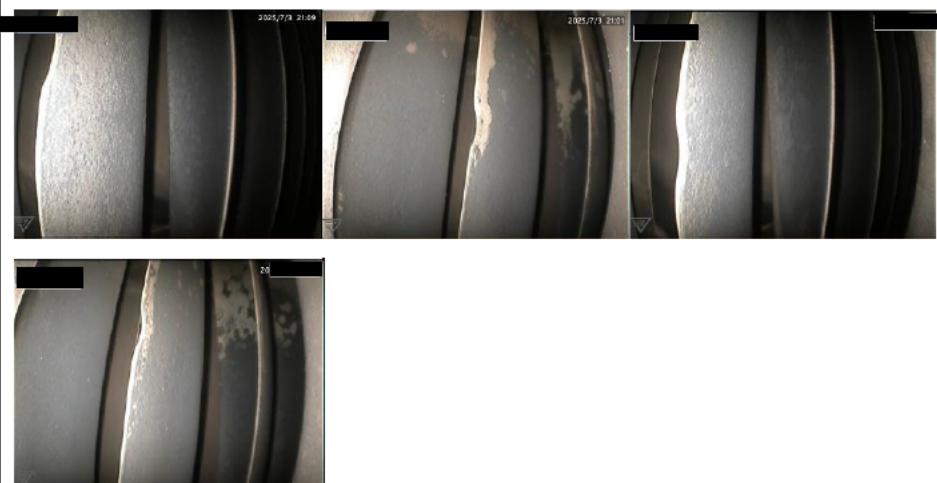
Stage 2	<p>Repair marks found</p>
