From: McConnell, DAVE P <dave.p.mcconnell@lmco.com>
Sent: Wednesday, January 25, 2017 8:50 AM
To: Grant Robinson
Subject: 920279 Swashplate Guide Paint Loss

Case Number: C0051351
Customer: Thai Aviation Services Limited
Aircraft S/N: 920279
Aircraft Model: S-92A
Aircraft TT: 666
ATA: 63
Part Number: 92351-15100-050
Case Subject: MGB-Swashplate Guide-Loss Of Paint

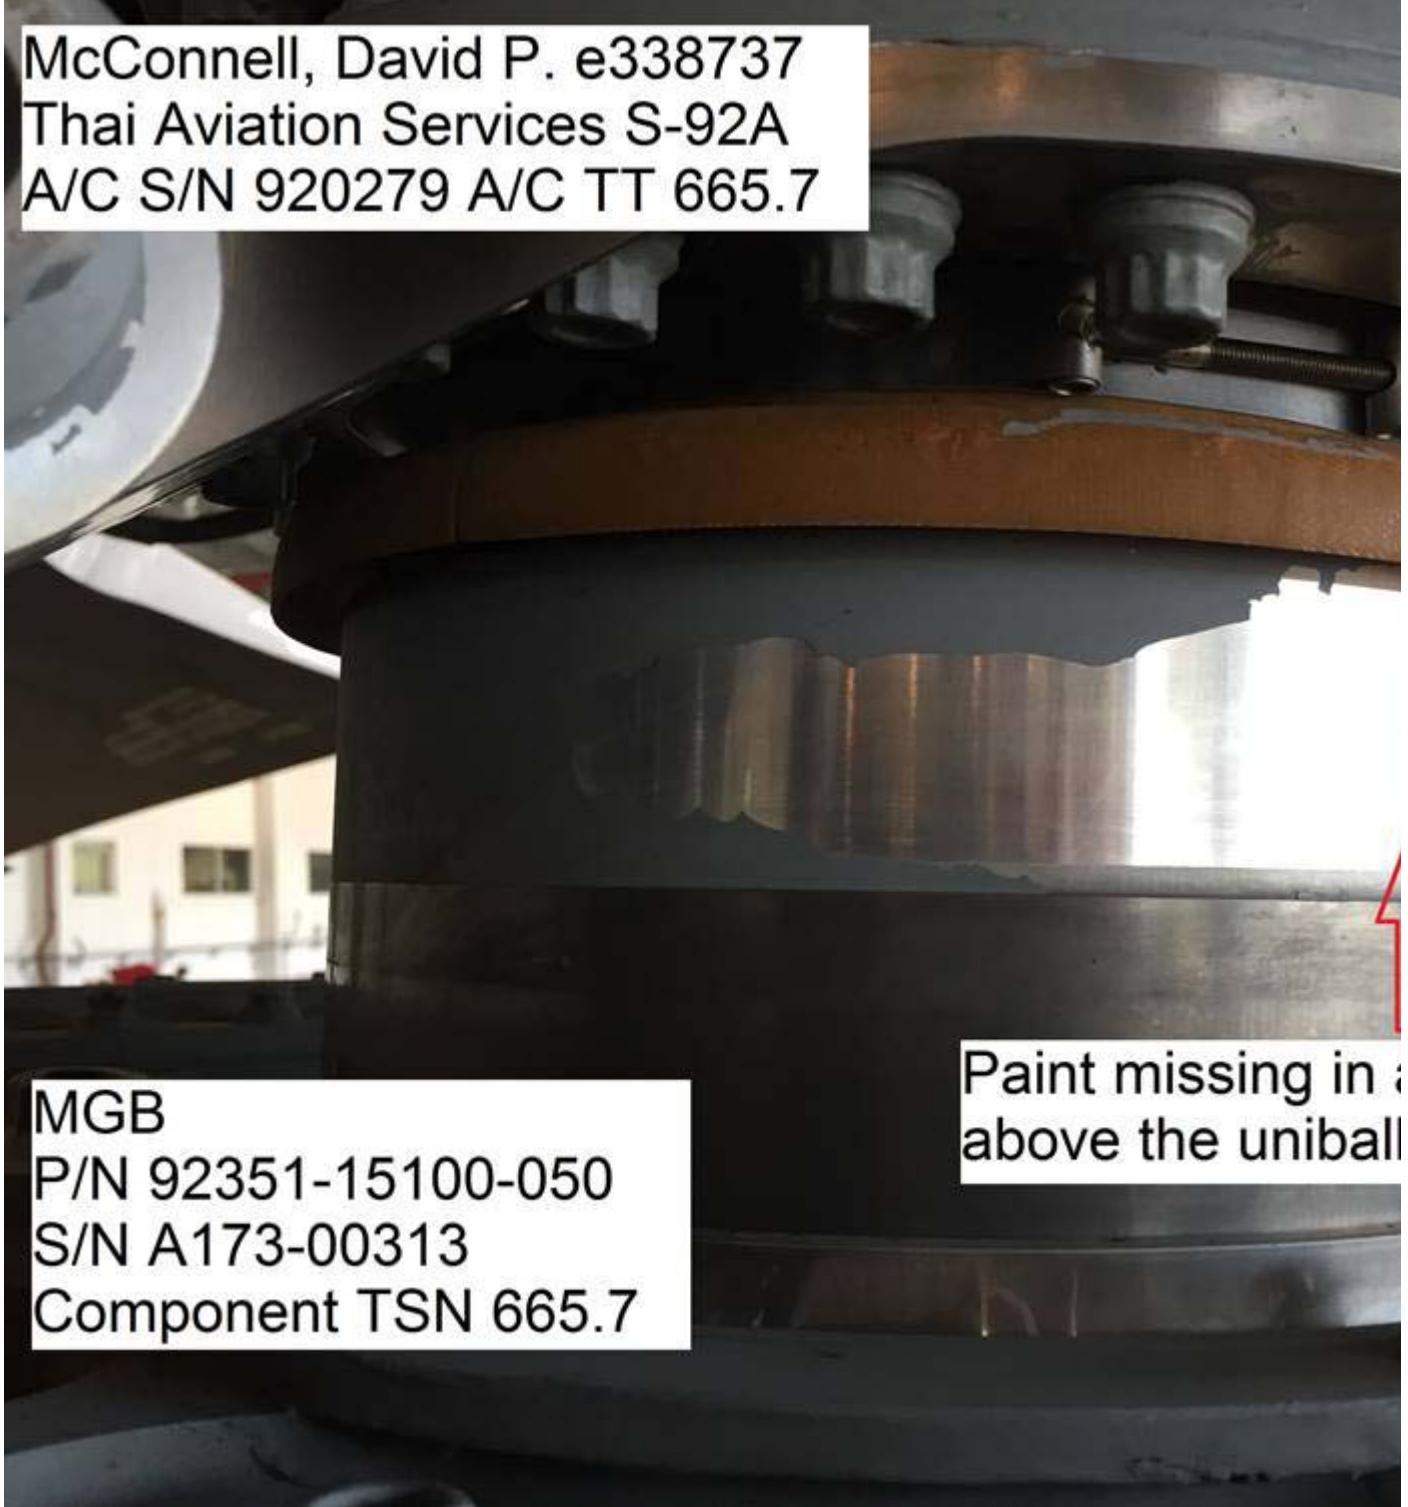
McConnell, David P. e338737
Thai Aviation Services S-92A
A/C S/N 920279 A/C TT 665.7

TAS maintainers note extensive paint loss on the upper half of the P/N 92351-15228-043 swashplate guide installed on MGB S/N A173-00310 fitted to A/C S/N 920279.

The area of missing paint measures approximately 11 inches long by 2.0 inches high over most of its length.

The parent metal underneath is shiny and bright. Paint loss appears to be attributable to poor paint adhesion. No corrosion is evident.

There is no evidence of blistering or corrosion of the coating in the area of uniball travel.

There is no evidence epoxy primer under the final paint. Engineering recommends having the customer remove the rest of the paint that is still applied to the Swashplate Guide. If the paint does not remove easily, then chip away the loose paint and feather the edges.

Clean the OD thoroughly with a chemical that cleans the metal and evaporates. Apply one coat of MIL-PRF-85582 Epoxy Primer to the entire exposed surface, and apply one coat of FED-STD-595 Paint Code 36231.
