## 920279 Swashplate Guide Paint Loss

Case Number: C0051351  
Customer: Thai Aviation Services Limited  
Aircraft S/N: 920279  
Aircraft Model: S-92A  
Aircraft TT: 666  
ATA: 63  
Part Number: 92351-15100-050  
Case Subject: MGB-Swashplate Guide-Loss Of Paint

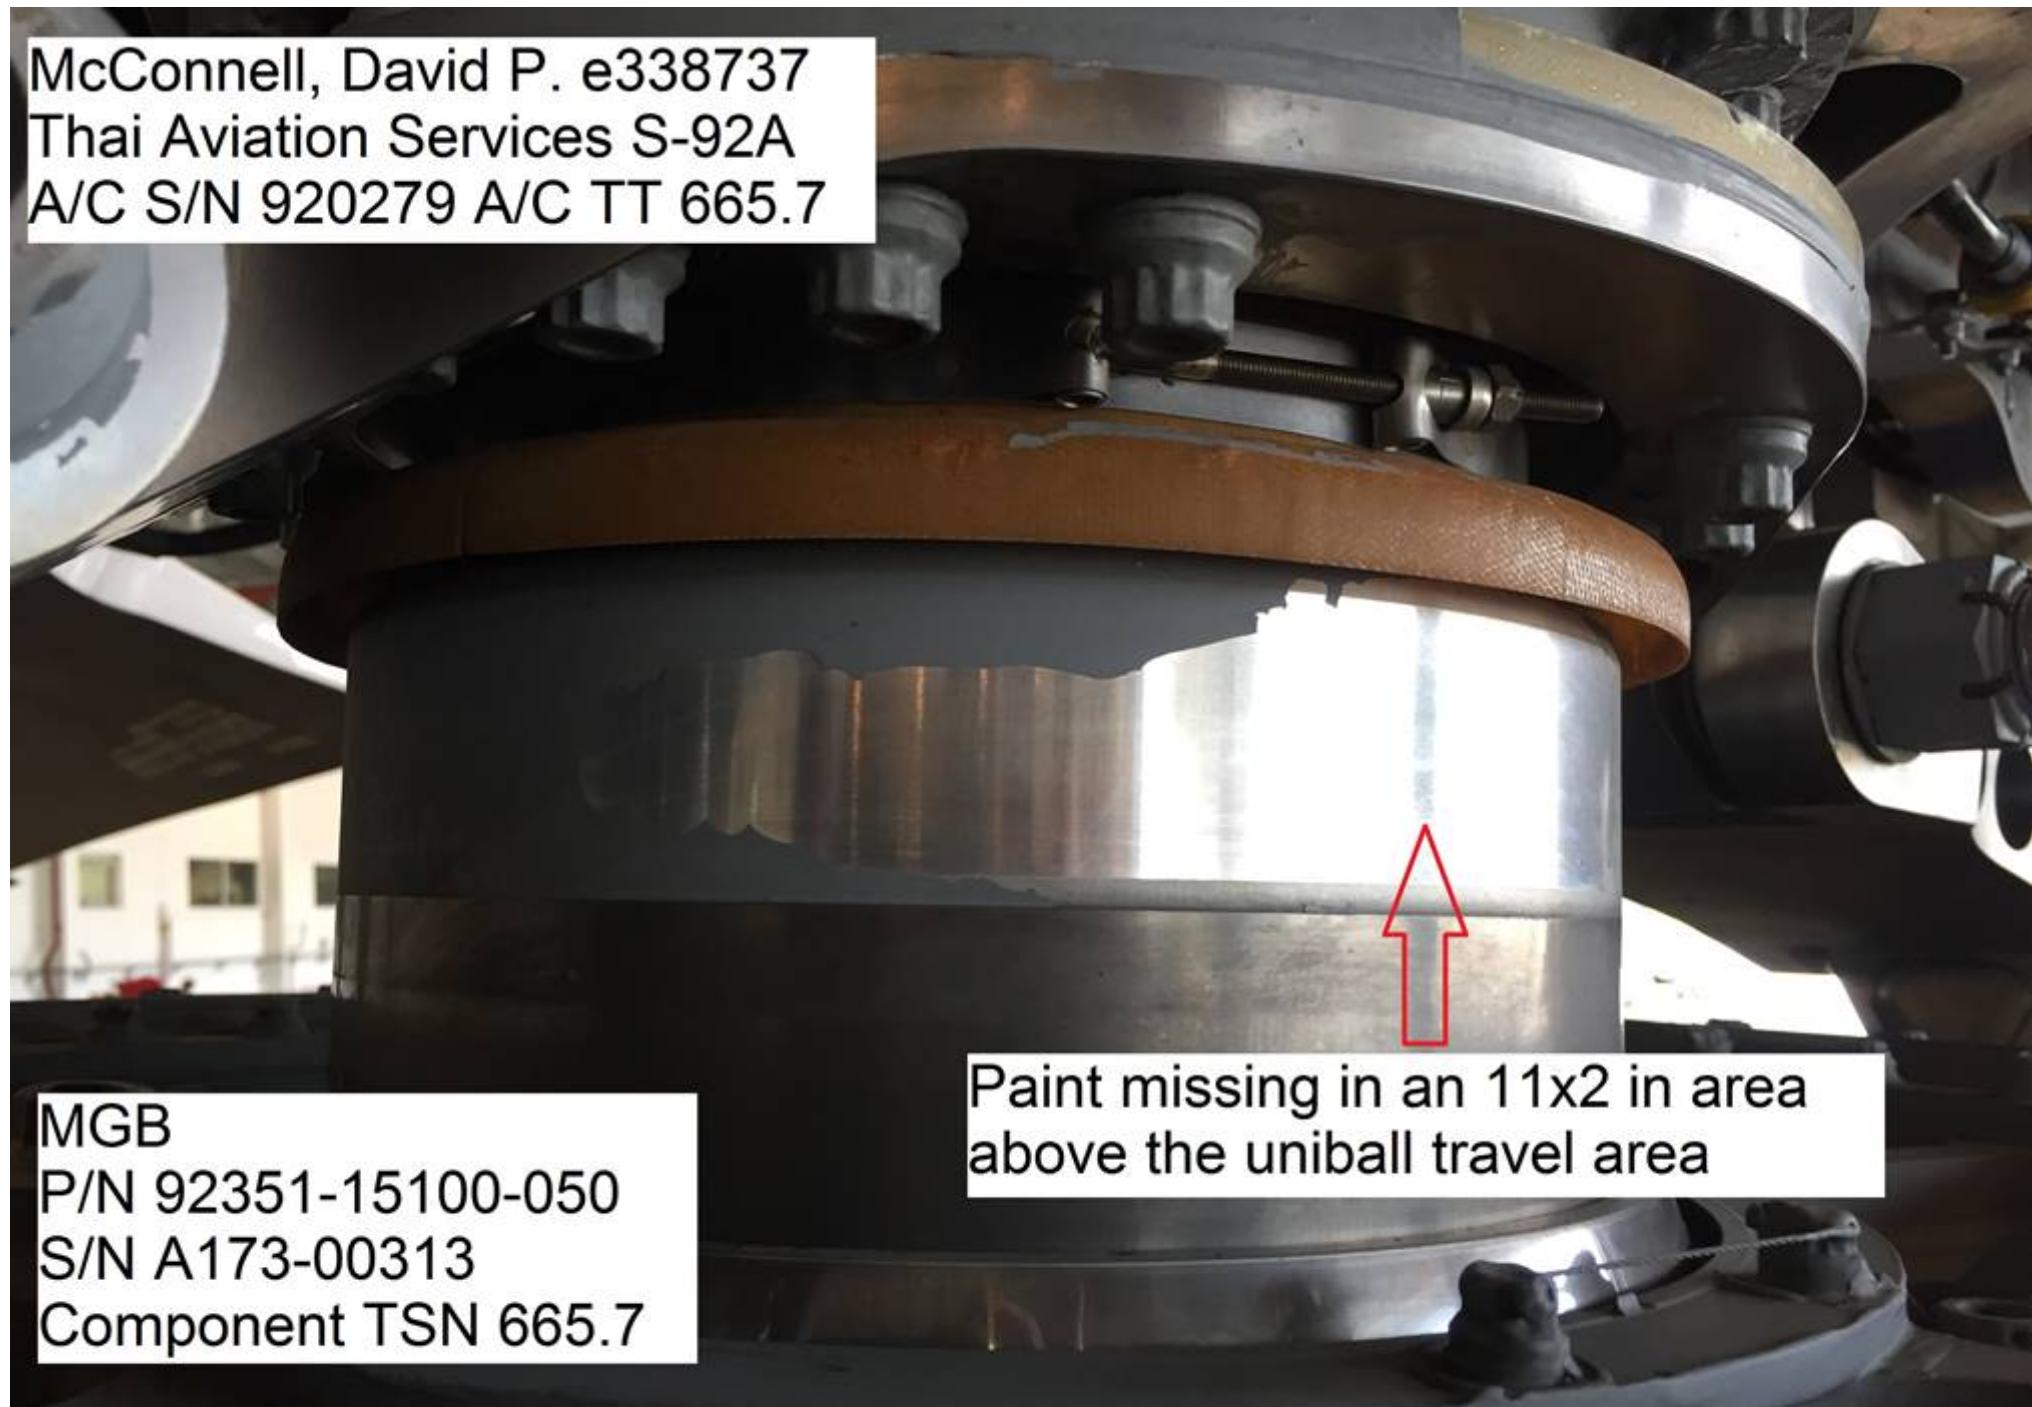
McConnell, David P. e338737  
Thai Aviation Services S-92A  
A/C S/N 920279 A/C TT 665.7

TAS maintainers note extensive paint loss on the upper half of the P/N 92351-15228-043 swashplate guide installed on MGB S/N A173-00310 fitted to A/C S/N 920279.

The area of missing paint measures approximately 11 inches long by 2.0 inches high over most of its length.

The parent metal underneath is shiny and bright. Paint loss appears to be attributable to poor paint adhesion. No corrosion is evident.

There is no evidence of blistering or corrosion of the coating in the area of uniball travel.

There is no evidence epoxy primer under the final paint. Engineering recommends having the customer remove the rest of the paint that is still applied to the Swashplate Guide. If the paint does not remove easily, then chip away the loose paint and feather the edges.

Clean the OD thoroughly with a chemical that cleans the metal and evaporates. Apply one coat of MIL-PRF-85582 Epoxy Primer to the entire exposed surface, and apply one coat of FED-STD-595 Paint Code 36231.
