From: McConnell, DAVE P <dave.p.mcconnell@lmco.com>
Sent: Thursday, January 25, 2018 6:08 AM
To: Nakhon Supervisor Engineer
Cc: Grant Robinson; Mrazik, Philip; Atiporn Chiwcharoen
Subject: S-76D Driveshaft Shield Crack Stop Drill

Case Number: C0085840
Customer: Thai Aviation Services Limited
Aircraft S/N: 761060
Aircraft Model: S-76D
Aircraft TT: 1,729
ATA: 63
Part Number: 76201-77003-123
Case Subject: Driveshaft Shield Crack-Request To Stop Drill

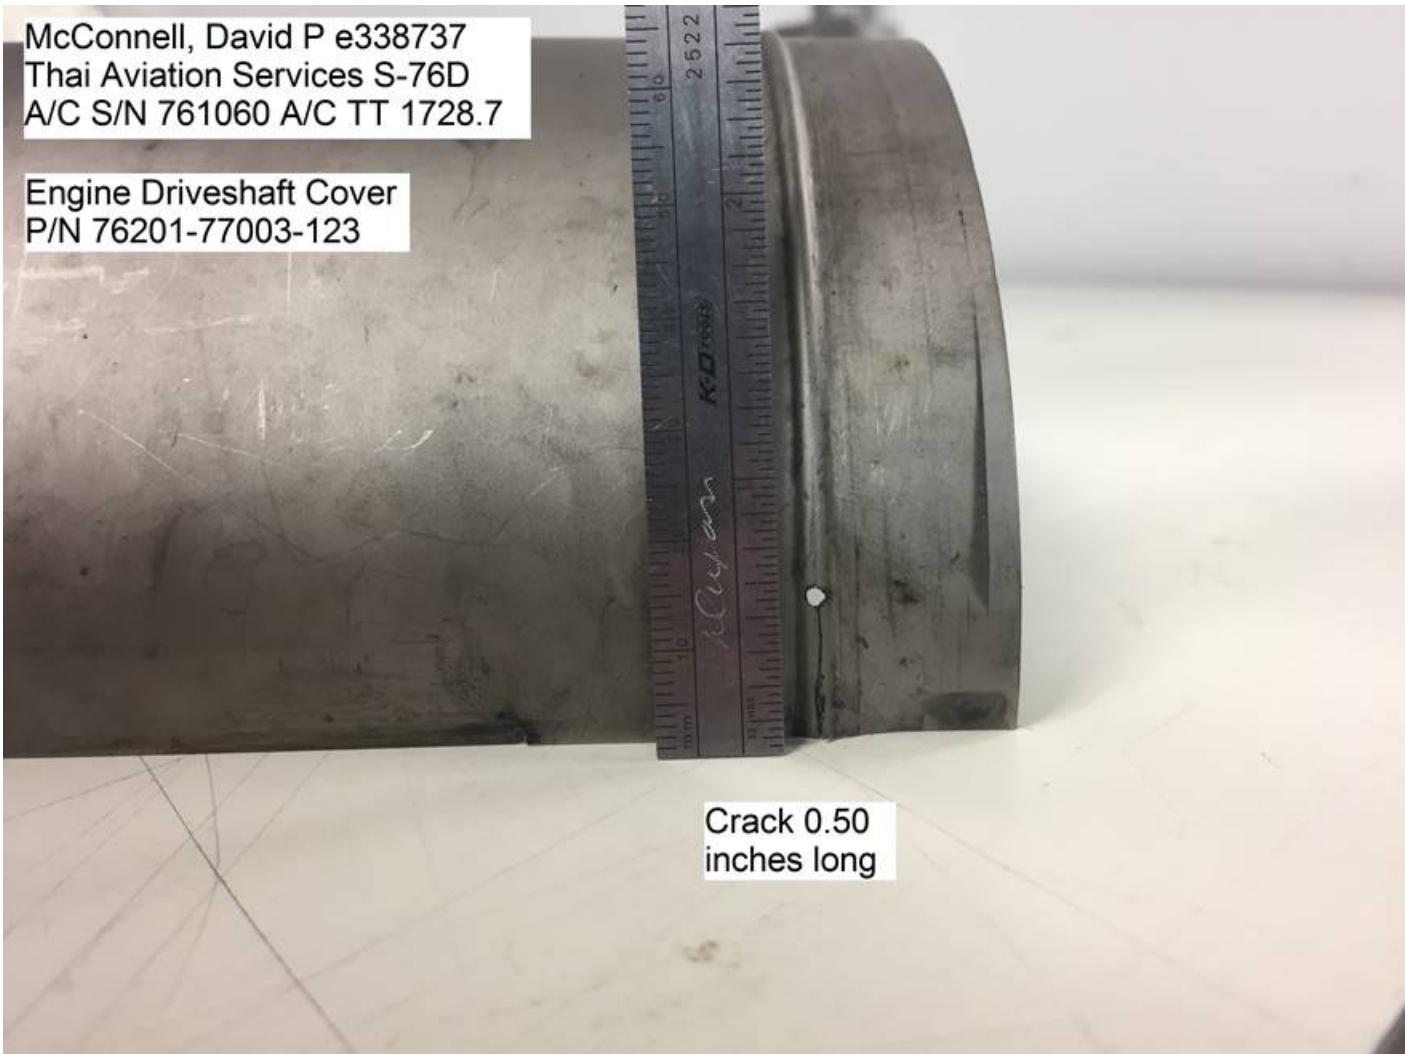
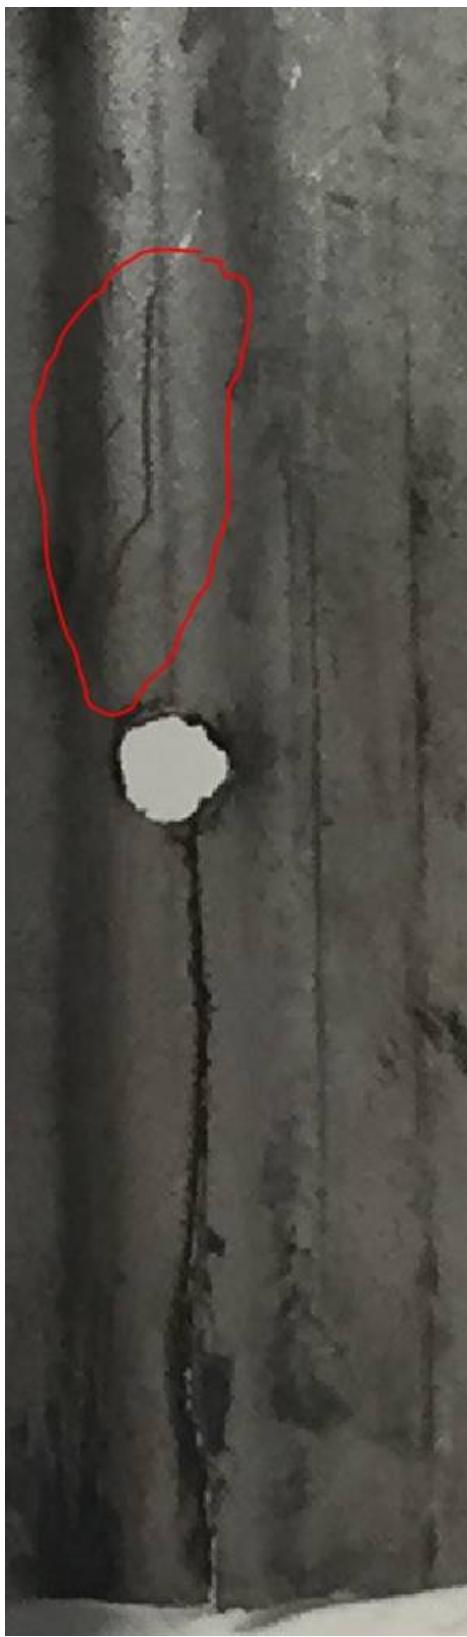
Engine Driveshaft Cover
P/N 76201-77003-123

Both shields are cracked circumferentially along the bead immediately aft of the forward band clamp. One crack is 0.50 inches long, the other is 1.5 inches long. Both cracks have been stop drilled.

Temporary stop drill is acceptable. Please re-evaluate the length of the shorter crack and stop drill again if necessary. Fire proof sealant should be applied along the cracks to uphold the integrity of the heat protection

function of the driveshaft covers.
