## **Big Sheep/Buhler Diversion Replacement**

Completion Report

Bonneville Power Administration Project Number 1992-026-01 Contract #52673 Performance Period May 1, 2011 to November 15, 2011

By R. Coby Menton, Grande Ronde Model Watershed

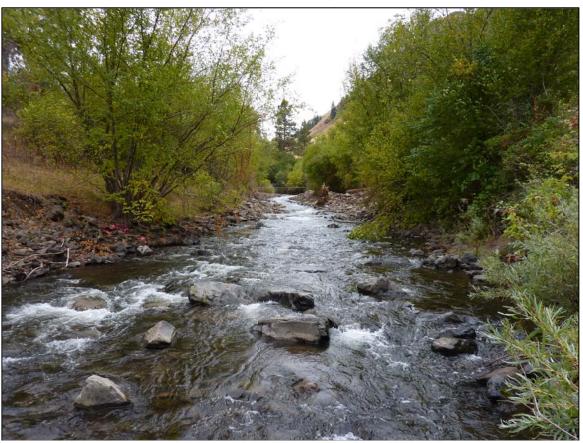
Photo 1: Looking upstream at completed project. Photo by R. Coby Menton on October 13, 2011.

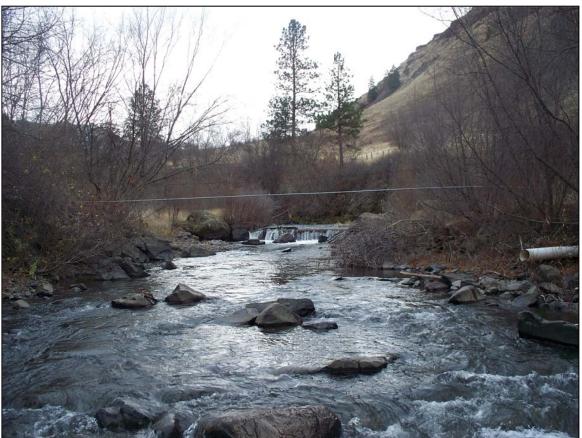
Sometime in the past a large log, approximately 2 feet in diameter, was placed just downstream of the diversion intake in an effort to increase the water depth in the forebay area. Over time the forebay area has been filled in with sediment and the streambed in the forebay is now level with the top of the log. On the downstream side of the log there is a vertical drop in the streambed of approximately 5 feet and then the creek continues at a relatively constant grade. The drop on the downstream side of the log creates a fish passage barrier, particularly when the creek is experiencing low flows.

Photo 2: Photo taken by Chas Hutchins of Anderson Perry on December 5, 2011. The channel-spanning log upstream in the photo is approximately 5-feet above the channel downstream.

Occasionally, a hole is developed upstream of the log and water begins to flow underneath the log. When this occurs irrigators enter the stream and place material in the hole to repair the check structure. This causes disturbance in the streambed and turbidity in the creek.

The designed solution to eliminate this passage barrier in Big Sheep Creek was to build a roughened channel starting at the diversion structure and continuing downstream for approximately 350-feet. The upstream end this roughened channel wedge raises the channel invert approximately 8-feet and at the downstream end the wedge trails off to the natural channel bottom. To maintain grade 6 cross vanes were installed and to improve

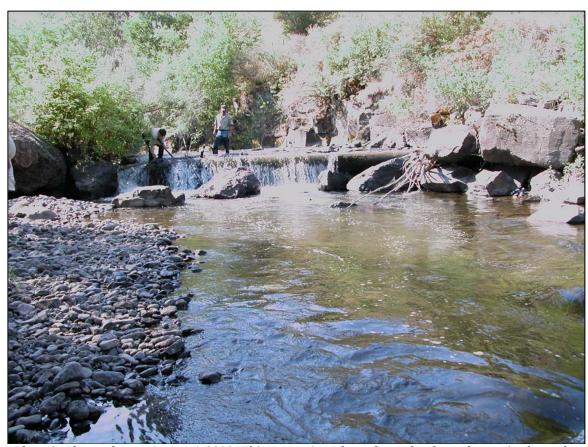
Photo 3: Photo taken on August 6, 2009. This pre-project photo shows the channel spanning log and diversion structure that is a fish passage barrier. The two ODFW biologists in the photo are removing rocks to try and provide passage to fish under the log.

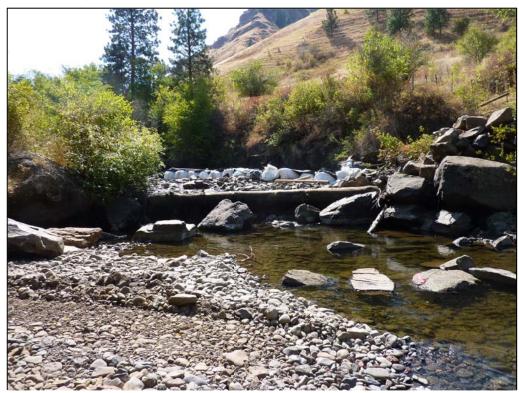
Photo 4: Photo taken on September 12, 2011. The white sand bags and tarp above the log were used to divert Big Sheep Creek around the work area. While the work area was completely isolated from fish it was not possible to completely bypass flow. The porous substrate allowed water to flow subsurface into the project area.

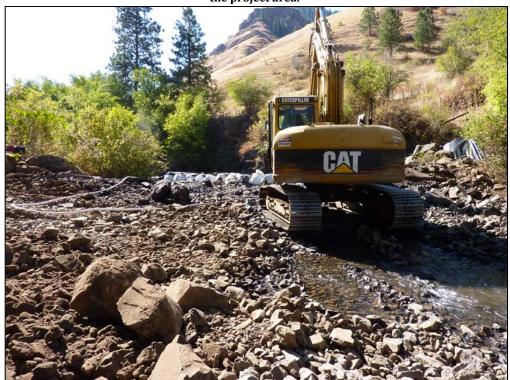
Photo 5: Photo taken on September 20, 2011. Grade control and stream simulation material installation nearly complete. The channel spanning log has been left in place and buried.

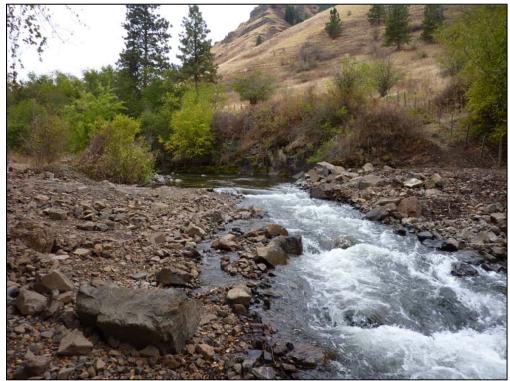
Photo 6: Photo taken on October 13, 2011. The project is complete and water is back in the main channel. All fish passage criteria including jump height and velocity have been met. The original elevation of the diversion has been maintained and need for maintenance has been eliminated.

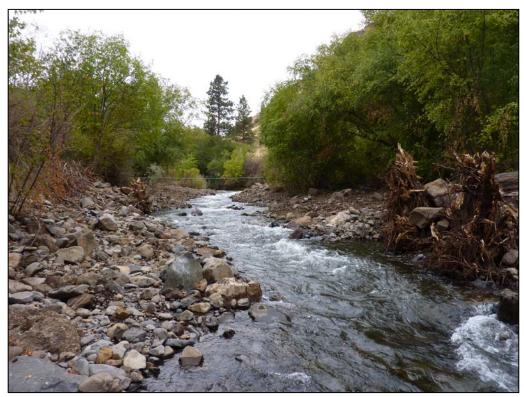
Photo 7: Photo taken on October 13, 2011. Large wood features are shown in this photo. Each feature is made with 3 logs keyed into the bank with the rootwad in the stream. Each log structure will improve habitat in the project reach.

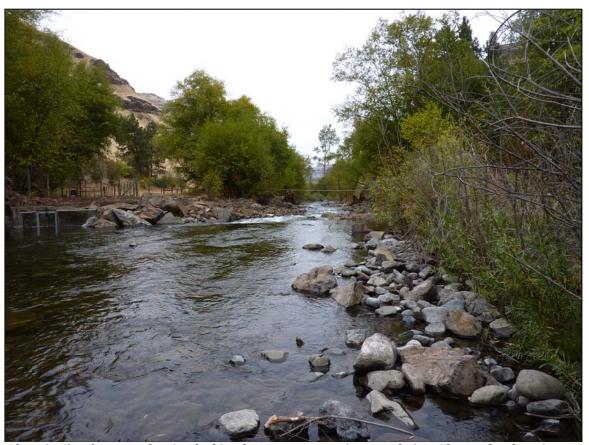
Photo 8: View from top of project looking downstream at project completion. The new headgate is on the left side of the photo. Very little riparian vegetation was disturbed during construction and all disturbed areas have been replanted with native seed and willows.
