NORTH FORK CABIN CREEK CULVERT REPLACEMENTS

Completion Report

Project No. 1992-026-01 Contract No. 45280

March 26, 2012

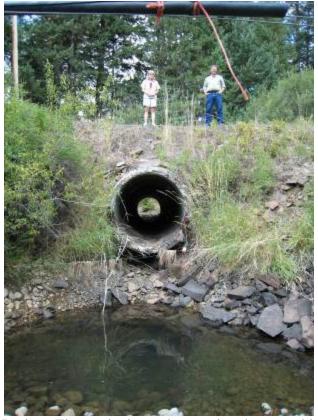
North Site #3

The North Site is on Robinson Road, managed and maintained by Union County Public Works Department. The pre-project structure was a four-foot round concrete culvert. The culvert had an approximate 5% slope with a two foot drop at the outlet. The initial installation (date unknown) resulted in relocation of the stream channel to facilitate the positioning of the culvert to be perpendicular to road. This required a 90 degree corner on the upstream side which frequently resulted in the culvert plugging during peak flows. It was possible, during very favorable flow conditions at the peak of the migration, for an occasional adult steelhead to pass the structure (see pre-project picture).

Pre-Project. Flow velocity and excessive drop combined to restrict steelhead and resident fish passage.

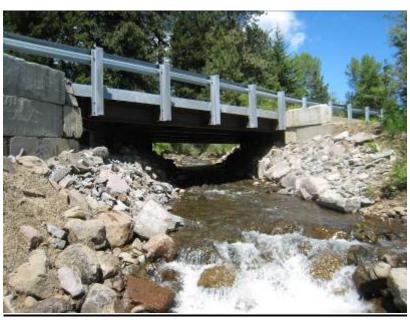
Post-Project. Stream was realigned to eliminate 90 degree corner above the old concrete culvert. Bridge wingwalls were reinforced with riprap and a vortex rock weir was installed below the bridge.

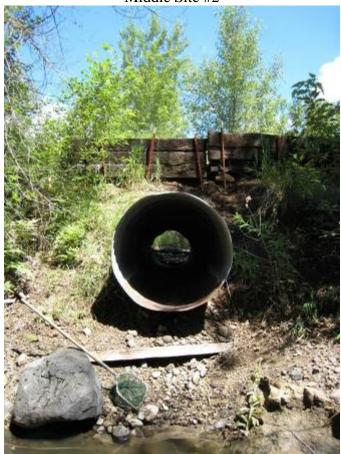
Middle Site #2

The Middle Site is on a private drive approximately 1/3 mile below the North Site. The preproject structure was a four-foot round corrugated metal culvert with about a four-foot drop at the outlet. Bedload had accumulated above the culvert and a three-foot deep scour pool had formed below the outlet. Juvenile passage was not possible and adult steelhead passage was unlikely due the drop at the outlet and high water velocities (see pre-project picture).

Pre-Project. Flow velocity and excessive drop combine to restrict steelhead and resident fish passage.

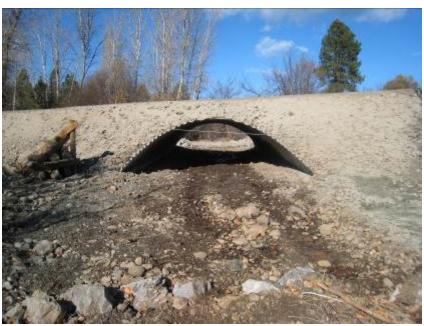
Post-Project. Bottomless steel arch was placed on concrete precast footings. Vortex rock weir was installed below the arch.

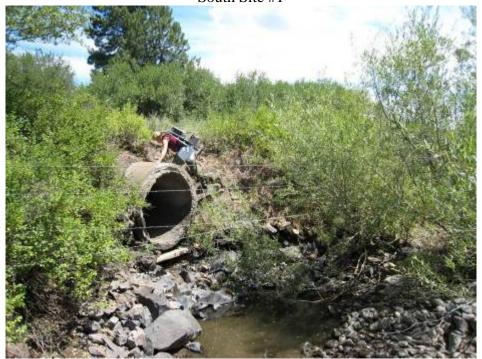
South Site #1

The South Site is on Robinson Road approximately ¾ mile below the Middle Site and is managed and maintained by Union County Public Works Department. The pre-project structure was a four-foot round concrete culvert similar to the North Site. It had about a 5% slope and a three-foot drop at the outlet. Juvenile passage was not possible and adult steelhead passage was unlikely, except under very favorable water conditions, due the drop at the outlet and high water velocities (see pre-project picture).

Pre-project. Downstream end of culvert. Flow velocity and excessive drop combined to restrict steelhead and resident fish passage.

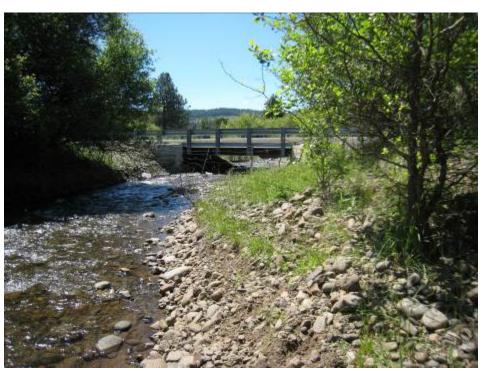
View from above bridge looking downstream. Stream alignment was unchanged.
