#### DAVIS DAMS FISH PASSAGE

**Completion Report**

Project No. 1992-026-01 Contract No. 52075

January 3, 2013

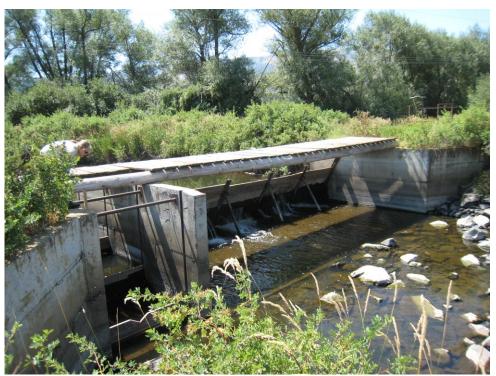
## Upper Davis Dam Pre-Construction

Low flow July 22, 2009. Note leakage through check boards and no flow in the fish ladder.

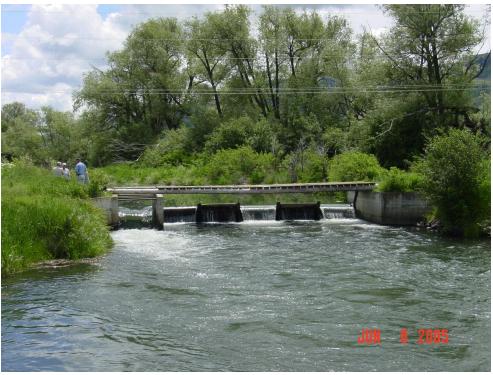
High flows with check boards installed. Although not meeting fish passage criteria, at this flow adult Chinook could pass the structure. Juveniles likely could not pass. This flow level was normally only maintained for a relatively short period after the check boards were installed.

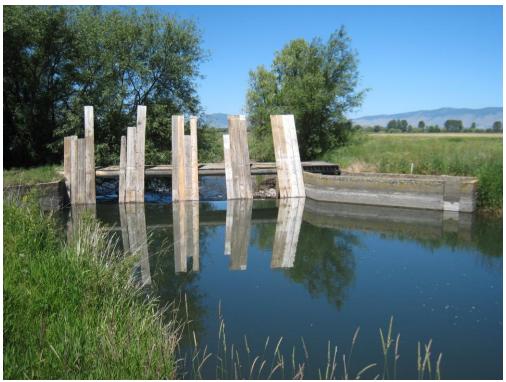
## Lower Davis Dam Pre-Construction

Moderate flow June 30, 2009. Even at moderate flows the step-pool ladder was not functioning.

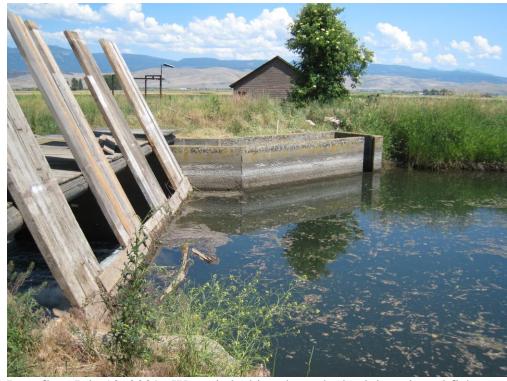
Low flow July 10, 2009. Water is leaking through check boards and fish ladder is not functioning.

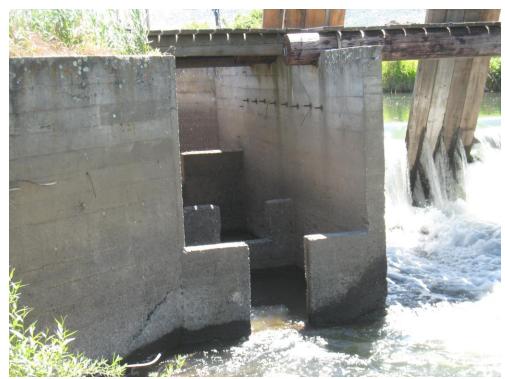
## Lower Davis Dam Pre-Construction

June 30, 2009. Inlet to fish ladder. Even at moderately high flows the fish ladder often had very little flow to attract migrating adults

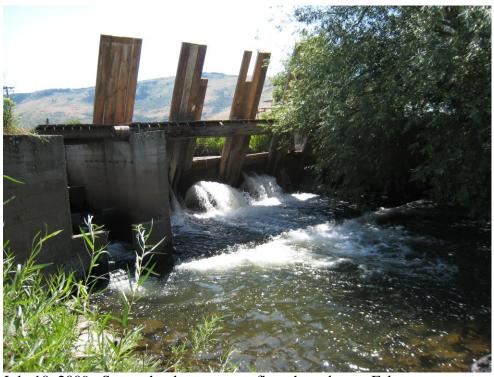
July 10, 2009. Somewhat lower streamflow than above. False attractant flow is coming through check boards with very little flow in the ladder

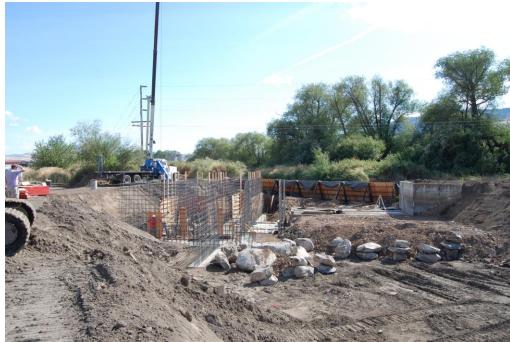
## Upper Davis Dam Construction

The entire construction site was dewatered. Concrete forming and rebar installation is in progress for the fish ladder. Rock in foreground will be used for the rock vane about 50 feet below the structure.

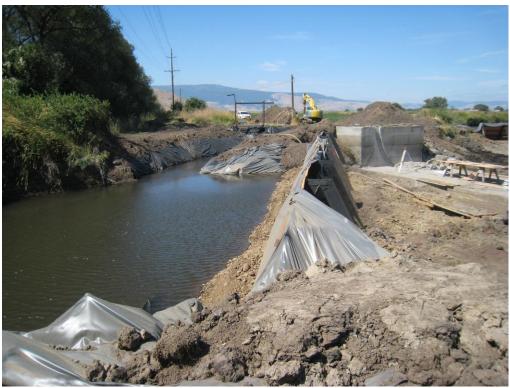
Cofferdam above the construction site diverted streamflow around the site. The left wall and slab from the original structure was incorporated into the new structure.

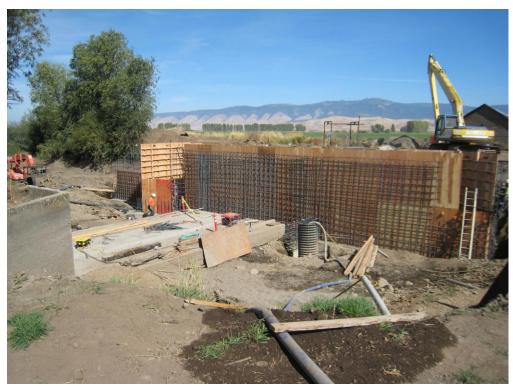
## Lower Davis Dam Construction

Forming for the vertical-slot fish ladder. The old ladder was completely removed. The floor and the left wall of the old structure was retained. All construction work occurred in a dry channel.

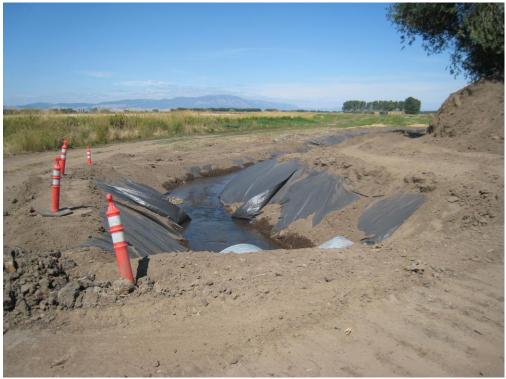
Flow bypasses were constructed around each construction site to dewater work areas.

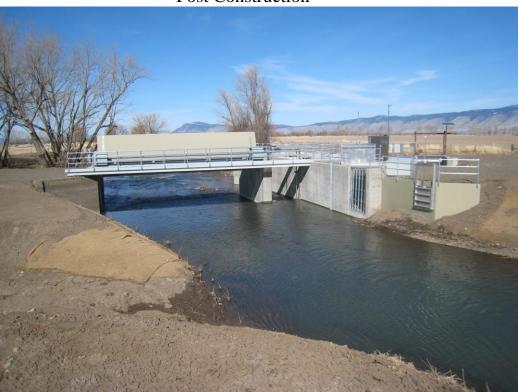
Lower Davis Dam with the radial gate in the up position. Multi-leaf gate in the flow bypass (right side of radial gate) is down in the open position. Fish ladder outlet is to the right of the flow bypass and the irrigation ditch entrance is to the far right.

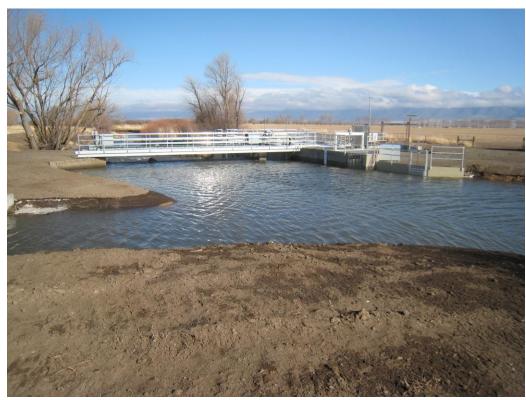
Lower Davis Dam with the radial gate down and at full pool.

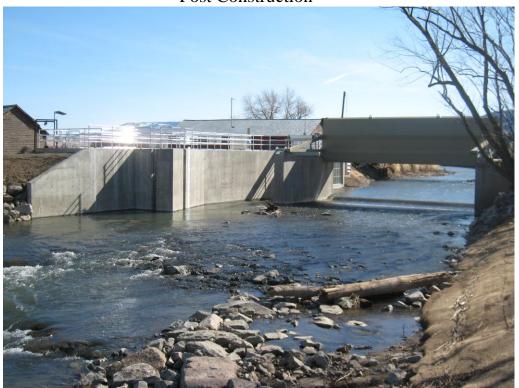
Lower Davis Dam with the radial gate in the up position as it will be outside the irrigation season. Note the fish ladder has two entrances, the one facing downstream will be open when the bypass is running nearly full. The one facing the stream will be used at low flows.

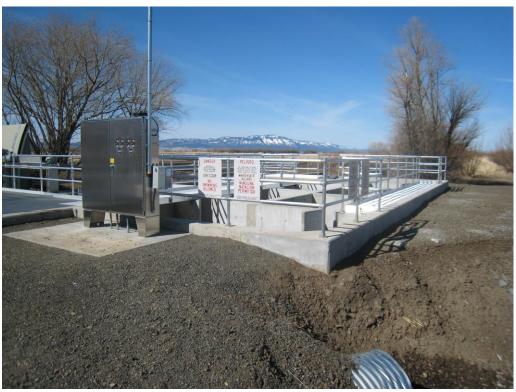
The main electric panel controls the motors for the radial and multi-leaf gates. The fish ladder has guard rails and partial coverage with aluminum grating.

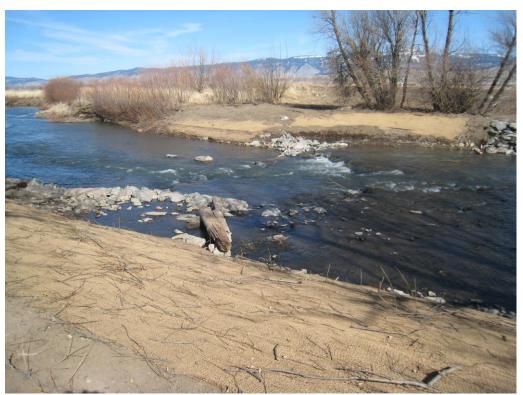
Rock vortex weirs were installed below each structure to center the stream flow and stabilize the streambed
