SIB 01 03 24  
G0X/2X/3X B46/58 EVAP SYSTEM PURGE (VENT) VALVE EXT LTD WTY  
(ELW) 15/150

2024-09-12

This Service Information bulletin (Revision 01) supersedes SI B01 03 24 **dated May 2024**

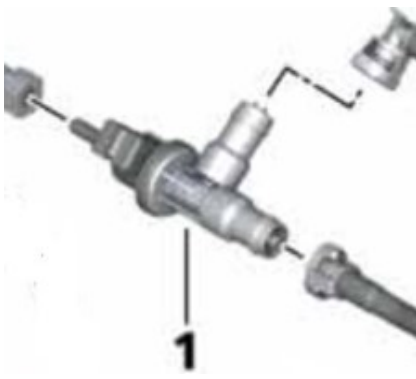
For the eligible vehicles and for the issue described below, BMW of North America, LLC (BMW NA) is extending the limited warranty for the vehicle's **Evaporative Emission Control (EVAP) System's Purge Valve** to:

Over time, the EVAP system's vent (purge) valve may develop material and operational issues, this can cause hard starting, and a rough running engine, especially at idling.

If a vehicle listed above arrives at your center with the issue described in this Service Information Bulletin, perform the corresponding diagnosis and when applicable, replace the EVAP system's vent (purge) valve as instructed or as determined by the diagnosis.
