HELIOVOLTA

THE PV CONNECTOR STATE OF THE FIELD REPORT

An updated guide for 2025
with findings from 5 GWs of
field inspections

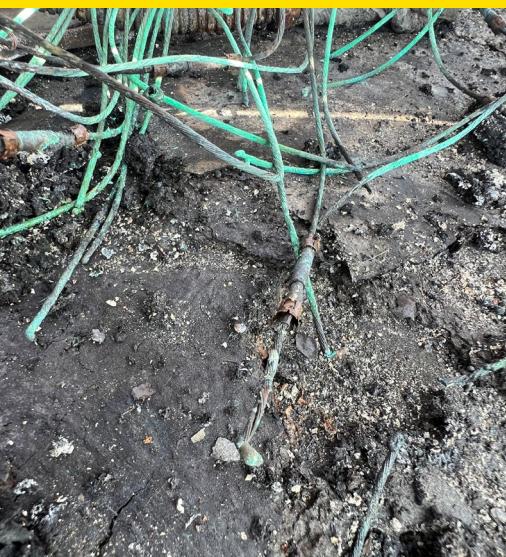
1 MW_{DC} ROOFTOP
TOTAL COST: \$558,450

EVENT	IMPACT
A fire caused by an overheated, arcing connector severely damaged PV system equipment and roof of a retail store. The root cause was systemic bad crimps during installation on all home runs.	<ul style="list-style-type: none"> 1-day store closure 3-month de-energization for inspection and remediation of affected 1 MW_{DC} site 1-month portfolio de-energization to complete inspections and rework of EPC's 9 other sites

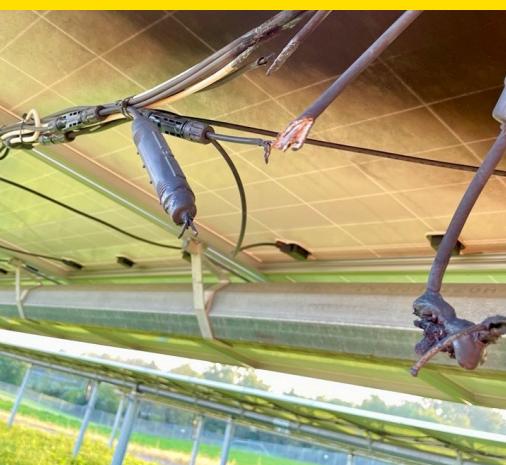
100 MW_{DC} PLANT
TOTAL COST: \$1,913,500

EVENT	IMPACT
A fire occurred due to failed connectors at DC string harness after 24 months of operation. The thermal event followed intermittent systemic failures that began 6 months after operations began.	<ul style="list-style-type: none"> If the fire had gone unnoticed, a major forest fire could have occurred Entire site de-energized immediately to prevent additional fires Block-by-block re-energization over 3 months as remediation work to replace 100% of DC connectors is completed

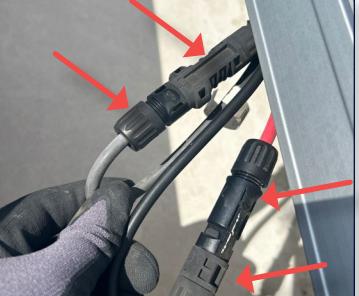
Inter-mated connectors pair positive and negative parts from different OEMs that fit together mechanically but are not electrically compatible, posing a high risk of thermal or electrical failures.

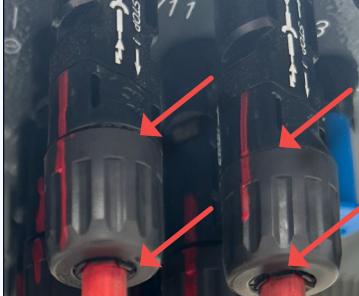
Overtorqued connectors are tightened beyond manufacturer specifications, which can cause internal component damage and compromise connector integrity and electrical performance.

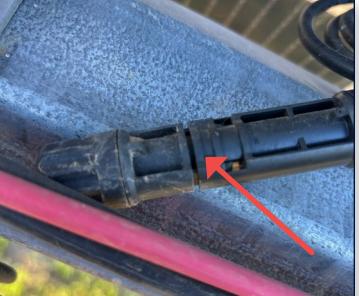
Loose connectors may physically disconnect over time. Improper seating can trigger arcing within the connector or create a higher resistance connection which can lead to a thermal event.

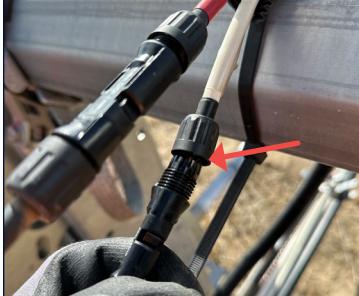
Undertorqued connectors are not tightened enough, compromising the connector's integrity and electrical performance.

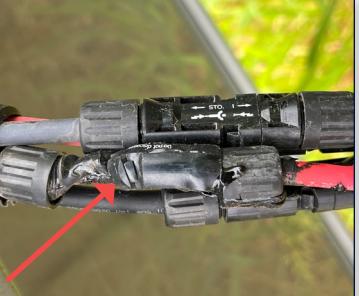
Signs of overheating include high temperatures, deformed plastic, and "shining" surfaces. They can indicate imminent failure.

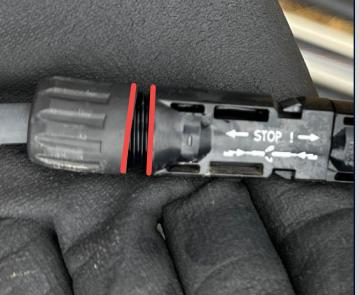
Cross-threaded back glands prevent proper torquing and increase susceptibility to environmental conditions.

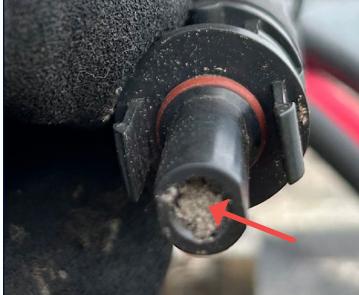
Uncapped/unlanned connectors are highly vulnerable to debris and moisture becoming trapped inside post-installation. This can undermine electrical performance until failure occurs.

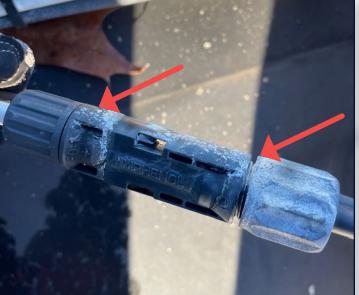
Damaged and corroded connectors allow moisture and debris to readily enter the connector interior, which can cause faults.

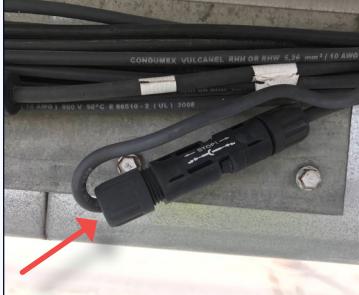
Wire bending radius that is overly tight damages the connector's gland seal, increasing the risk of moisture ingress.
