The Ultimate Safety Guide for Solar PV Connectors

An In-Depth Primer with Best Practices for Solar Professionals and Asset Owners

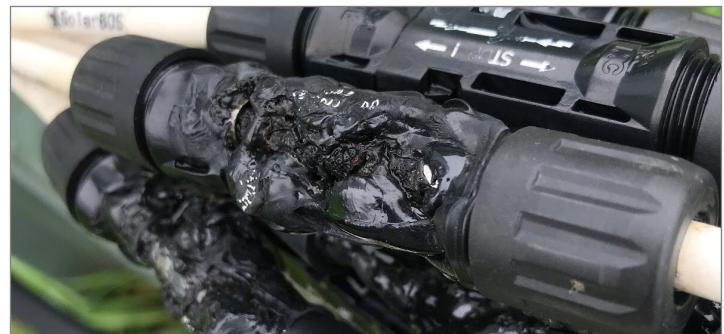
Burnt and melted connectors at an operating project.

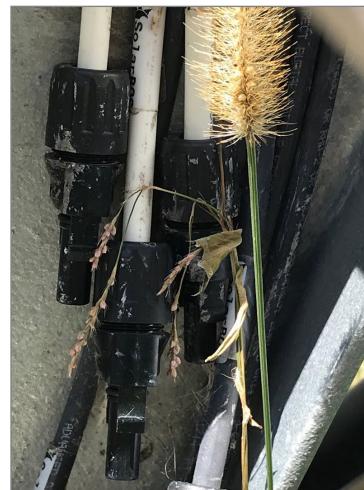
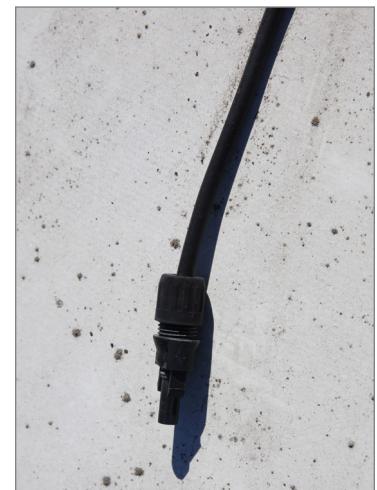
Connectors that are left unplugged and uncapped during construction are often exposed to moisture and foreign particulates, such as dirt or other organic matter. Without connector caps, the metal pins of the connectors will be exposed to moisture and begin to corrode.

Then, once the connector is closed, the corrosion continues to propagate, increasing connector resistance until the connection eventually fails. **These connectors can become time bombs waiting to ignite to the field.**

The connectors above are examples of potential time bombs: they were left unplugged without end caps at a utility-scale plant (left) and a commercial rooftop system (right).

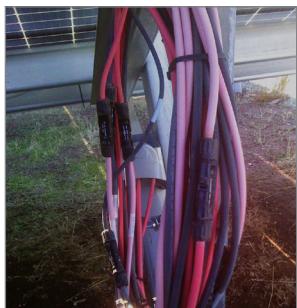
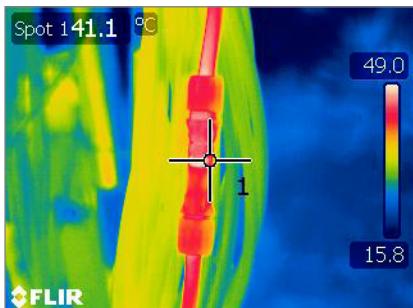
The images above show differential temperature failures. One of the connectors in the bundle (left) has an operating temperature that is 15°C higher than the others, as indicated by the thermal image (right).

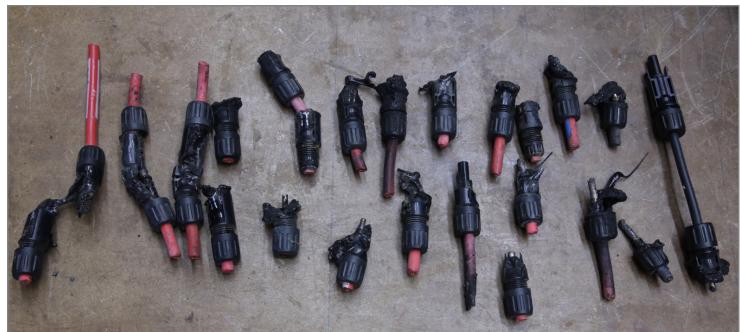
The sample of failed connectors above melted due to high temperature operation in the field. PVEL removed the devices from the field for testing and root cause failure analysis.

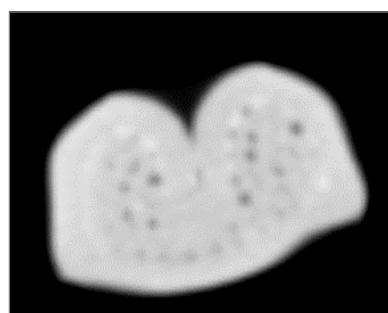
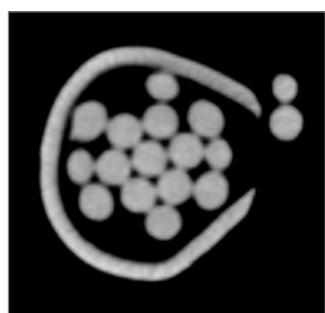
The above XCT cross-section images show the difference between a correct (left) and poor (right) connector crimp found by PVEL in an active PV installation.

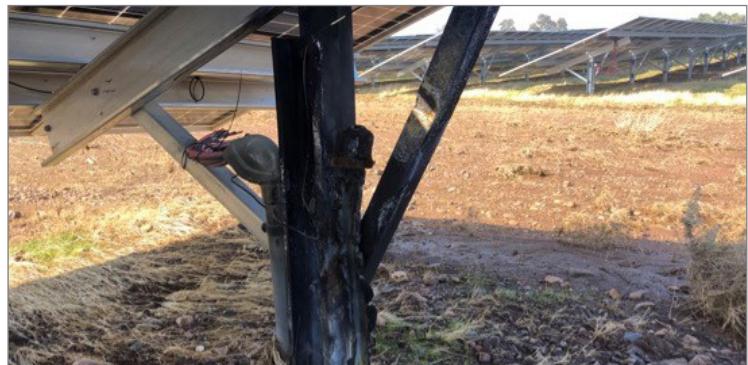
A single overheated connector caused this catastrophic failure. Per PVEL's testing, installation error is likely the root cause.

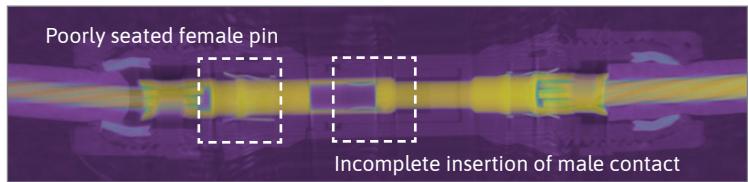
- Critical connector installation errors were extensive, including under- and overtightened nuts, poor placement, improper crimping, and improperly seated contacts.
- 40% of the connectors evaluated with XCT had installation issues, and 20% had incomplete insertion of the contact, which suggests issues are widespread throughout the site.
- Persistent inverter nuisance tripping based on insulation resistance faults could be due to the widespread poor sealing of connectors due to under-torqued back nuts.

These XCT images show two poorly installed connectors. The top image reveals incomplete insertion and the left image zooms in on a channel for water ingress due to an undertorqued nut.

PVEL recommended further inspection and/or total replacement of all field-made connectors in the project due to significant installation errors.
