# Recovery Programme – Export Cable 2

Severn Subsea Cables Ltd · Doc. SSC-HB-PRG-0031 Rev 0

Elena Márquez · 14 August 2026

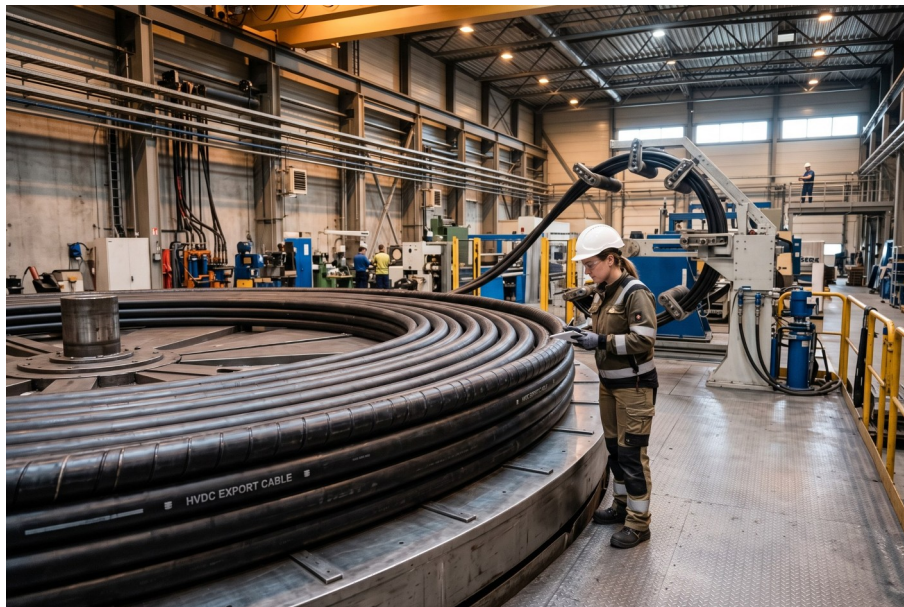
*Export cable 2 on the turntable at Newport during cut-out preparation*
