Peer Review Comment Response

42 Mill Street, Westwood MA

Re: Peer Review Comment Response
 42 Mill Street, Westwood MA

Construction Sequence
for
42 Mill Street
Westwood MA, 02090
DEP File No. 338-0756

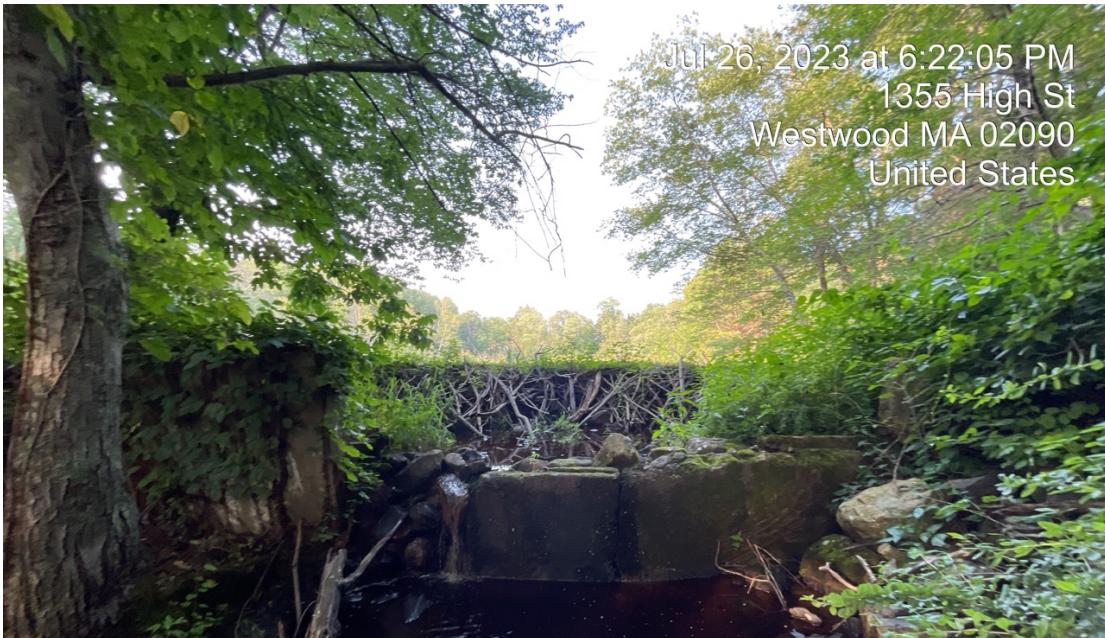
On May 22, 2023, a Notice of Intent application was submitted to the Westwood Conservation Commission for proposed repairs to the dam located at 42 Mill Street, Westwood MA. This concrete dam is dilapidated and crumbling (Photo 1). A beaver dam is present just above the concrete dam. This document details the construction activities that will be undertaken to complete these repairs. All work described in this document shall be overseen by a qualified wetland scientist. A post-construction report will be submitted to the Commission after work on the dam is complete (see step 11 of sequence below).

Photo 1. View of dilapidated concrete spillway.

Once the dam is repaired and trees removed, work will commence on the spillways. These concrete structures are in disrepair and need concrete work to avoid continued deterioration or undermining. This work will be conducted in a period of low flow (i.e. between July and September) to minimize the amount of water that needs to be diverted. To conduct these repairs, sandbags will be added to supplement the existing beaver dam and prevent the flow of additional water to the concrete spillway. A sump pump may also be used in the area between the sand-bagged beaver dam and the concrete spillway to export any water that seeps through.

Concrete will be prepared at the staging area and brought to the spillway for repairs by hand atop the newly cleared earthen dam berm, or via concrete pump. Concrete work will be conducted by hand per the specifications on the attached site plan's details. No machines will access the area via the narrow earthen berm.

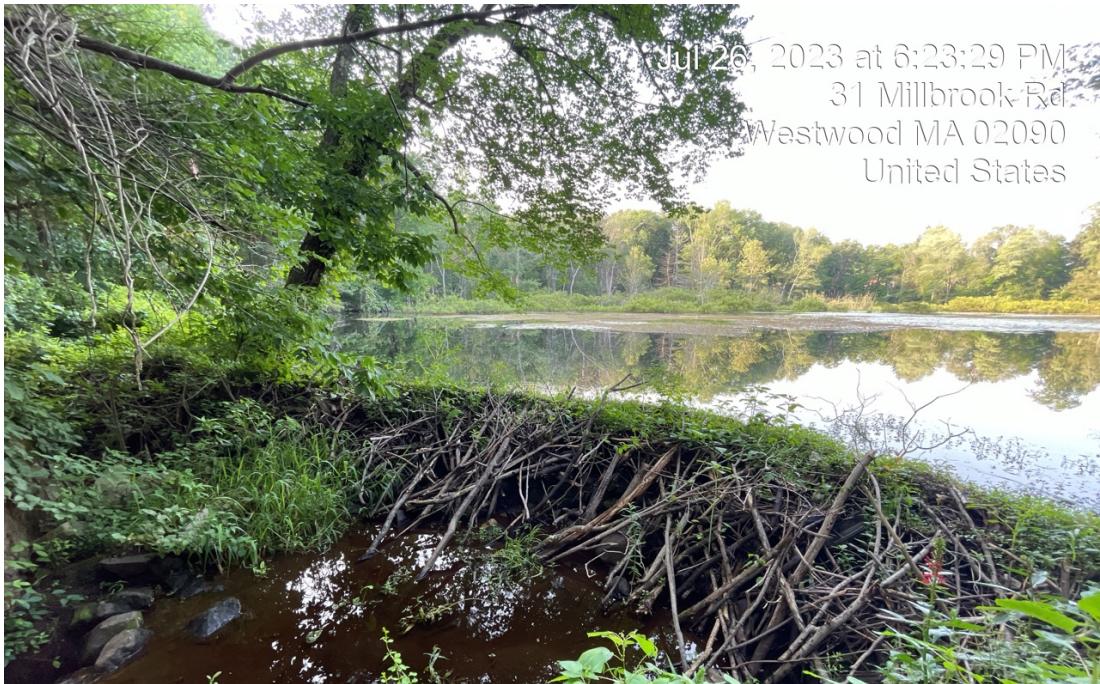
The applicant proposes to conduct repairs to the Mill Brook dam. The existing beaver dam (Photo 2), which is situated just above the concrete spillway to be repaired, in fact helps with construction because it provides most of the damming required to conduct concrete repairs. The beaver dam will be left in place during construction and supplemented with sandbags to ensure this area is sufficiently dammed. Under current conditions, very little water moves past the beaver dam and over the concrete spillway – most water flows over the emergency spillway (Photo 3). If it is necessary to fully evacuate all water, a sump pump may be utilized temporarily to pump out water from the area between the beaver dam and the concrete dam.

Photo 2. View of beaver dam above concrete spillway.

Following completion of dam repairs, the existing beaver dam will be removed. The applicant will contact the Town Board of Health to permit the removal of the existing beaver dams and a licensed beaver removal contractor contacted to breach and remove the dams, per BOH permits. In order to not wash out downstream areas, the beaver dam will be removed slowly and methodically, not lowering the water level of the pond by more than 6" per day.

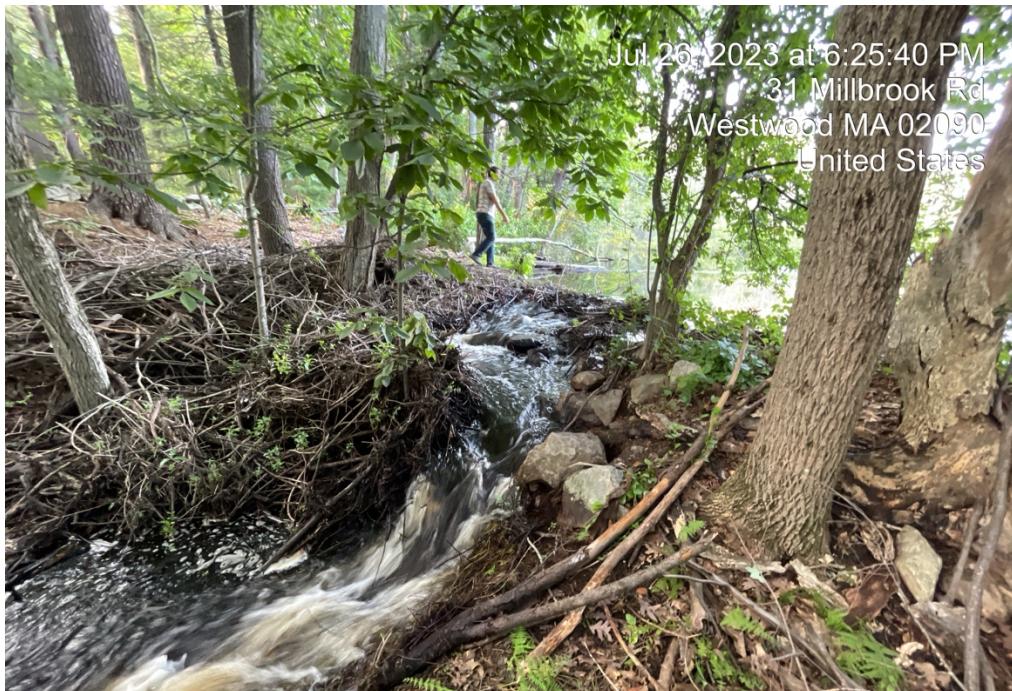
The project also proposes to clear the earthen dam berm adjacent to the concrete spillway of woody vegetation. The woody vegetation currently present on this berm poses a risk of windthrows, which could destabilize the berm and accelerate its failure. Additionally, the overflow spillway to the north of the earthen berm is proposed to be cleared of debris and reshaped with modified riprap. This will ensure that it is capable of conveying overflow water sufficiently so that the concrete spillway and earthen berm are not overwhelmed. The overflow spillway has been designed to be able to convey more water than that which would result from the occurrence of the 100-year storm.

Photo 3. View of overflow spillway, which presently conveys most flow from Baker's Pond.

The emergency spillway will be cleared of debris and reshaped with an invert of 1 foot lower than the adjacent earthen berm. This section will be constructed of modified riprap per the detail on the attached site plan.
