Report to the President

**PRESIDENTIAL  
COMMISSION**

On the Space Shuttle  
Challenger Accident

June 6th, 1986  
Washington, D.C.

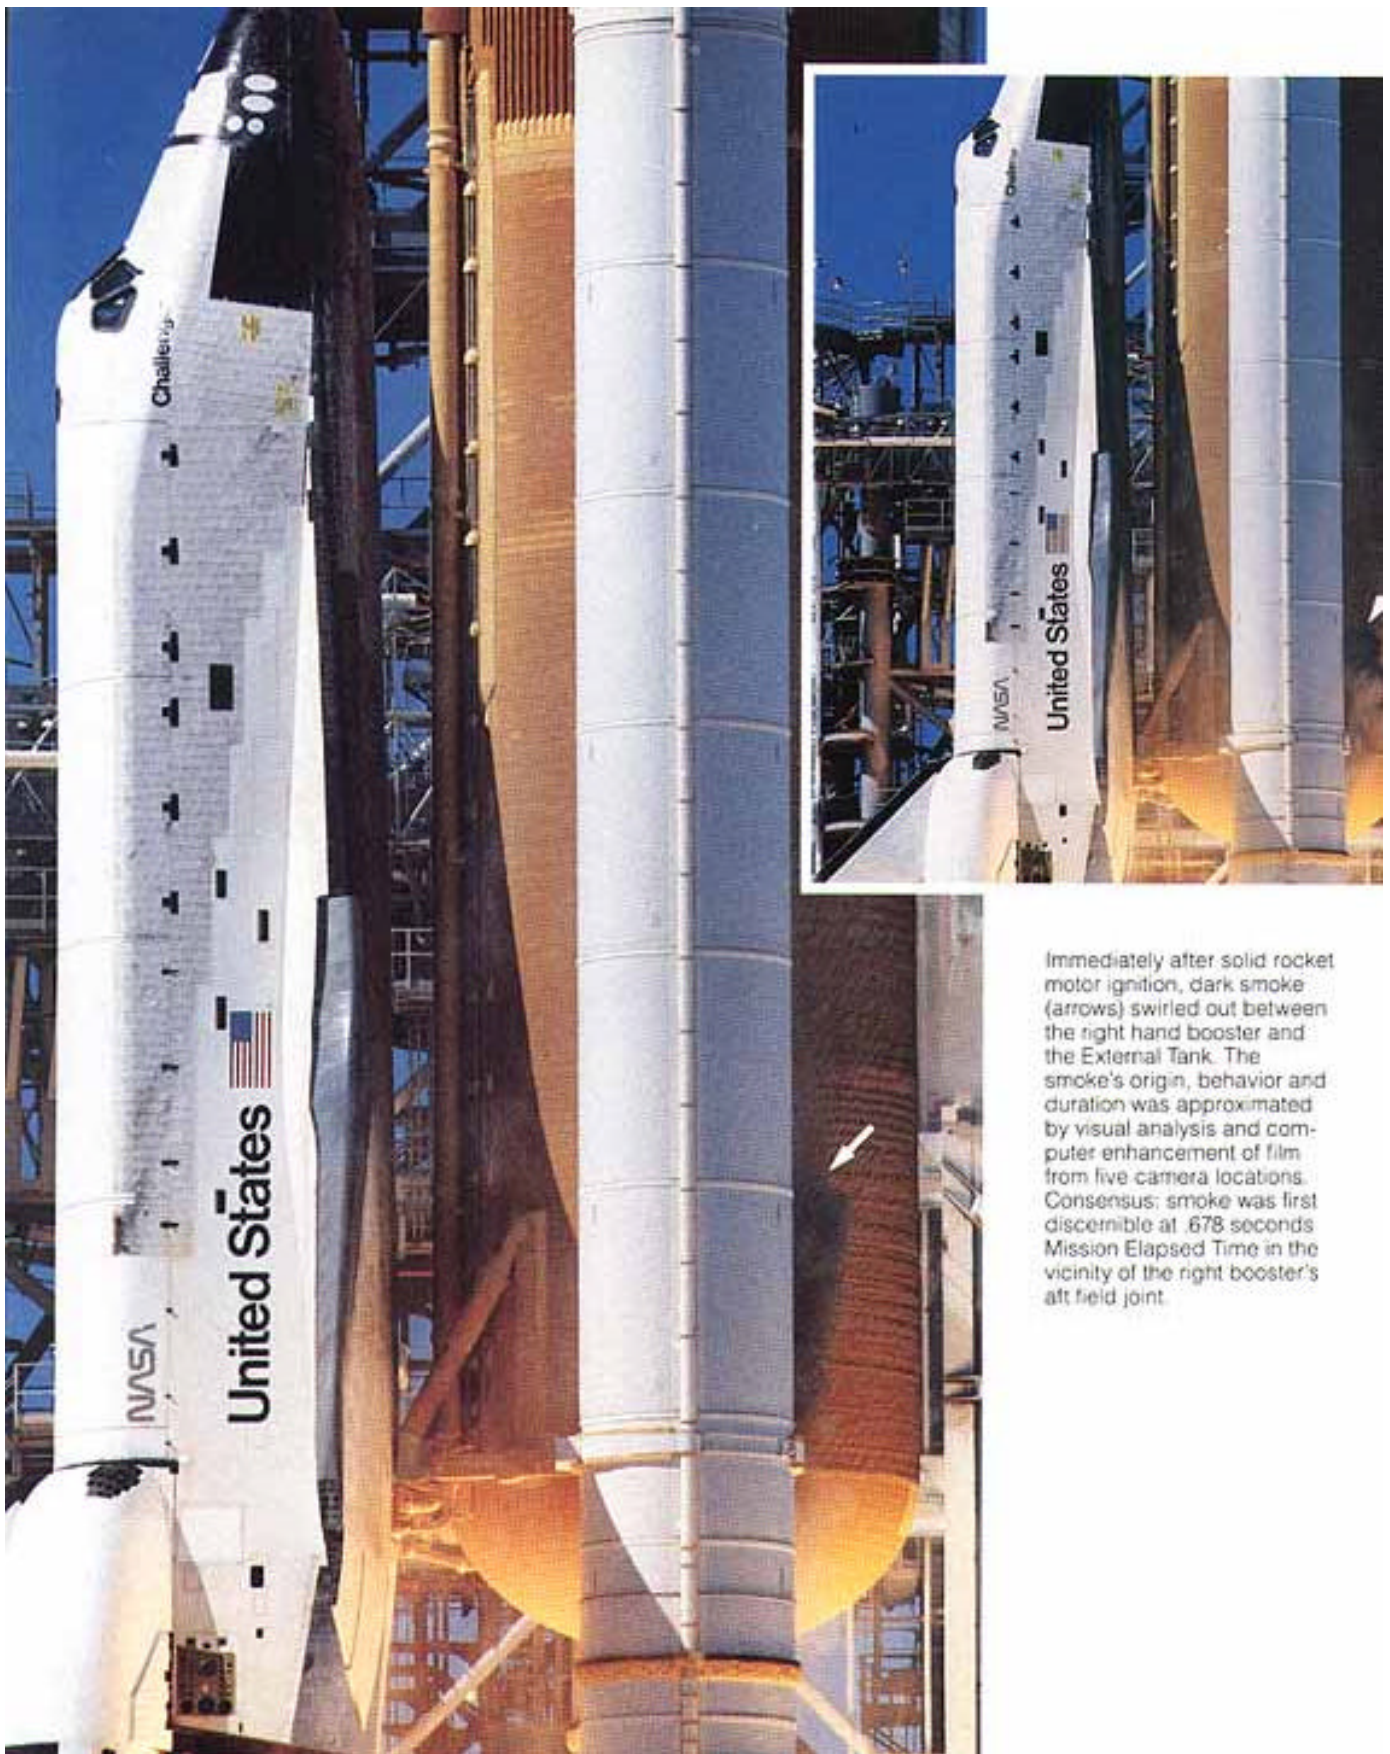
Immediately after solid rocket motor ignition, dark smoke (arrows) swirled out between the right hand booster and the External Tank. The smoke's origin, behavior and duration was approximated by visual analysis and computer enhancement of film from five camera locations. Consensus; smoke was first discernible at .678 seconds Mission Elapsed Time in the vicinity of the right booster's aft field joint.

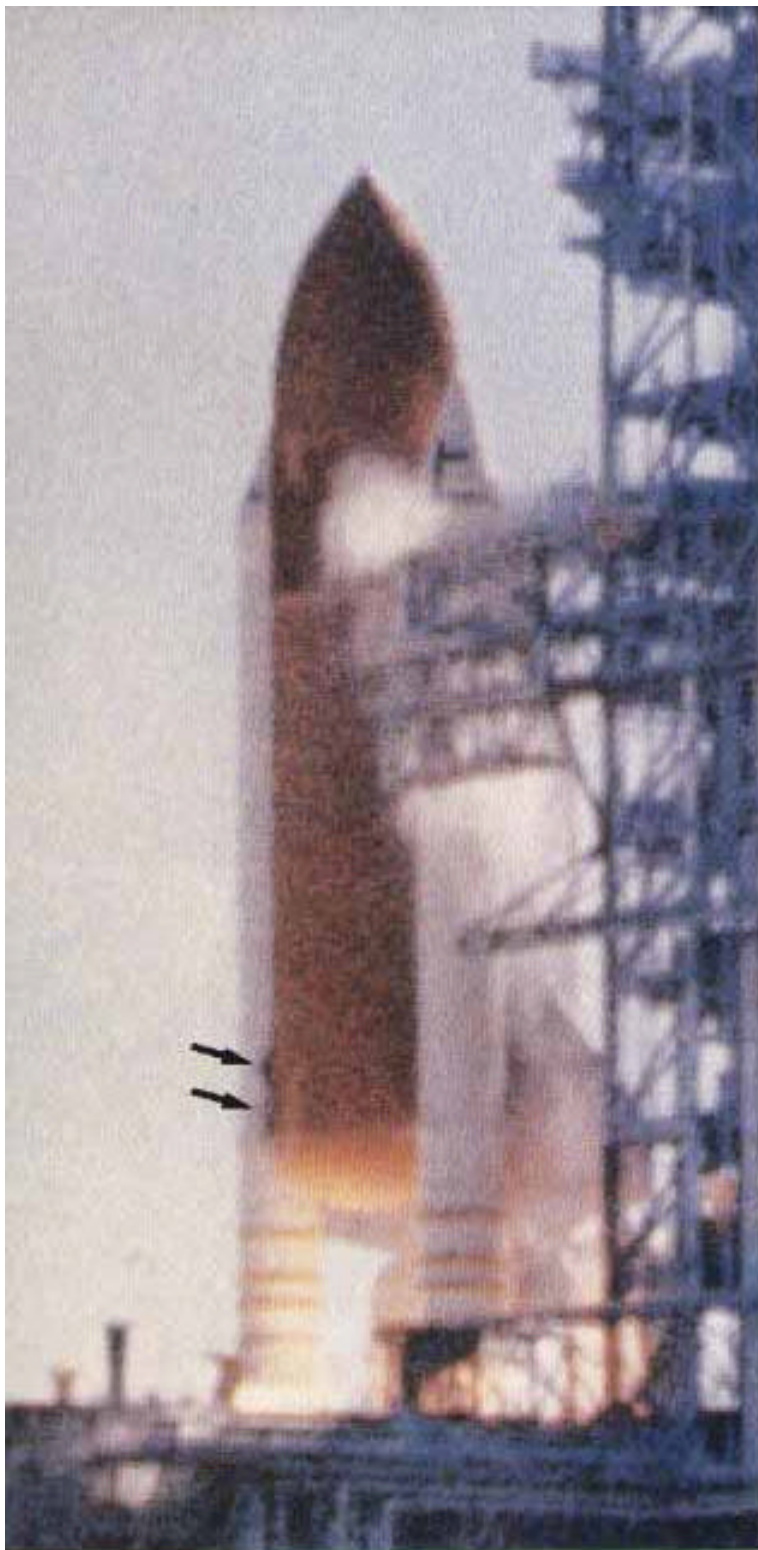
Multiple smoke puffs are visible in the photo above (arrows). They began at .836 seconds and continued through 2.500 seconds, occurring about 4 times a second. Upward motion of the vehicle caused the smoke to drift downward and blur into a single cloud. Smoke source is shown in the computer generated drawing (far right).

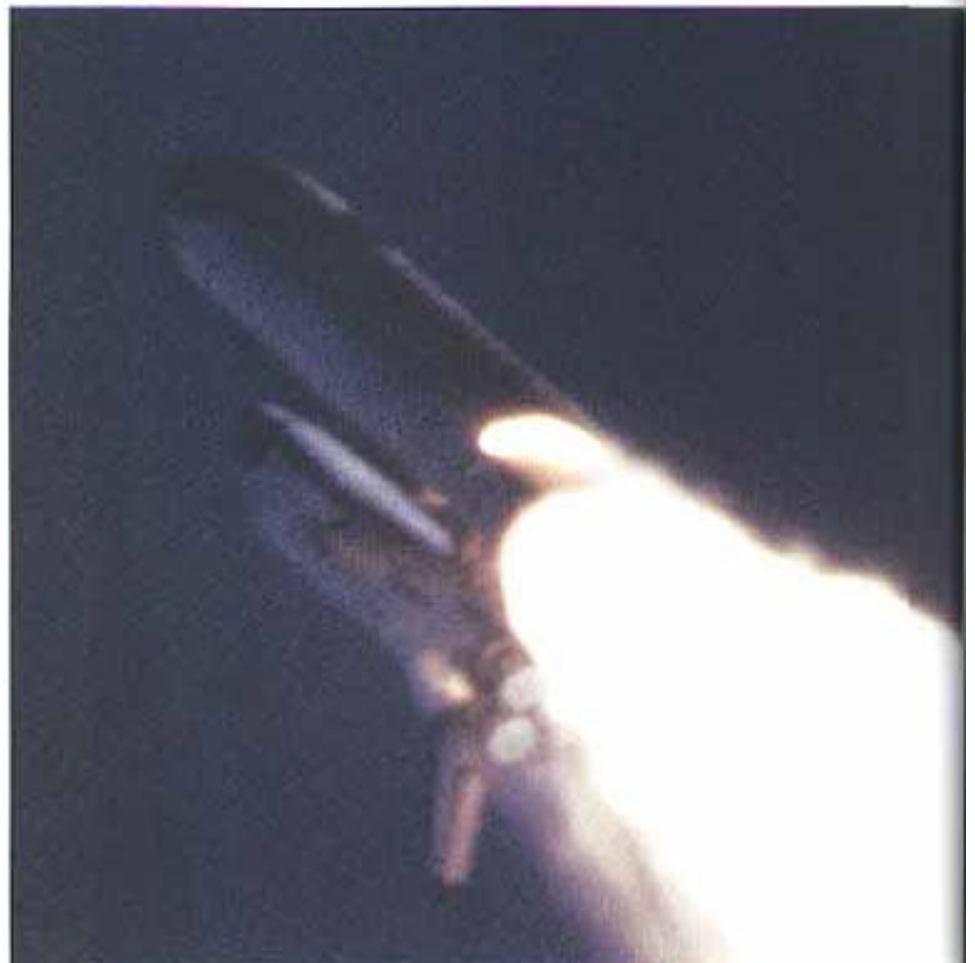
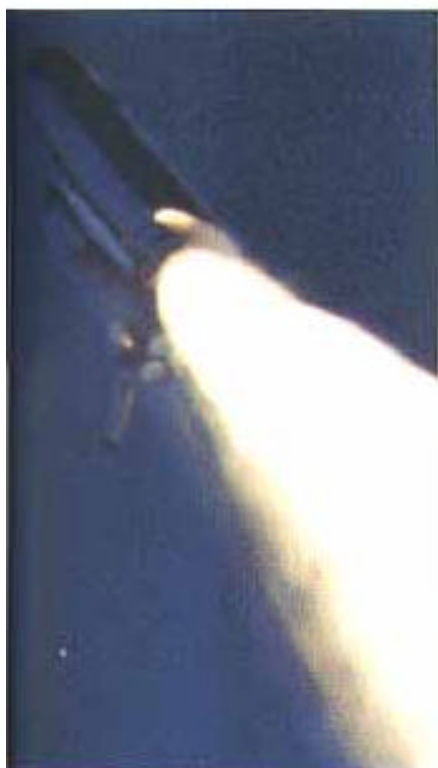
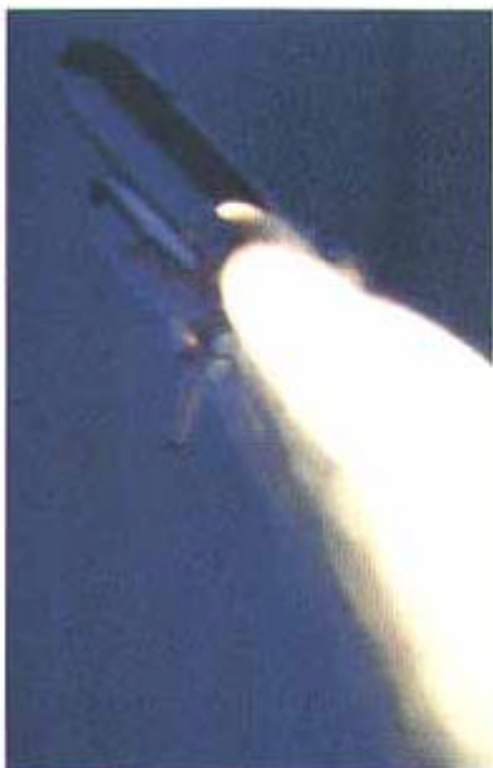
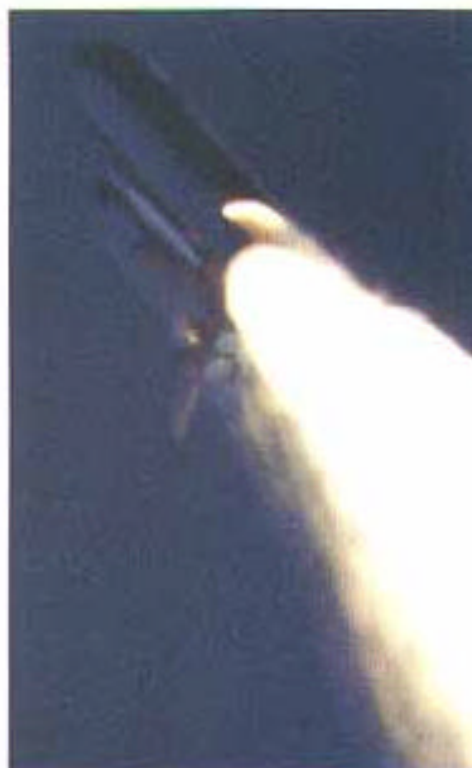
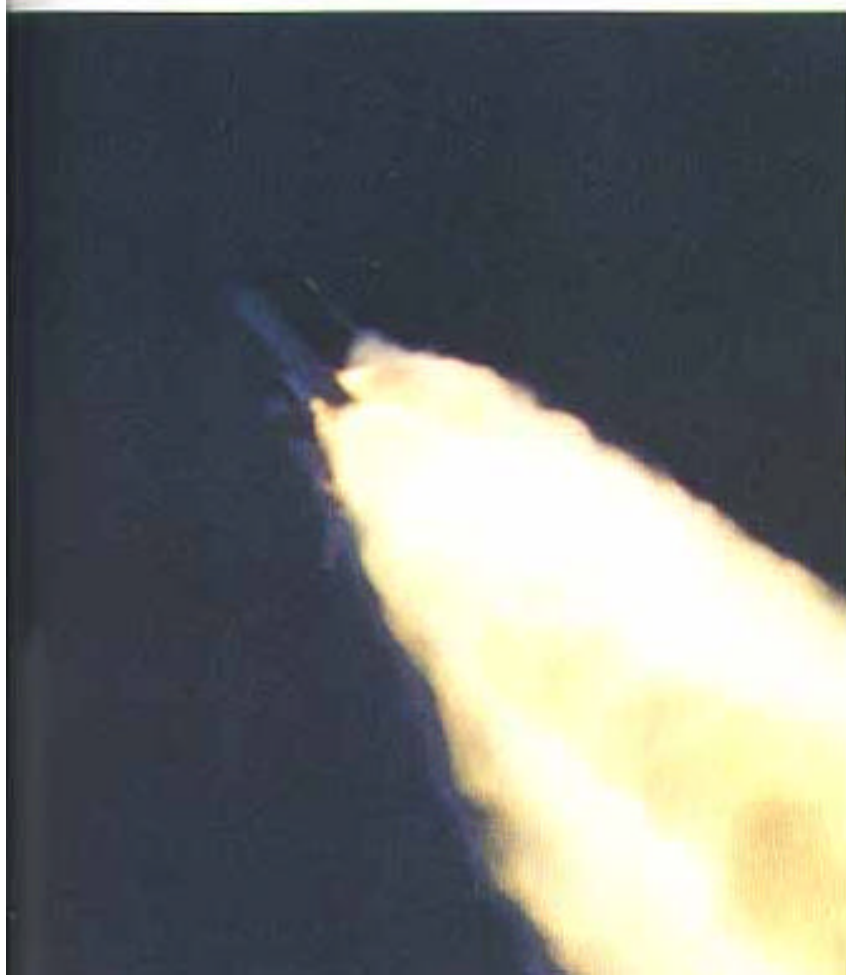
At 58.788 seconds, the first flicker of flame appeared. Flare visible above, it grew into a large plume and began to impinge on the External Tank at about 60 seconds. Flame is pinpointed in the computer drawing between the right booster and the tank, as in the case of earlier smoke puffs. At far right (arrow), vapor is seen escaping from the apparently breached External Tank.

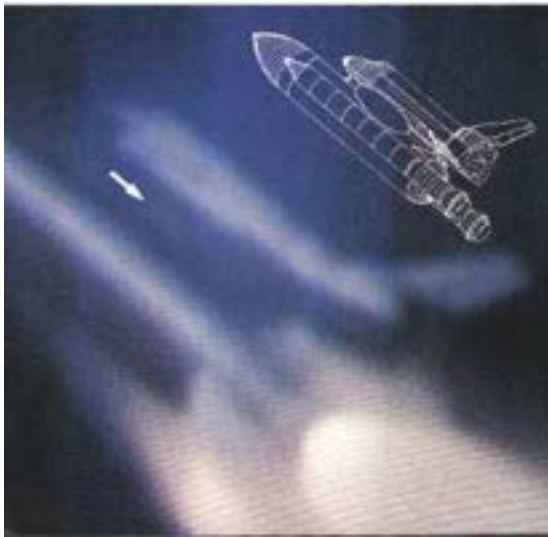
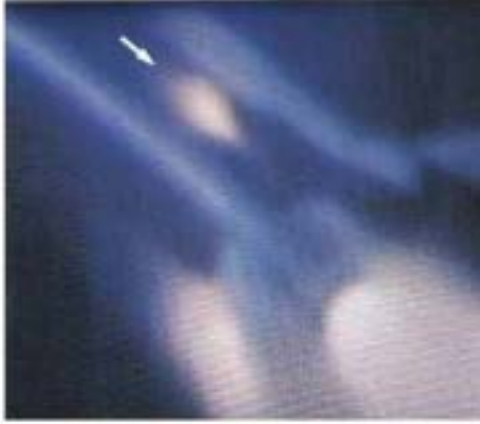
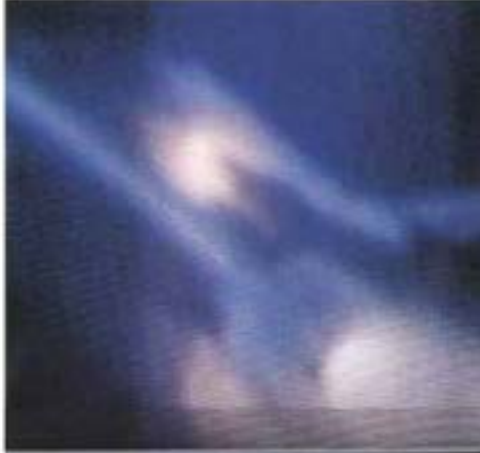
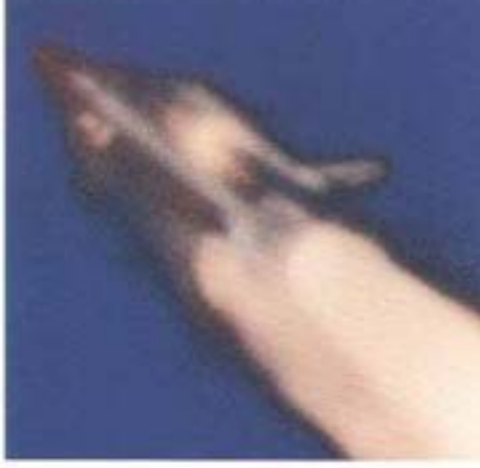
Camera views indicate the beginning of rupture of the liquid hydrogen and liquid oxygen tanks within the External Tank. A small flash (arrows above) intensified rapidly, then diminished

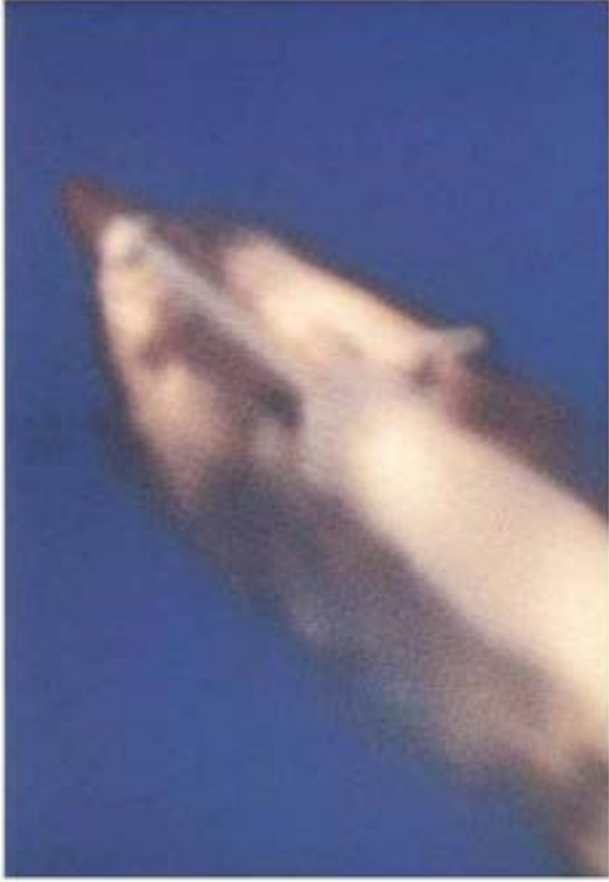
A second flash, attributed to rupture of the liquid oxygen tank, occurred above the booster/tank forward attachment (below left) and grew in milliseconds to the maximum size indicated in the computer drawing.

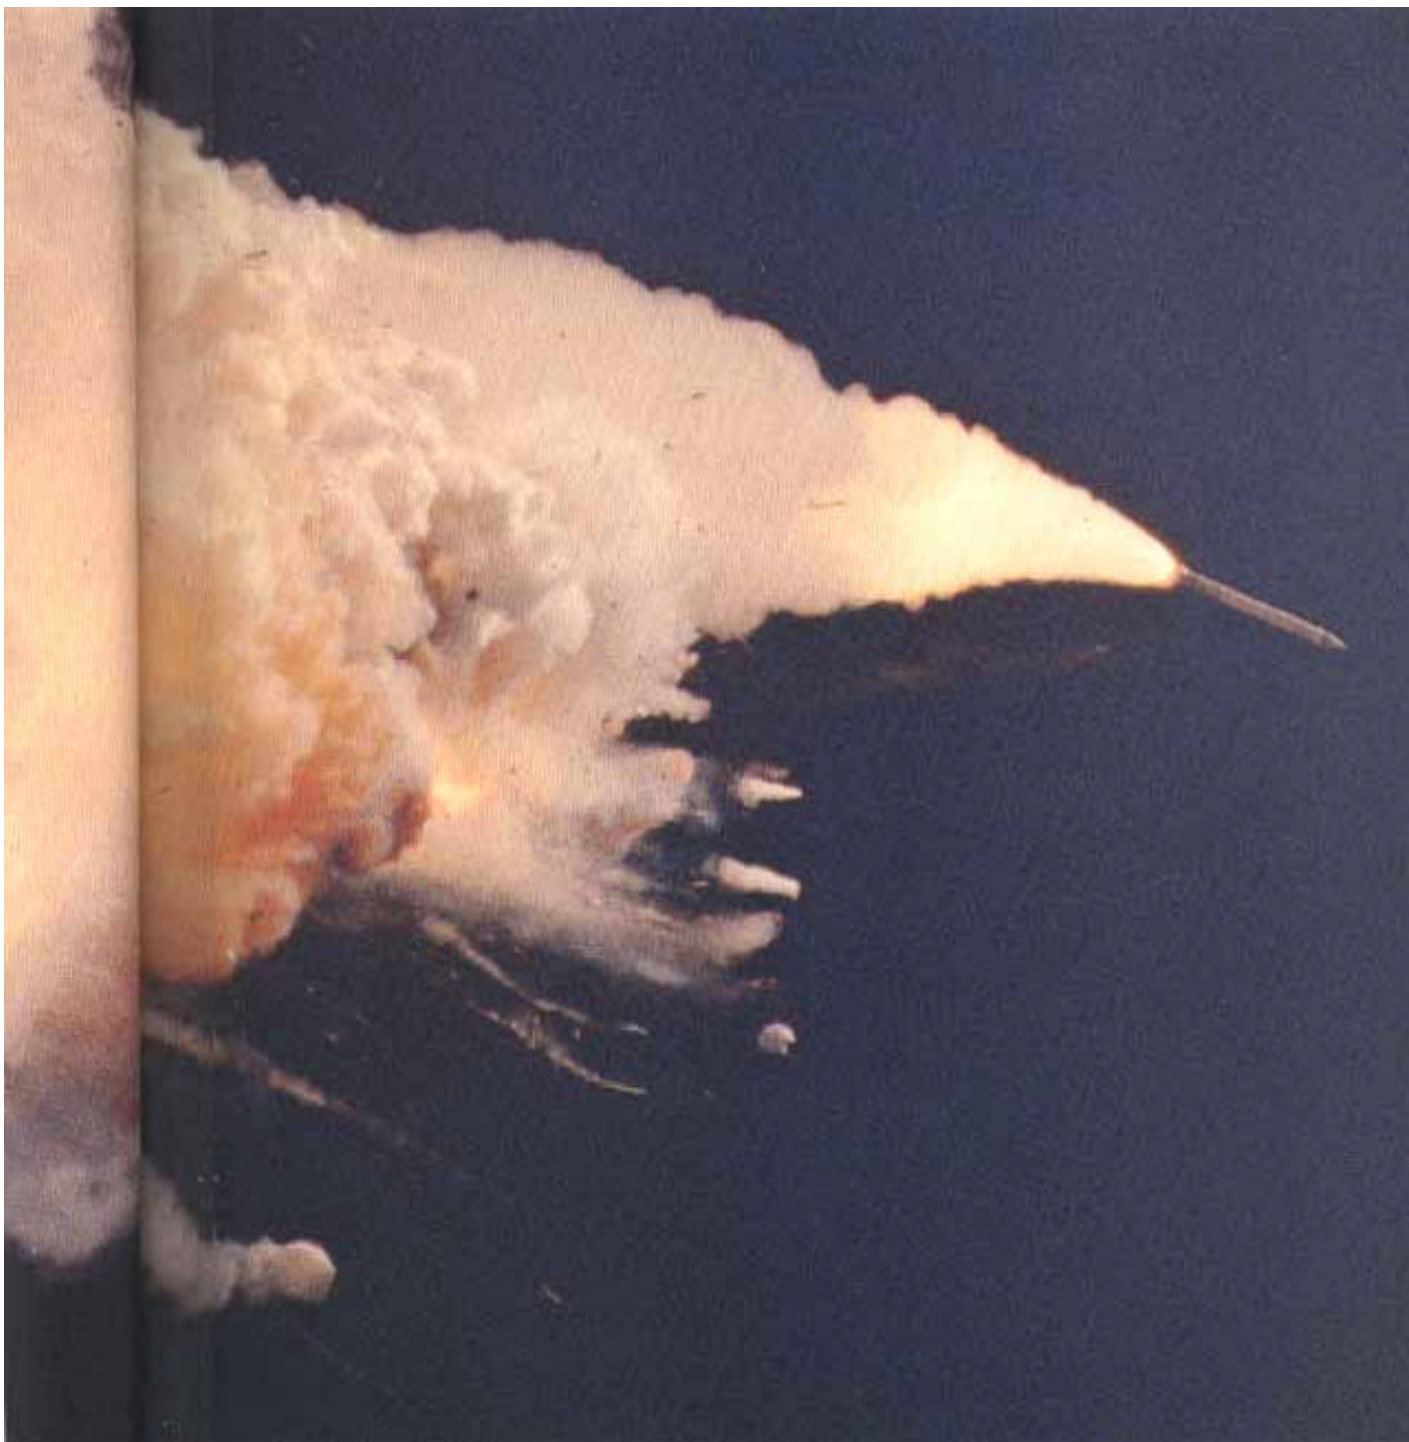
At about 76 seconds, unidentifiable fragments of the Shuttle vehicle can be seen tumbling against a background of fire, smoke and vaporized propellants from the External Tank (left).

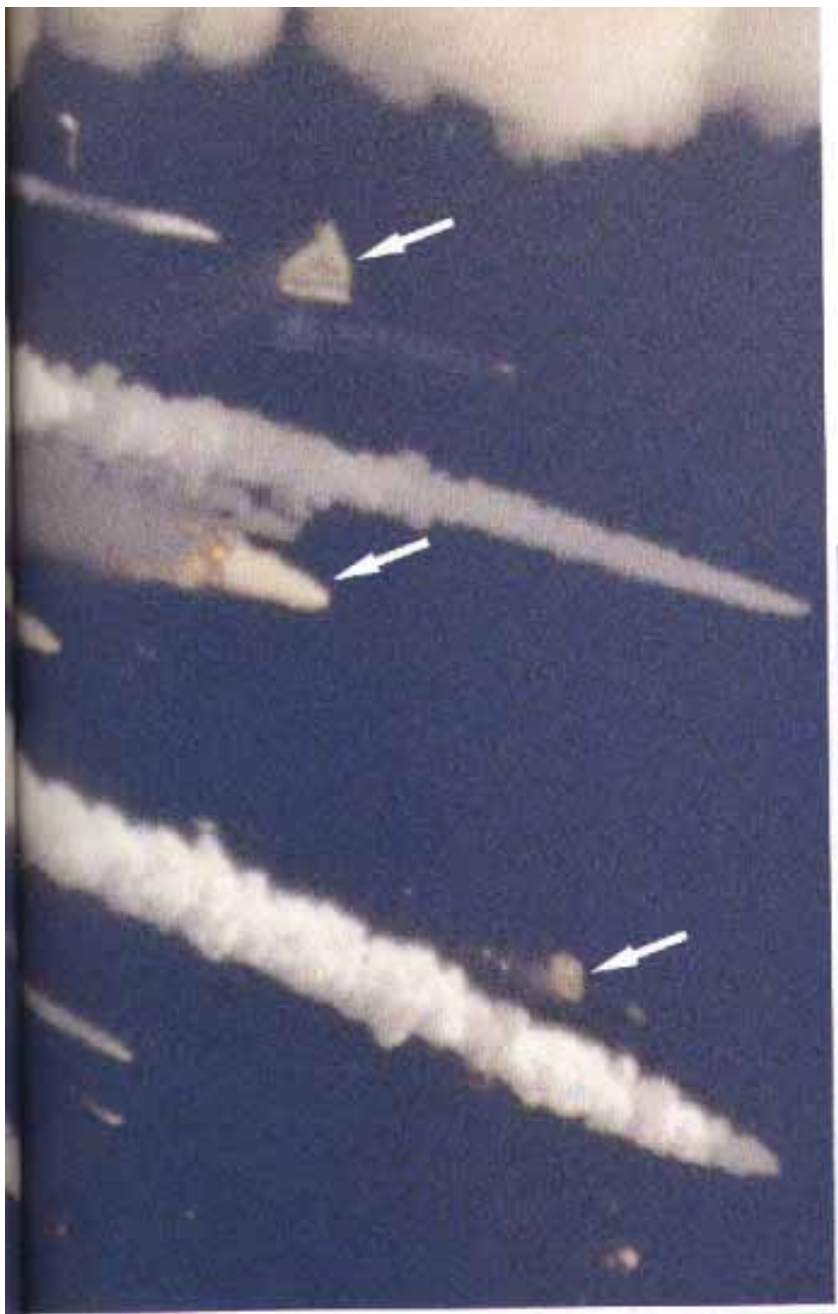
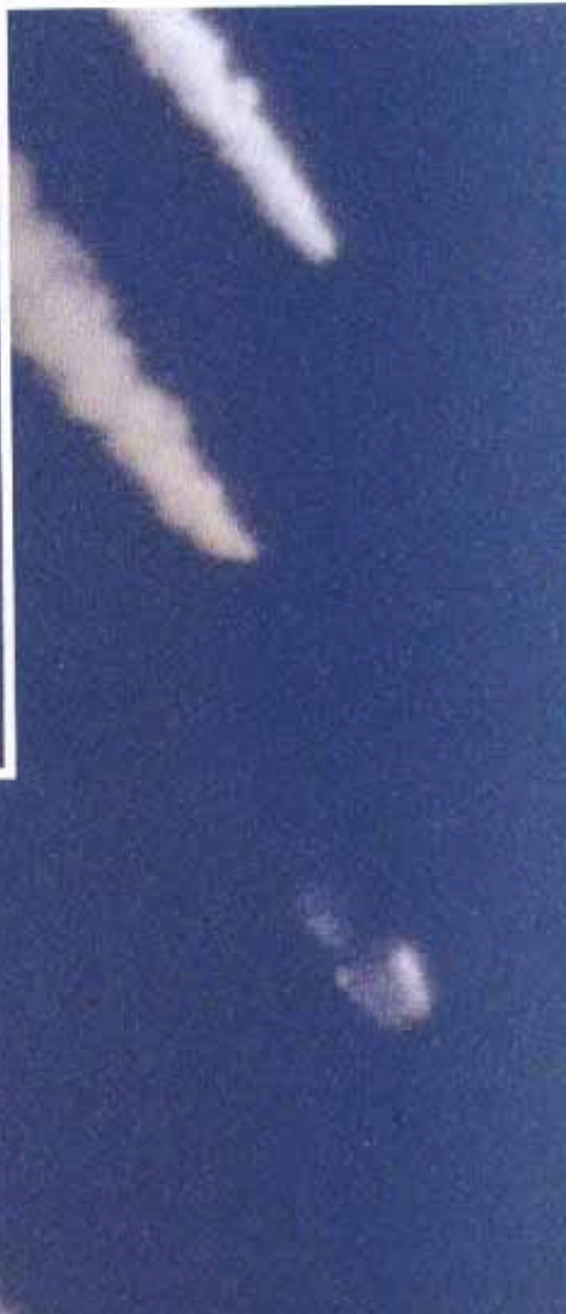
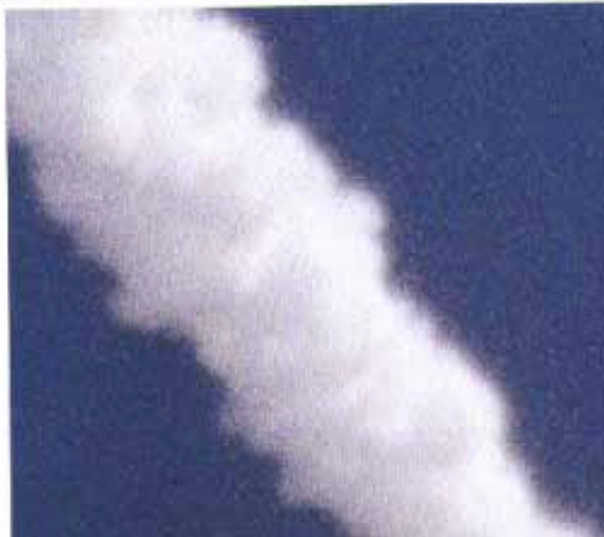
Hurting out of the fireball at 78 seconds (left) are the Orbiter's left wing (top arrow), the main engines (center arrow) and the forward fuselage (bottom arrow). In the photo below, it plunges Earthward, trailed by smoking fragments of Challenger.

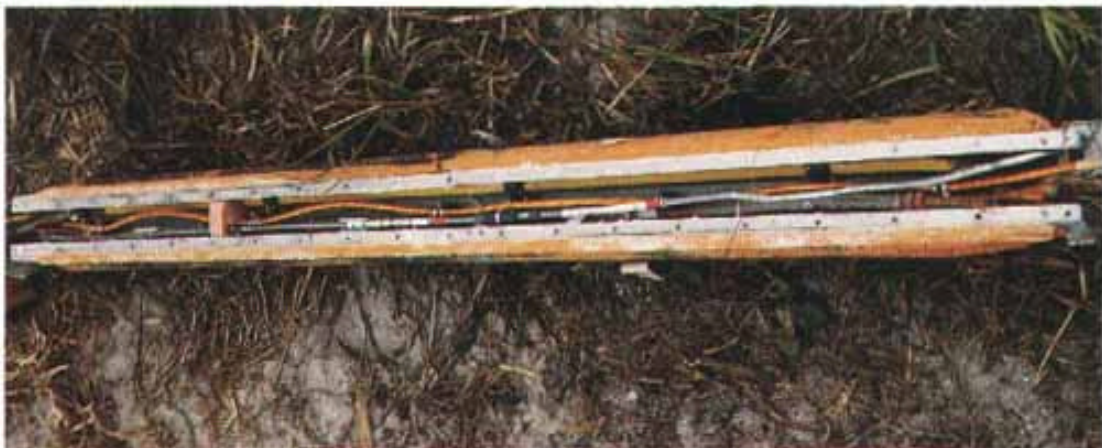
C

The lower photos show the range safety destruct charges in the External Tank. These charges were exonerated when they were recovered intact and undetonated.

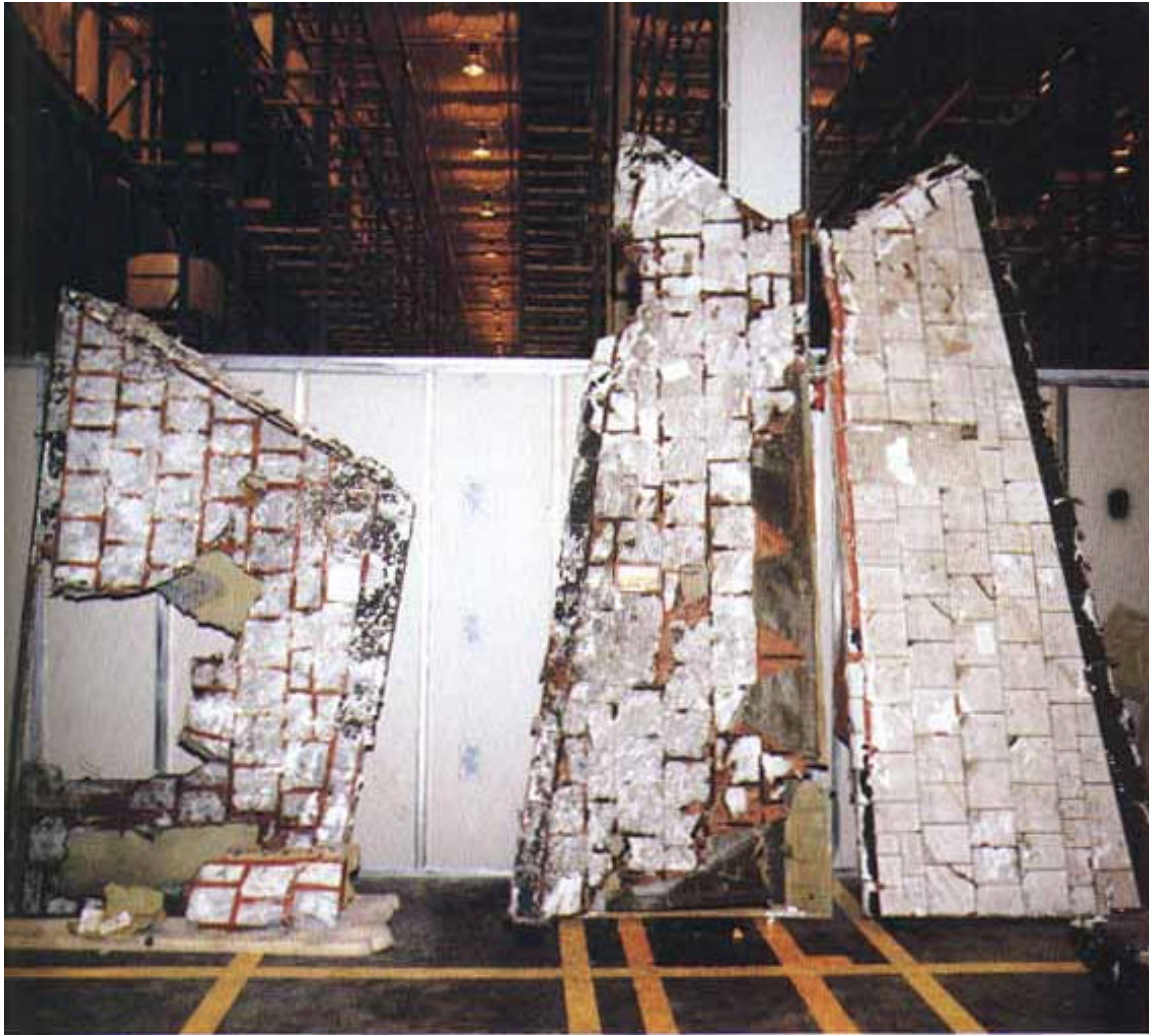
B

The upper photos show, from left to right, the left side of the orbiter (unburned), the right lower and upper rudder speed brake (both burned damaged) and left upper speed brake (unburned), confirmation that the fire was on the right side of the Shuttle stack.

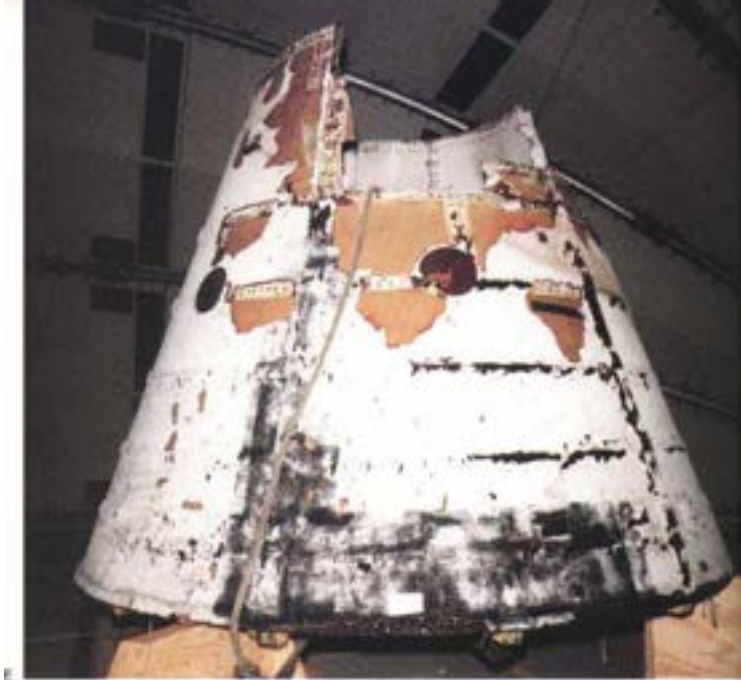
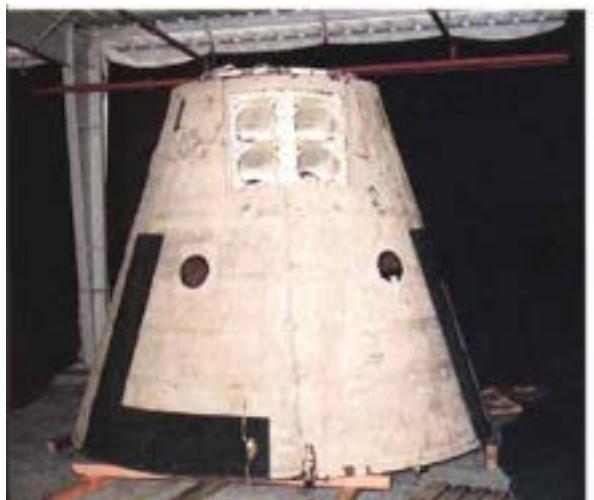
The frustrums on the left page are parts of the Solid Rocket Booster forward assemblies that contain recovery parachutes, location aids and flotation devices. The frustum of the left hand booster (lower left) is virtually undamaged. The right frustum shows impact damage at top and burns along the base of the cone; evidence indicates it was damaged when it impacted with the External Tank. Shown at right above is another Solid Rocket Motor stack crosshatched to show the burned area of the right booster's aft joint (diagram at right). The flame from the hole impinged on the External Tank and caused a failure at the aft connection at the External Tank.

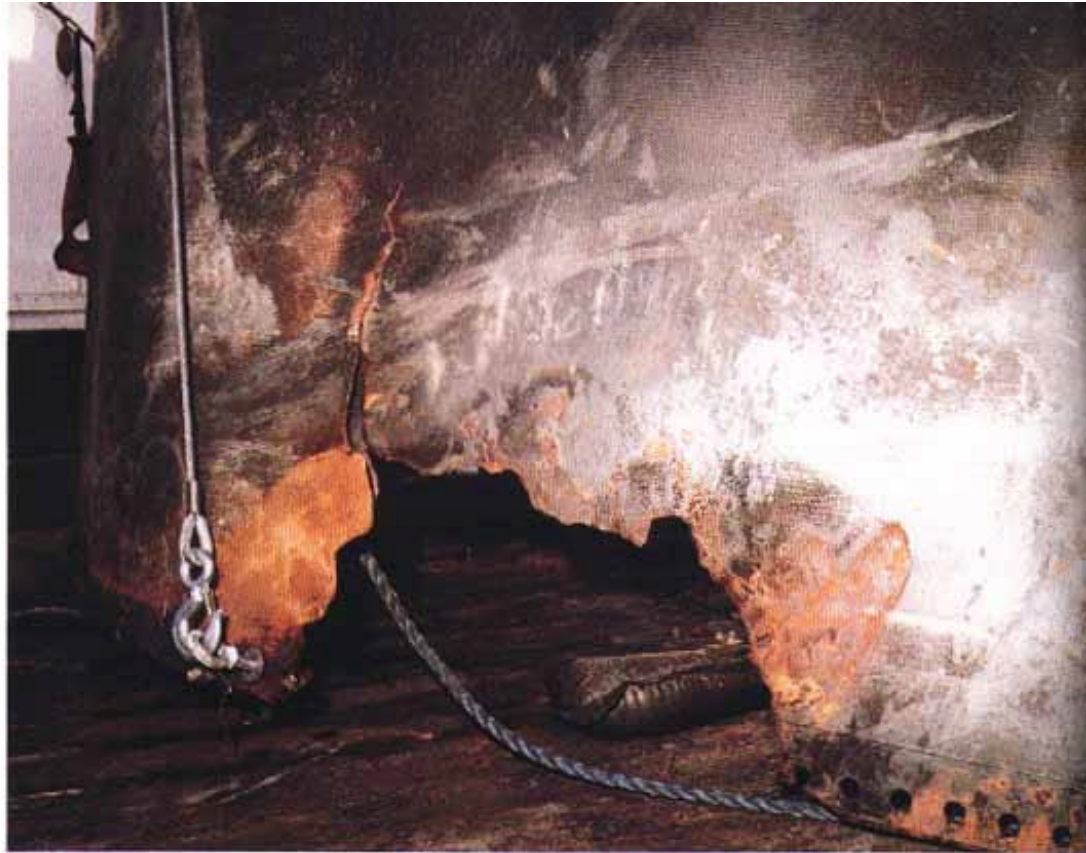
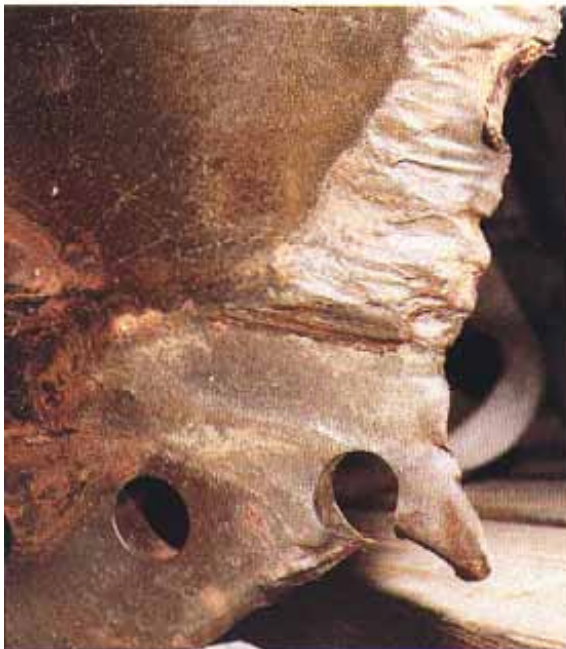
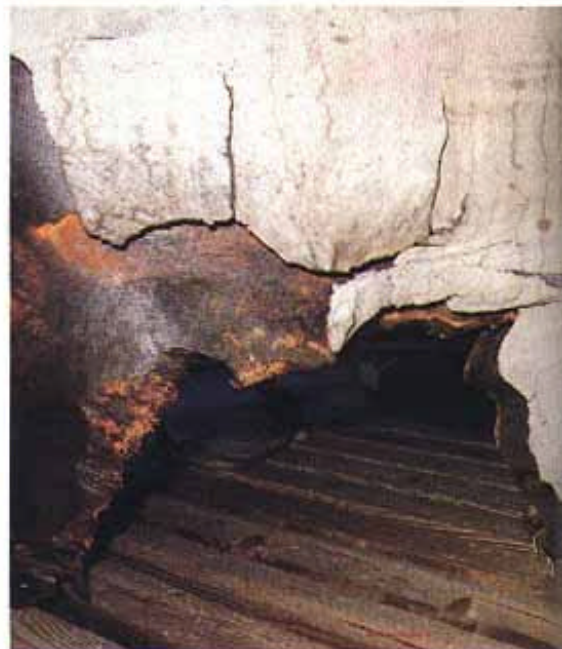
Photos I, J & K [clockwise]

: Examined at Kennedy Space Center after their recovery from the ocean, these fragments show the extent of burn through the right hand booster's aft field joint. On the left page are sections of the aft center motor above the joint. On the right page are sections (inverted) of the aft motor segment showing burn-hole below the joint (bracket). Except for the interior views on lower left, the camera is viewing the parts from outside the casing.

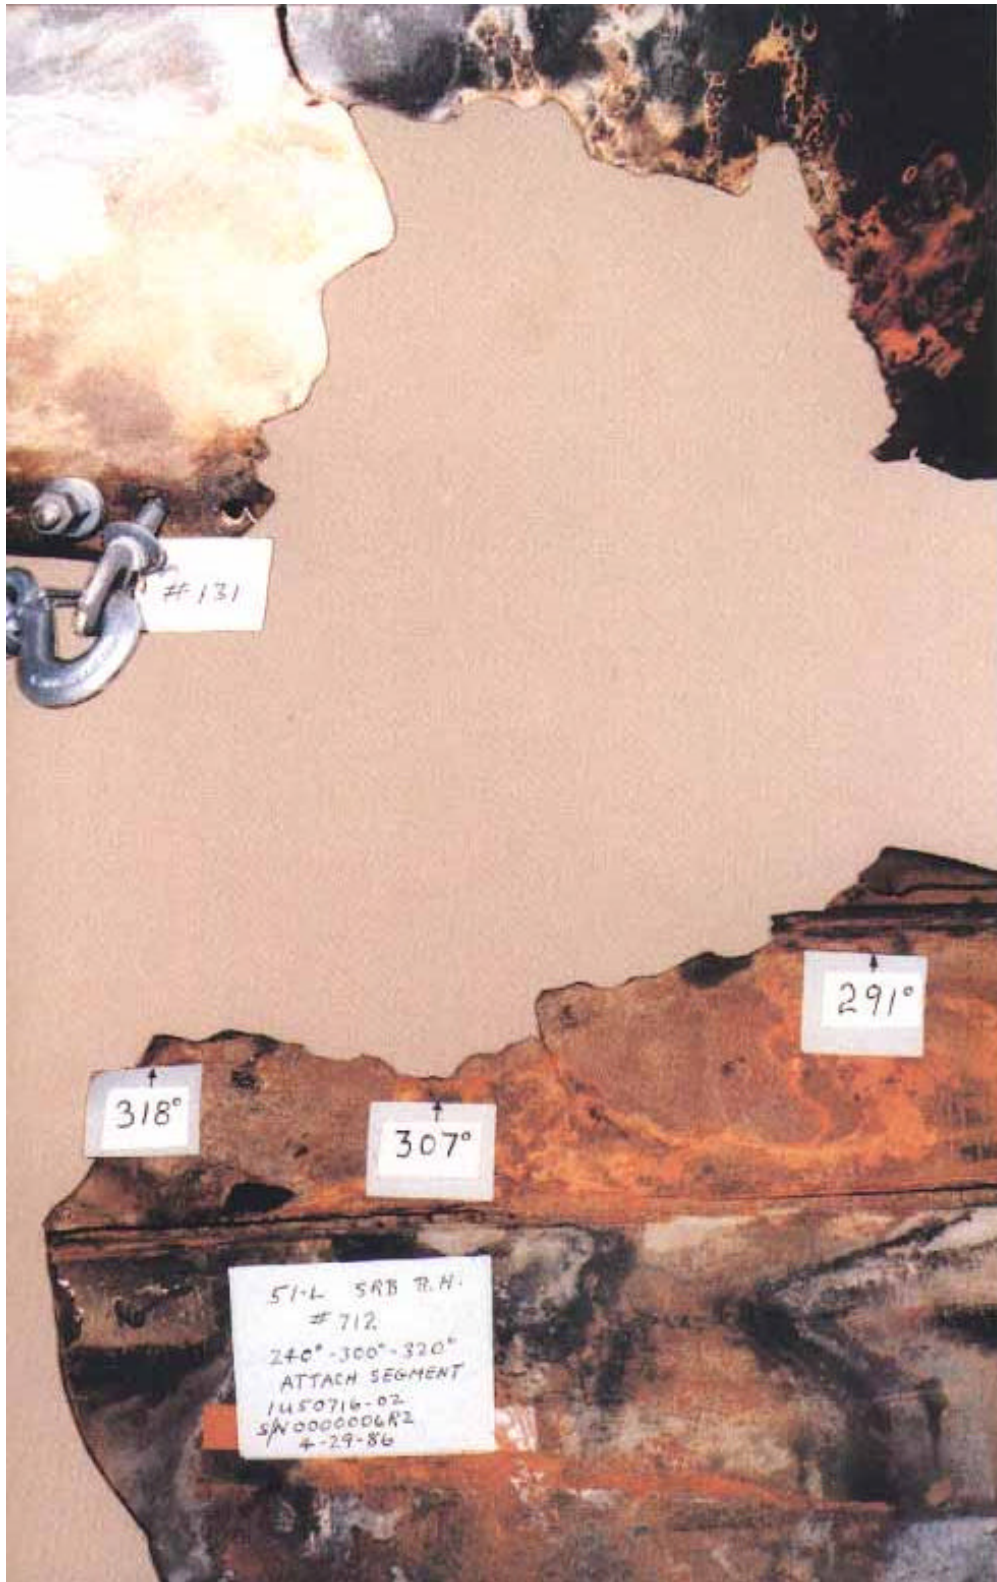
Photos N & O [top, bottom]  
 At upper left is the aft segment burn viewed from inside the casing; the lower photo is a closeup of the same section. The latter photo shows a hole (arrow) where the flame plume may have burned through the casing from the outside. At right is a composite view of the burn above and below the aft field joint.

At upper left is the aft segment burn viewed from inside the casing; the lower photo is a closeup of the same section. The latter photo shows a hole (arrow) where the flame plume may have burned through the casing from the outside. At right is a composite view of the burn above and below the aft field joint.

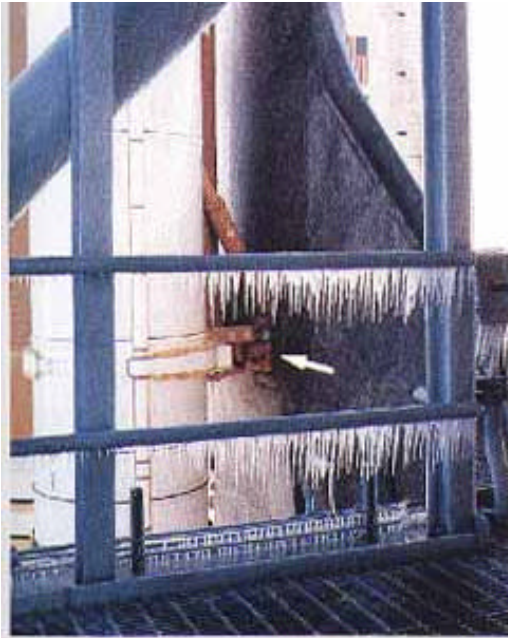
Above, Shuttle 51-L on Kennedy Space Center Pad 39B in the early morning of launch day. Temperatures were well below freezing, as indicated by the lower left photo, which shows thick ice in a water trough despite the use of an anti-freeze solution.

Above, foot long icicles on a lower level of the Fixed Service Structure frame the attachment point where the Orbiter is attached to the external tank (arrow). Icing was even more extensive at upper levels of the service structure (upper right and below). At right below is a ground communications box (not used during launch) rendered inoperable by heavy ice.
