**AIRCRAFT ACCIDENT INVESTIGATION BUREAU
GOVERNMENT OF INDIA**

**FINAL REPORT ON SERIOUS INCIDENT INVOLVING
AIRPROX THAT OCCURRED IN DELHI AREA
BETWEEN NCR840, KLM875 AND EVA061
ON 22.12.2018**

**Final Report on Serious Incident involving Airprox that occurred in Delhi Area
between NCR840, KLM875 and EVA061 on 22.12.2018**

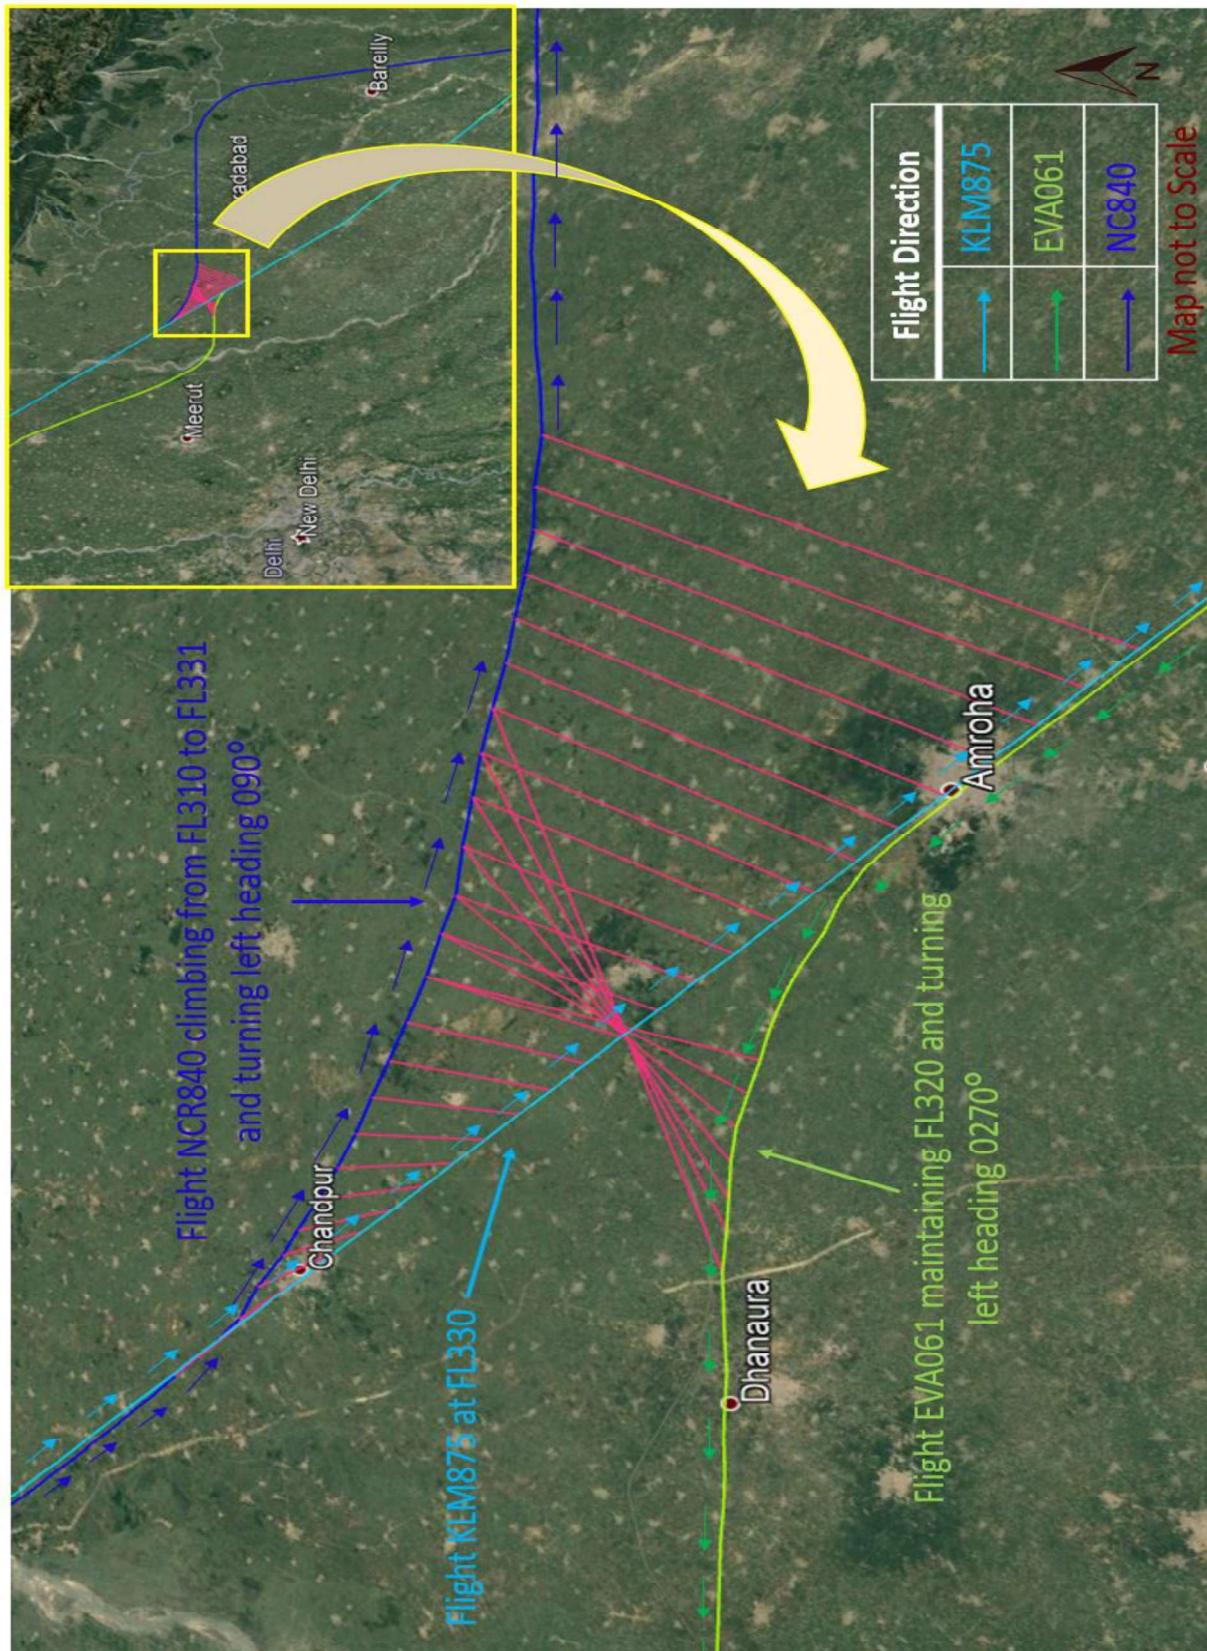
Figure 1: Flight Track superimposed on map.

Flight Tracks were plotted using data from the Delhi Radar. The tracks can be seen in the figure below: -

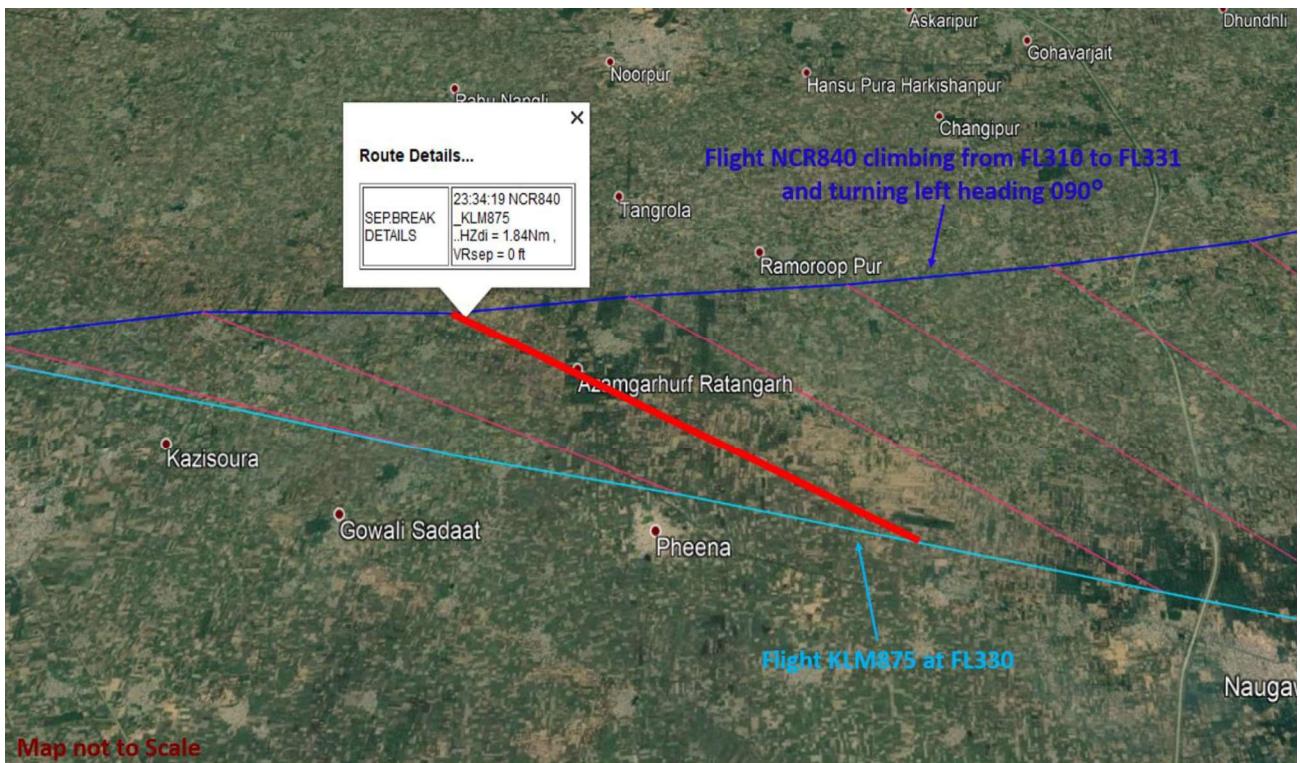
Figure 2: Separation between NCR840 and KLM875

The Lateral Separation between NCR840 and KLM875 at 23:34:19 UTC can be seen as 1.84 Nm while Vertical Separation was 0 Feet, in the Figure 2 below: -

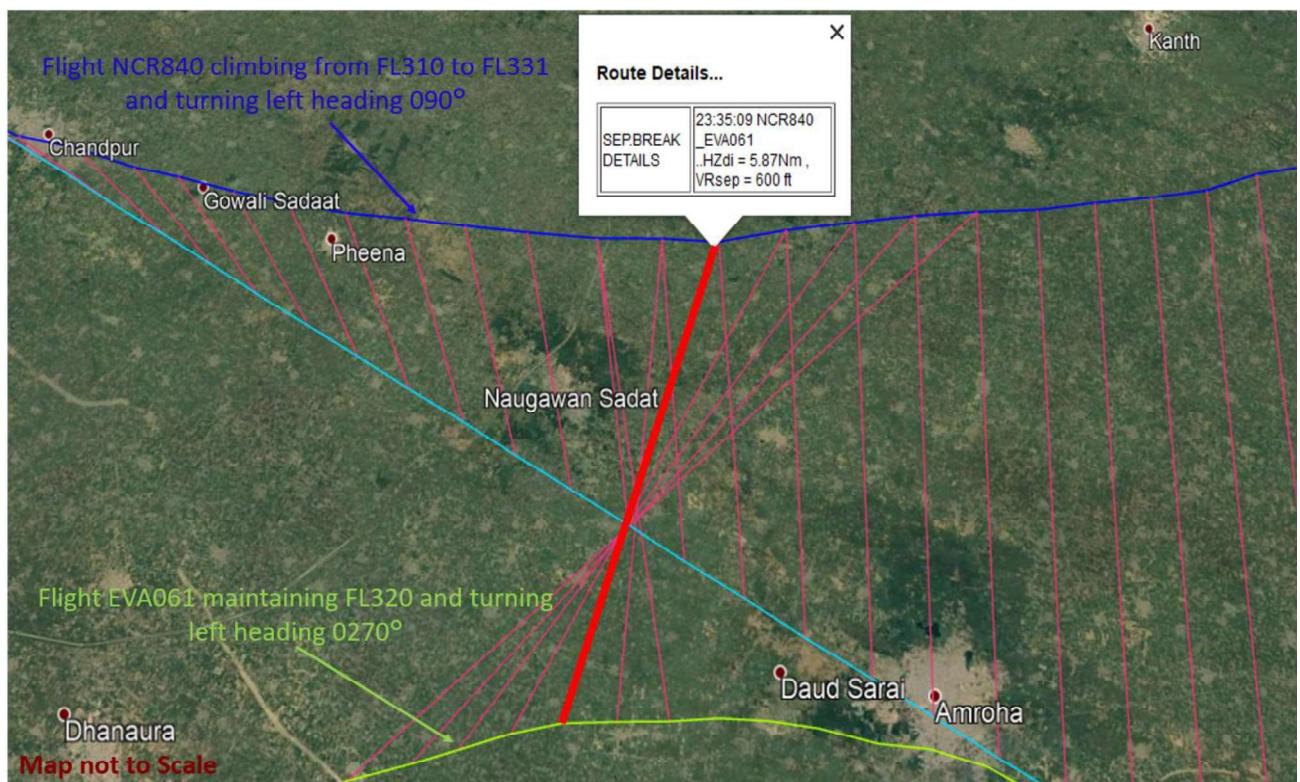
Figure 3: Separation between NCR840 and KLM875

The Lateral Separation between NCR840 and EVA061 at 23:35:09 UTC can be seen as 5.87 Nm while Vertical Separation was 600 Feet, in the Figure 3 below: -

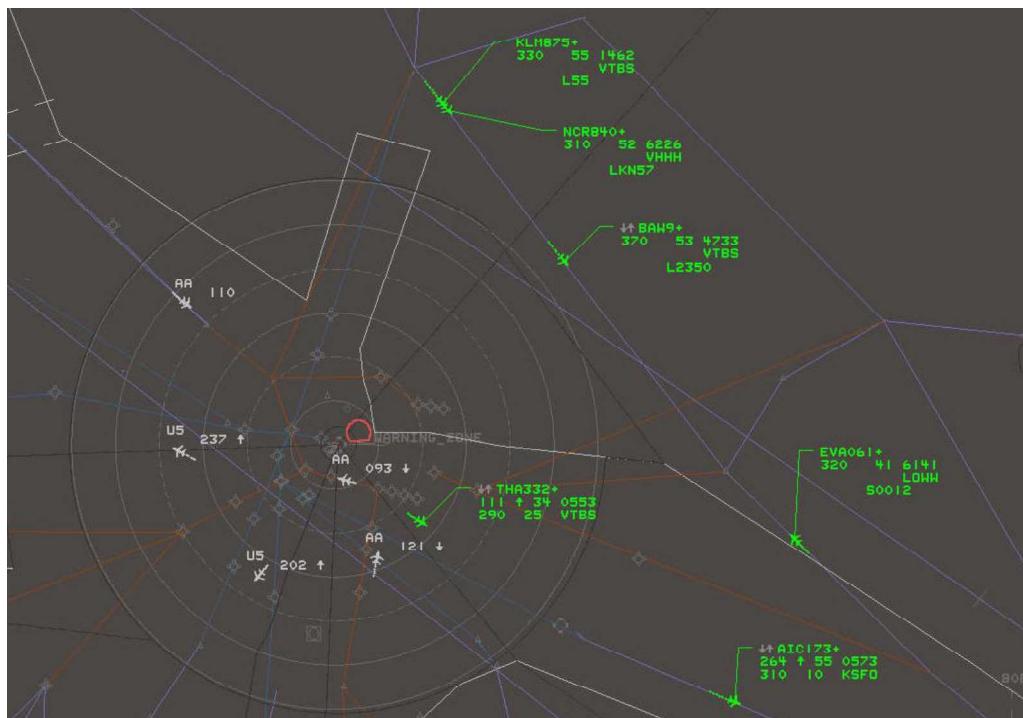
Figure 4: 23:27:11 UTC

The radar snapshot of time 23:27:11 UTC and 23:32:41 UTC shown in Figure 4 and 5, shows NCR840 maintaining FL310 and KLM875 maintaining FL330. EVA061 is maintaining FL320 flying in reciprocal direction to NCR840 and KLM875.

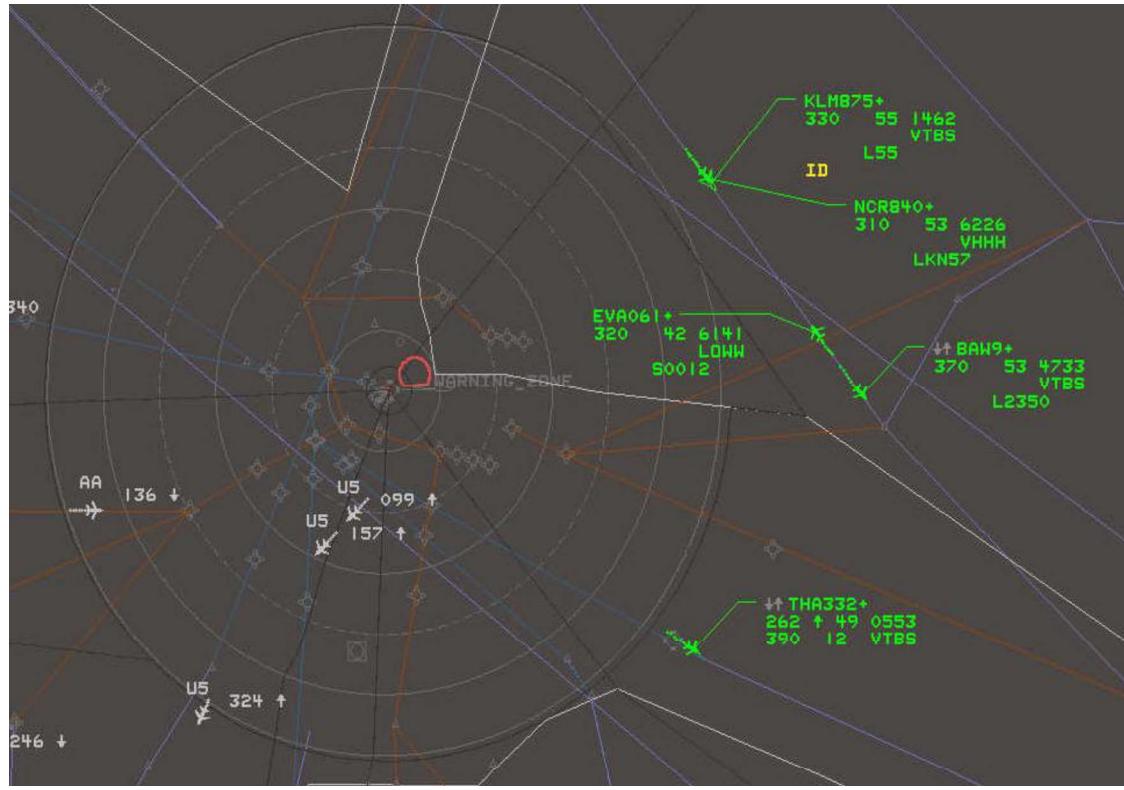
Figure 6: 23:33:12 UTC

At 23:33:12 UTC, KLM875 was just above NCR840 at FL 330 and FL310 respectively, as per the radar snapshot shown in Figure 6.

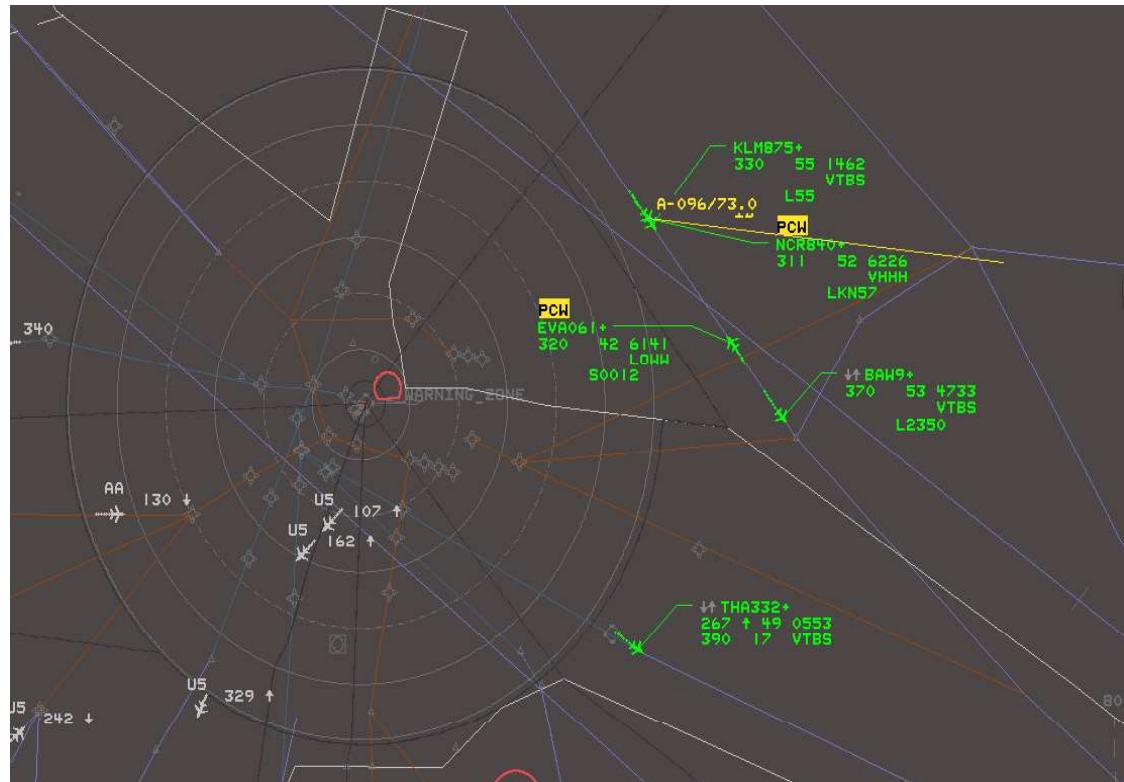
Figure 7: 23:33:28 UTC

In radar snapshot of time 23:33:28 UTC shown in Figure 7, NCR840 can be seen commencing climb. PCW is generated between NCR840and EVA061.

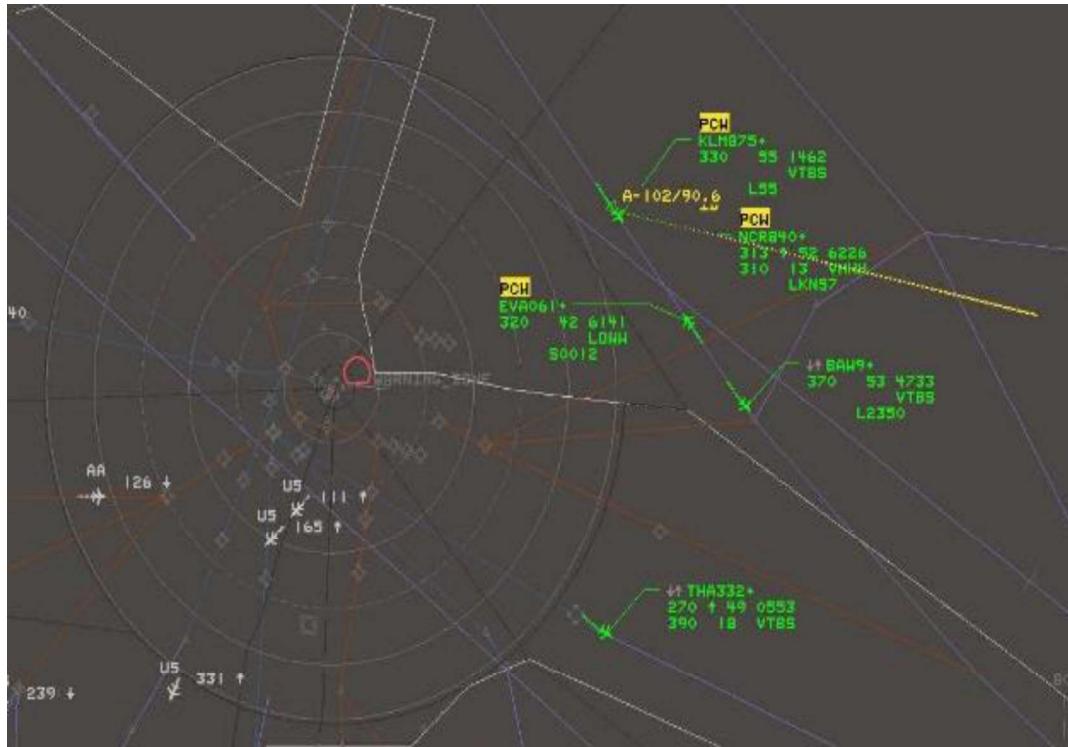
Figure 8: 23:33:38 UTC

In radar snapshot of time 23:33:38 UTC shown in Figure 8, NCR840 can be seen as climbing and having reached FL313. PCW is also seen generated between NCR840 and KLM875.

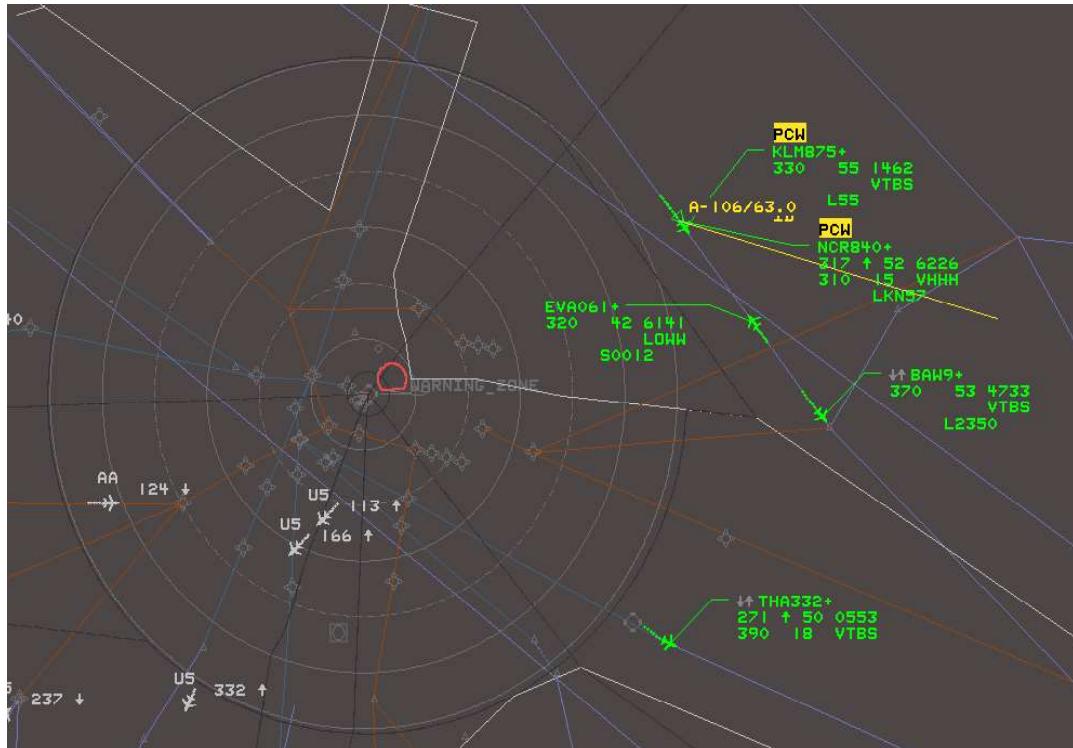
Figure 9: 23:33:44 UTC

In radar snapshot of time 23:33:44 UTC shown in Figure 9, NCR840 can be seen as climbing and having reached FL317. PCW between NCR840 and EVA061 is not seen any more.

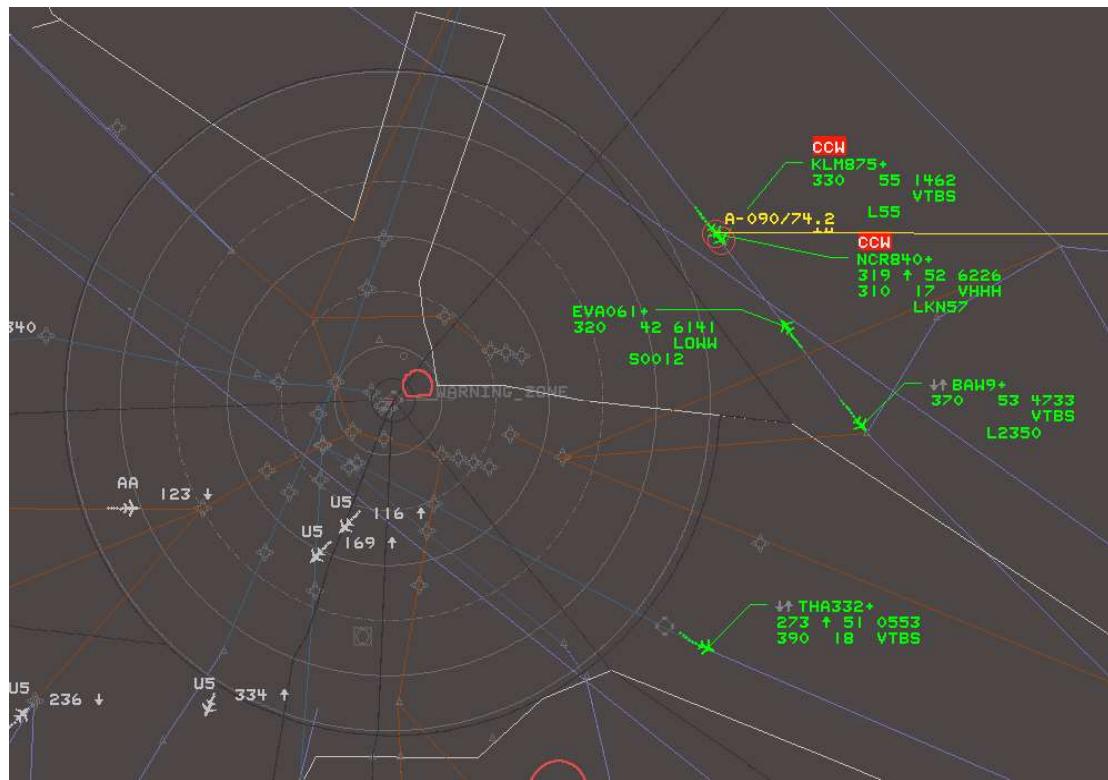
Figure 10: 23:33:50 UTC

In radar snapshot of time 23:33:50 UTC shown in Figure 10, NCR840 can be seen as climbing and having reached FL319. CCW is seen generated between NCR840 and KLM875.

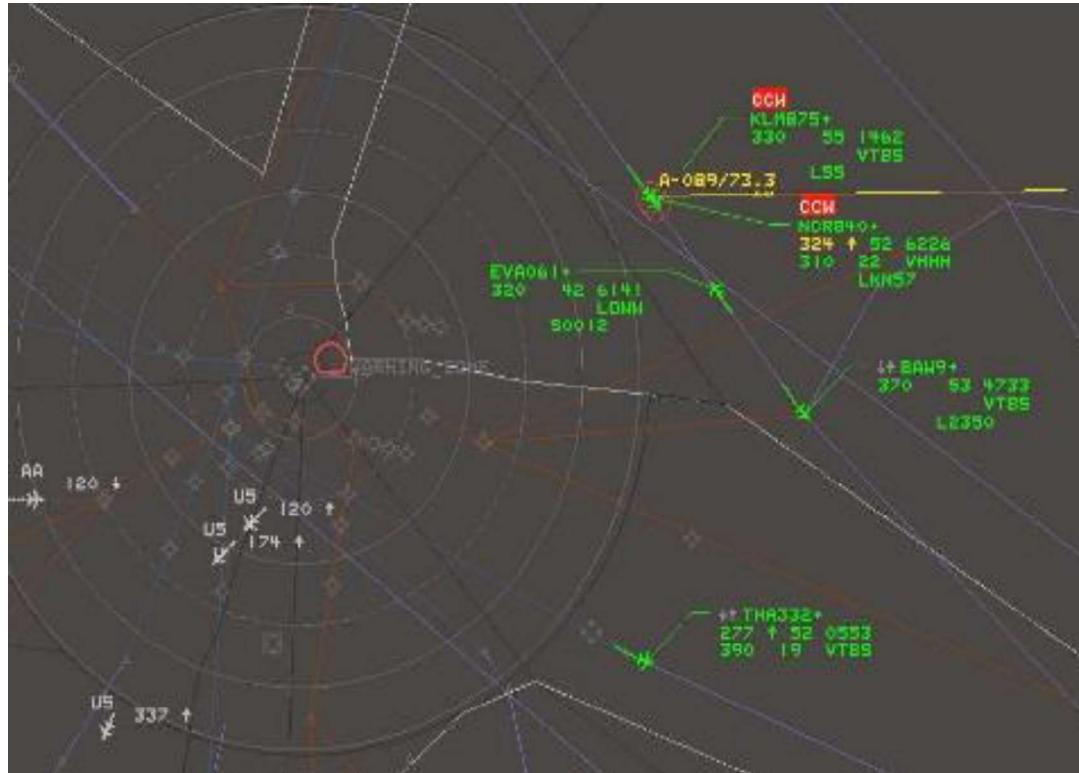
Figure 11: 23:34:01 UTC

In radar snapshot of time 23:34:01 UTC shown in Figure 11, NCR840 can be seen as climbing and having reached FL324. CCW continues between NCR840 and KLM875.

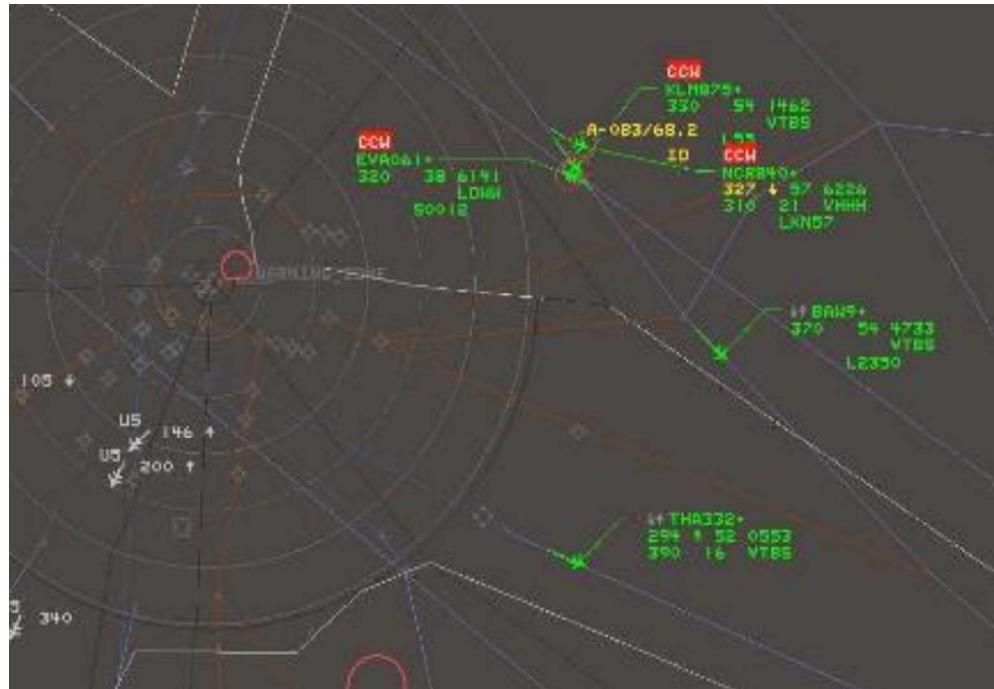
Figure 14: 23:35:03 UTC

In radar snapshot of time 23:35:03 UTC shown in Figure 14, CCW between NCR840 and KLM875 as well as CCW between NCR840 and EVA061 persists. NCR840 can be seen having descended to FL327 and both NCR840 and EVA061 continue left heading.

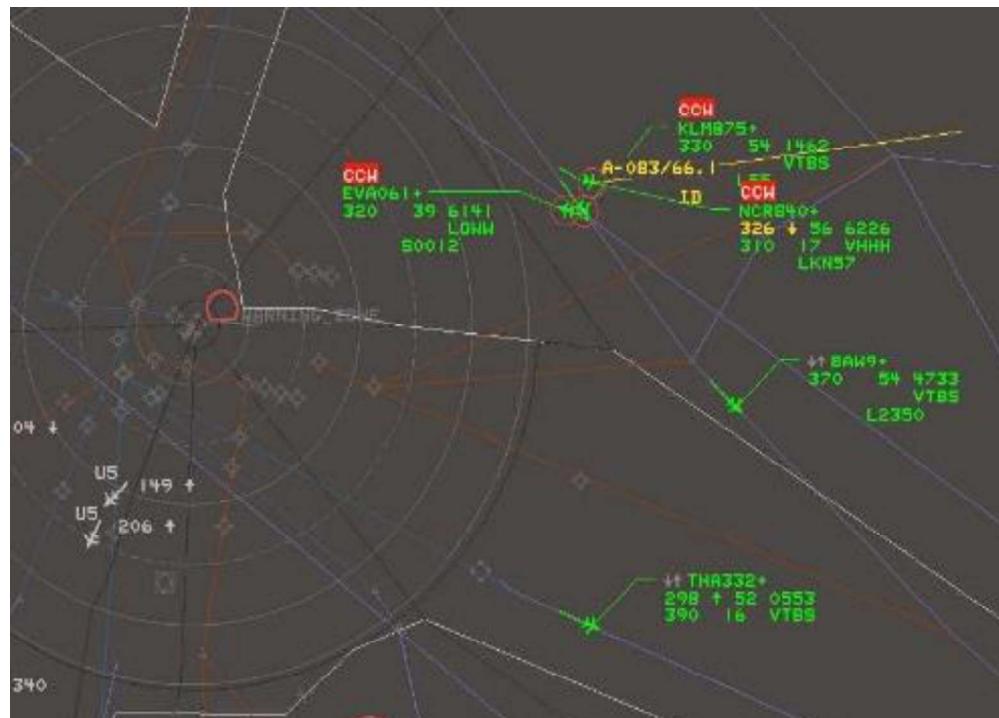
Figure 15: 23:35:16 UTC

In radar snapshot of time 23:35:16 UTC shown in Figure 15, CCW between NCR840 and KLM875 as well as CCW between NCR840 and EVA061 persists. NCR840 can be seen having descended to FL326 and both NCR840 and EVA061 continue left heading.

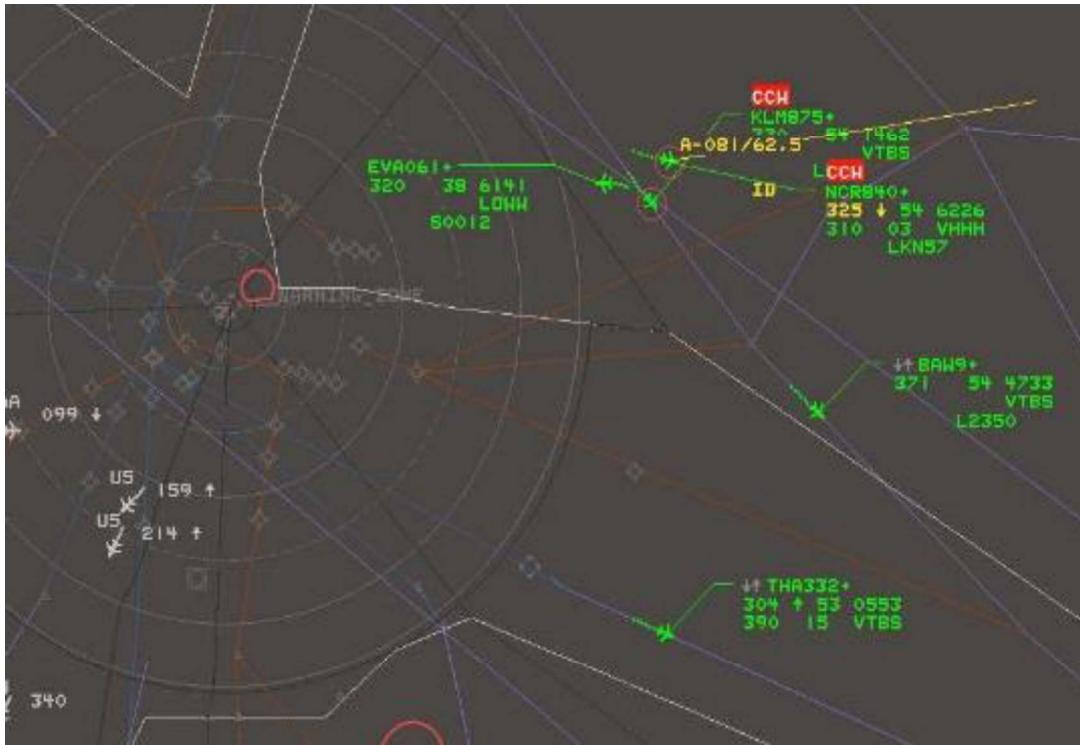
Figure 16: 23:35:43 UTC

In radar snapshot of time 23:35:43 UTC shown in Figure 16, CCW between NCR840 and KLM875 persists but CCW between NCR840 and EVA061 is resolved. NCR840 can be seen having descended to FL325 and both NCR840 and EVA061 continue with left heading. CCW had ceased when standard separation of 10 NM was re-established between EVA061 and NCR845.
