# Power Delivery Engineering

**EIT Training Review:**

**Progress Report**

# 2.1.1 PROJECT DESCRIPTION

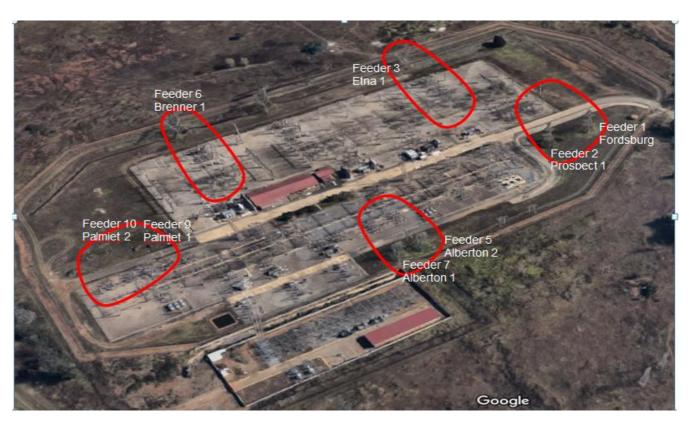
Figure 2: Aerial view of Eiger substation

A walk down was done at the substation or site with the substation operator and the three engineers. A walk down to each feeder or incoming line into the substation affected by the refurbishments and or being part of the scope of work was checked. The walk down was conducted to check the space constraints, the orientation of the substation and the affected feeders, the different towers, the conductor arrangements and to get a general virtualisation of the substation and feeders. The findings are highlighted below. Figure 2 shows the aerial view of Eiger substation and the affected feeders which were checked.

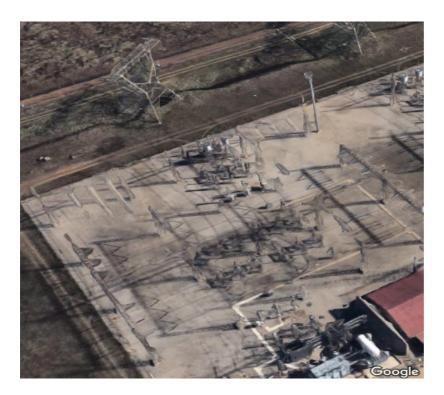
Figure 3: Aerial view of the 275 kV Feeder 6: Brenner 1

Figure 3 shows the aerial view of the Brenner feeder, figure 4 shows the terminal tower of the incoming line on the Brenner feeder and figure 5 shows the terminal tower label. It was found that there is an access road between the Brenner terminal tower and the live yard fence as shown on figure 4. The road was said to be a temporary road to access the live yard and that there is another road just behind the terminal tower. It was also observed that there was a small puddle between the terminal tower for Brenner and Lethabo indicating that this is a wet area.

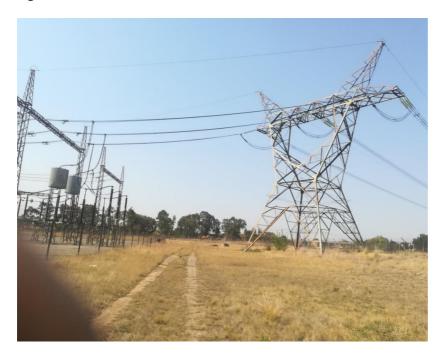
Figure 4: The Brenner 1 feeder and terminal tower

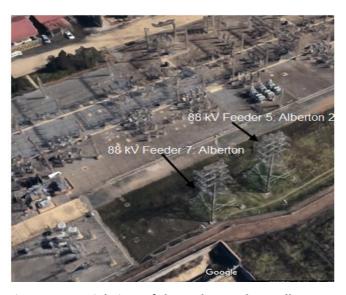
Figure 12: Aerial view of the 88 kV Feeder 5 Alberton 1 and Feeder 7 Alberton 2

Figure 12 shows the aerial view of the Alberton 1 and Alberton 2 feeders and figure 13 shows the terminal tower of the incoming lines on the Alberton 1 and Alberton 2 feeders and their terminal towers. It was found that there is access road between the two double circuit terminal towers for Alterton 1 and 2 and it was reported that the road is used to gain entry into the 88 kV yard. The access road introduces space constraints. It was also found that these two lines are double circuit lines and that only one circuit from each line is connected to a bay that is fully equipped. Meaning, one double circuit tower has both conductors for the two circuits but only has one circuit terminating in a bay that is fully equipped and the other circuit terminates on a bay that has no equipment's installed. This is as shown on figure 14.

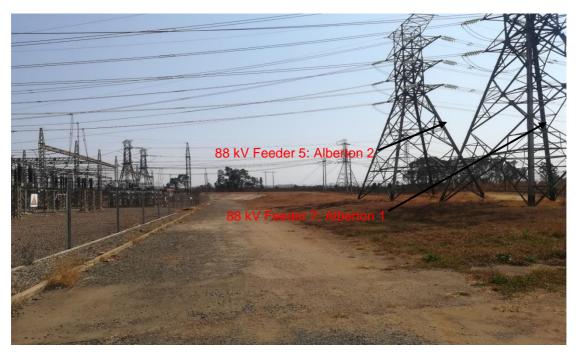
Figure 13: Alberton 1 and Alberton 2 incoming line plus the terminal tower
