Automotive Mechatronics Laboratory

GRADUATION PROJECT

Inverter testing

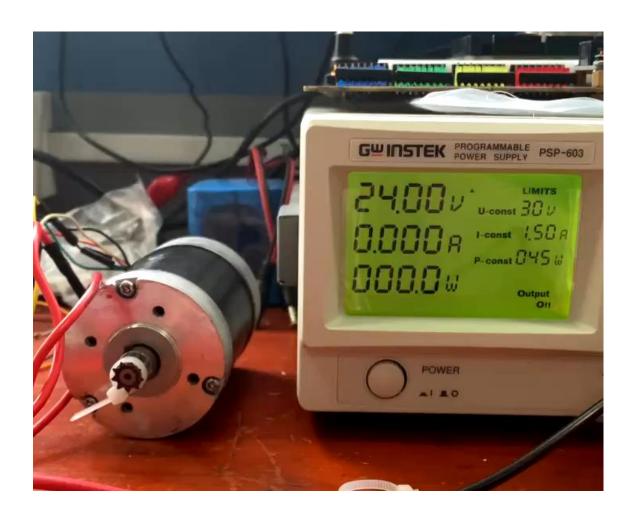
• Clockwise rotation, duty = 70%

• At these rotor's angle, BLDC can't start although the current is ~ 6A

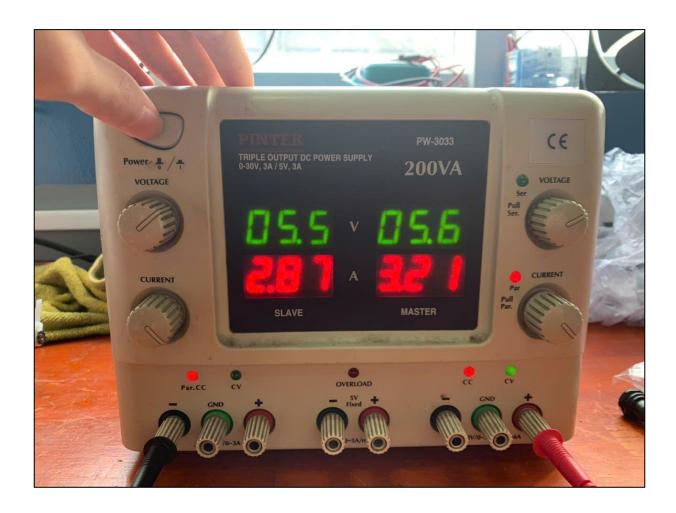
- 2nd inverter:
 - Can't run the motor
 - The power supply relay turns ON/OFF continuously.
 - 12V pin has no voltage
