## Technical Note

### **Subject – Trench Repair when trenching through BaseLok® Geogrid**

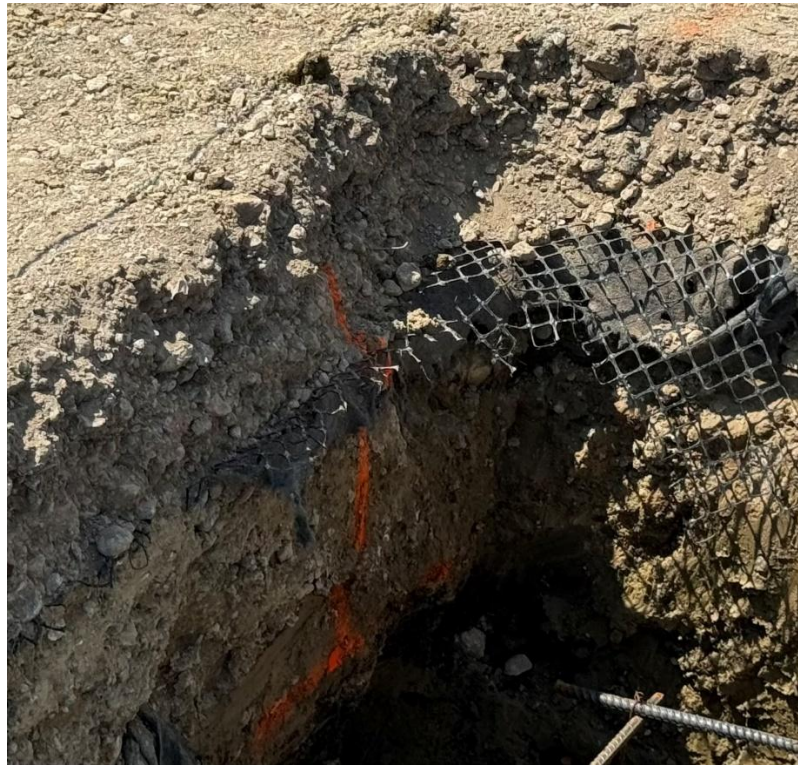
Industrial Fabrics, Inc. (IFI) manufactures the BaseLok® line of geosynthetics in Houston, TX. Our products include geogrid, geocell, and laminated geogrid called FabGrid®. Questions often arise regarding what happens when trenching or drilling through our geogrid products. BaseLok® Geogrid products are punched and drawn geogrids manufactured from polypropylene sheets. The process of punching and drawing the geogrids align the polymers increasing the tensile modulus of the geogrid. Our geogrid products typically break at approximately 13-15% strain. The ability to reach the ultimate tensile strength at these low strains allows for trenching, drilling, etc. through the geogrid. When a piece of equipment encounters the geogrid, the geogrid will slightly elongate, then break, allowing the tool to pass through. Below is a picture of BaseLok® geogrid that was recently drilled through that shows this.

Notice that the grid simply shears off and the surrounding soil hasn't been overly disturbed. If the area needs to be repaired, such as in a utility trench application, follow the detail below.
