1 REQ'D AS DRAWN MK: BM12

**ISSUES BM12-01 / 02 / 03 | CENTRAL AWNING NODE**

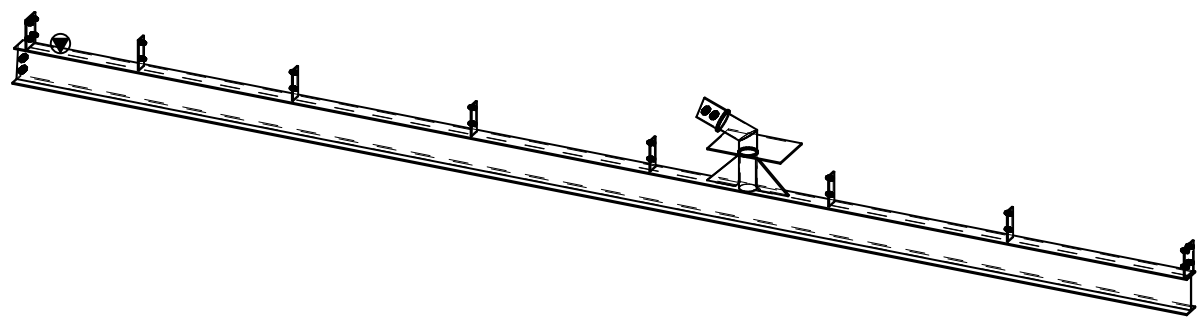
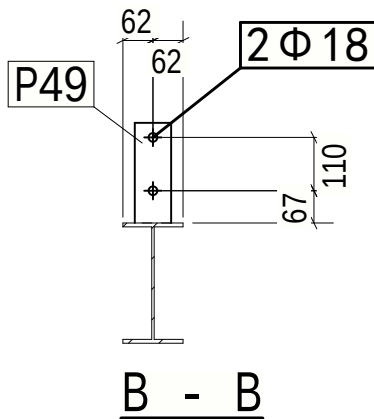
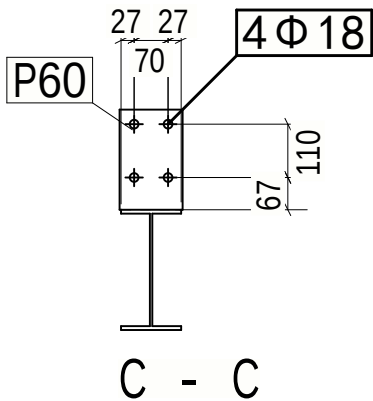
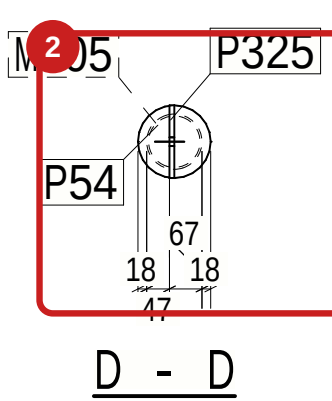
- 1. 10 mm stiffener plate EACH SIDE of the M104 web is not separately detailed; P52 is not the required stiffener.
- 2. P54 closes the CHS end; no HDG vent/drain-hole arrangement or approved alternative is shown.
- 3. Consultant 6 CFW to awning rafter is not explicitly located or defined; general 6 CFW U.N.O. is insufficient.

**ACTION:** add independent web stiffeners, HDG vent/drain detail and node-specific weld callouts.
