# The Effect of Climate Change on Earth Dam Failures

## Case Study: Delhi Dam in Iowa

# The Effects of Climate Change on Dam Failures

CEE 3410 Project

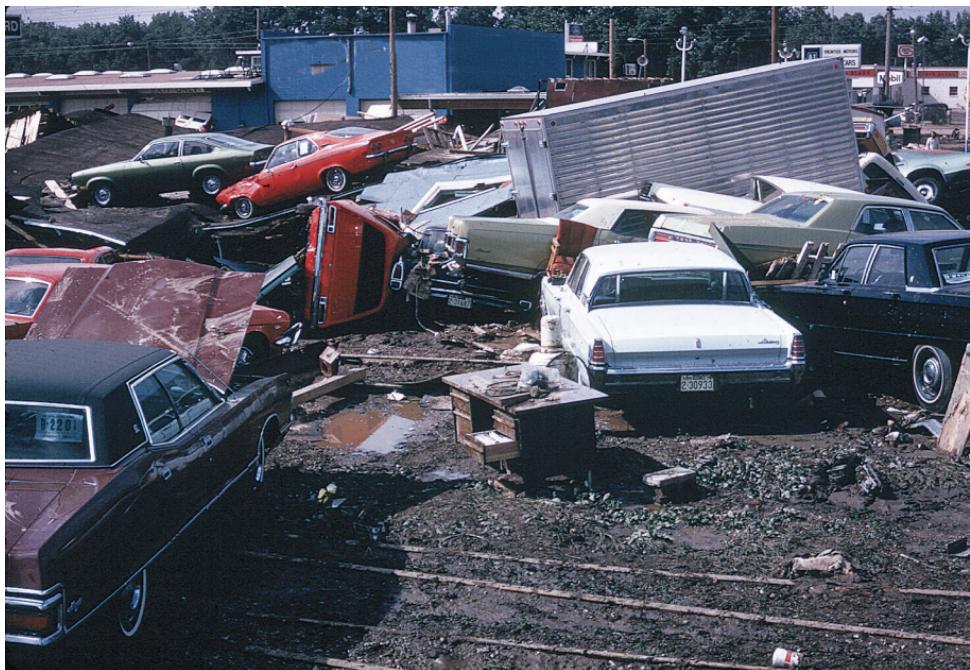
*Figure 1B: Property Destruction from Canyon Lake Dam Failure (Carter, 2002)*

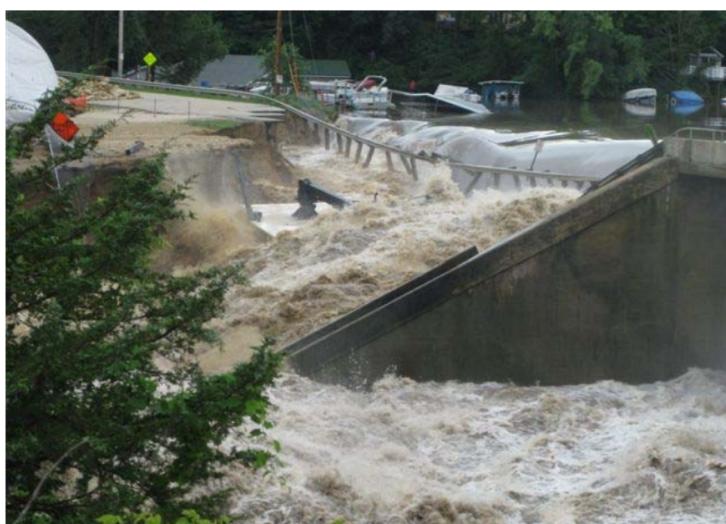
*Figure 5:*

Later that morning, at 6:00 AM, the dam's crest began to settle further into the ground where the whirlpool was earlier observed. Furthermore, it was confirmed that there was seepage on the downstream side of the dam, near the toe of the embankment. Three hours later at 9:00 AM, the seepage flow became brown and dirty. The embankment was fully breached at approximately 1:00 PM, with a breach width of about over 200 feet at its maximum (McDaniel et al., 2010).

*Delhi Dam being breached  
(McDaniel et al., 2010).*
