## **Vehicle Damage Detection Report**

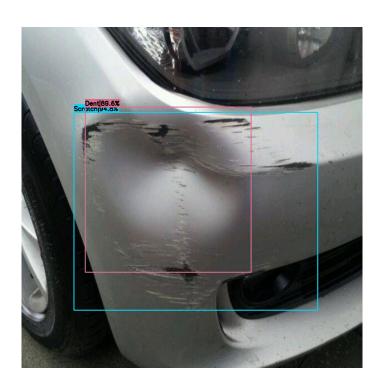
Marked Image

1. Scratch - Confidence: 0.95%

2. Dent - Confidence: 0.90%

Scratch (Mild):

Parts: Negligible, unless it's deep enough to require touch-up paint. Assume Rs.500-Rs.1500

Labor: Rs.1000-Rs.3000 for cleaning, preparation, and applying the touch-up paint.

Dent (Mild):

Labor: Rs.2000-Rs.5000 for PDR (Paintless Dent Repair) or traditional dent removal and

smoothing. PDR is more cost-effective if possible.

Paint: Only if PDR isn't sufficient and touch-up paint is required (Rs.500-Rs.1500).

Considering both the scratch and dent, a reasonable total cost range from a mid-range repair shop

in India would be Rs.4,000 - Rs.12,000. The higher end accounts for potential complications, need for extra paint, or more extensive labor if PDR is not effective on the dent.
