# THE FLOOD AND CHALLENGES OF RASUWAGADHI, KERUNG BORDER

Sujan Paudyal

B.Sc. 4<sup>th</sup> year (Geology), Tri-Chandra Multiple Campus, Tribhuvan University

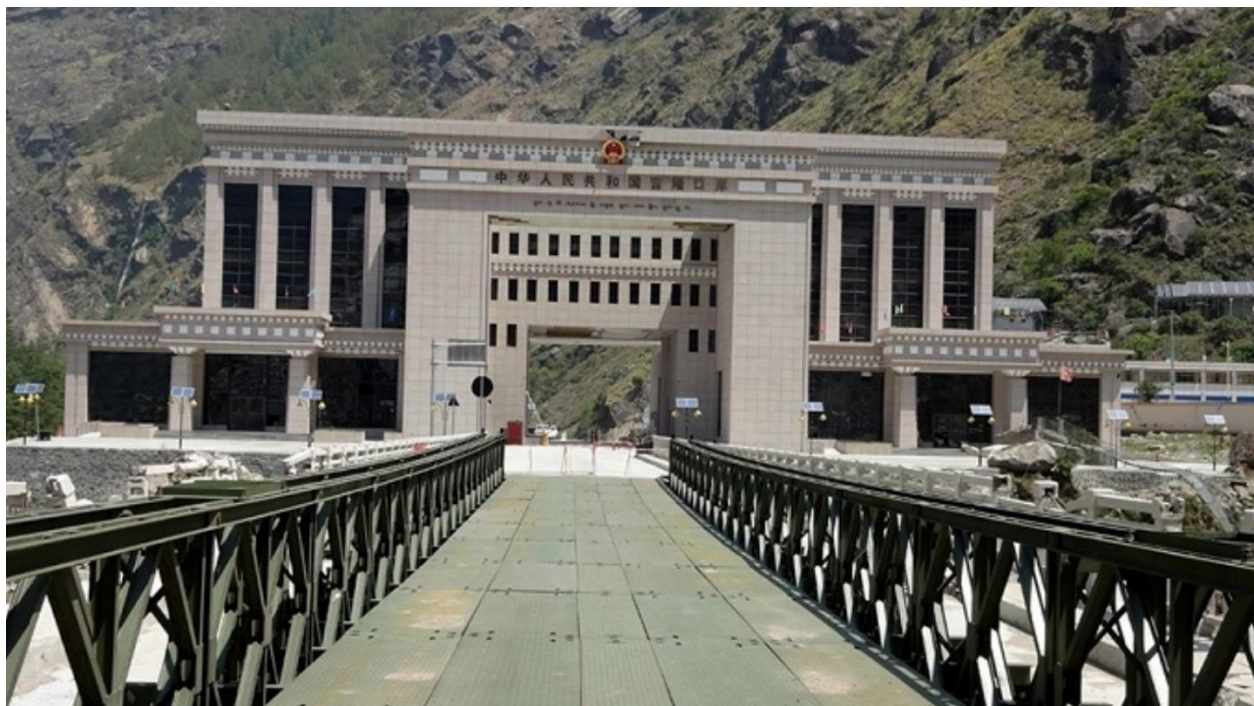
As Nepal's second official border checkpoint with China, this location carries both economic and geopolitical importance (Figure I shows this border before the devastating flood). The Lhende and Kerung rivers of Tibet are the main sources shaping the Bhotekoshi Valley. Since these Himalayan rivers flow with great force, the risk is ever-present.

Figure I Kerung Border before flood, Source: RSS, 2023

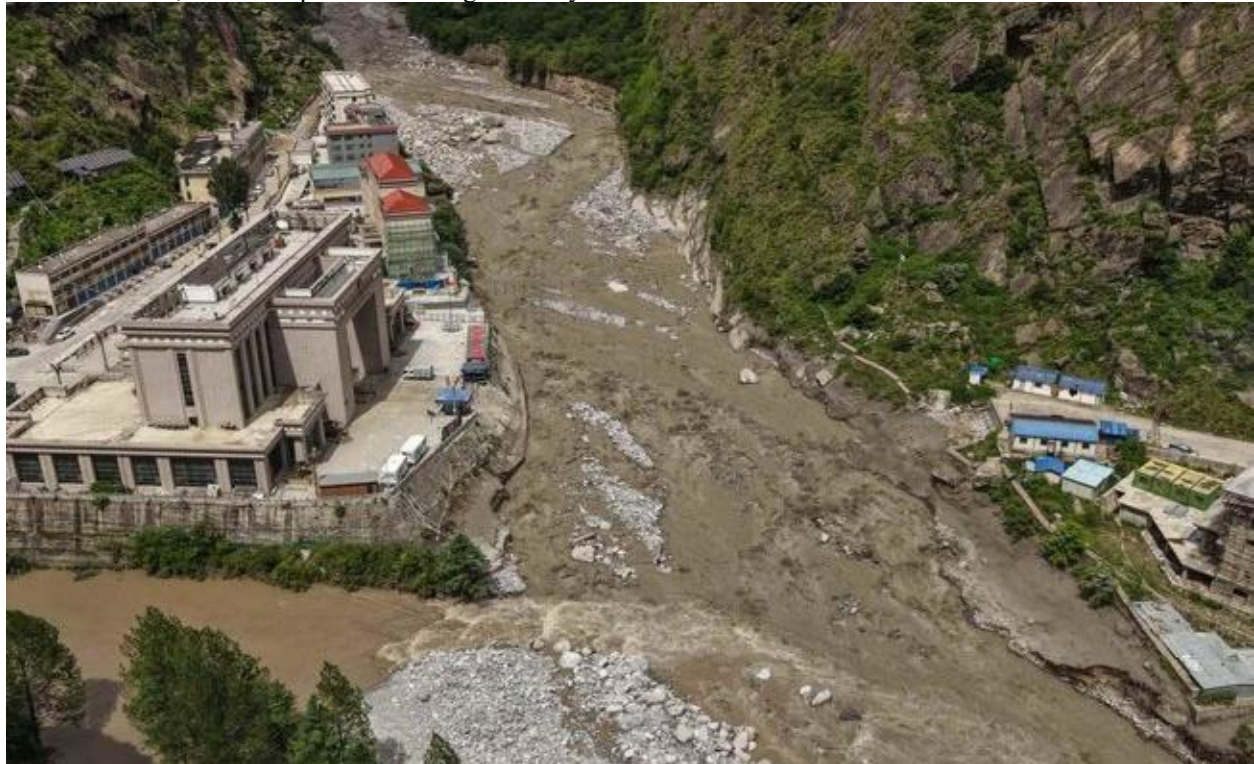
At around 3:15 a.m. on July 8, 2025, a sudden and massive flood struck the Bhotekoshi River. The flood destroyed the Nepal - China Friendship Bridge, swept away customs infrastructure, damaged roads, and caused severe losses to hydropower projects. Hundreds of trucks, electric vehicles, and heavy machinery were reported to have been carried away by the river. Storage warehouses were destroyed, and commercial activities came to a halt (Figure II illustrates the Kerung border after the flood).

Figure II Kerung Border after flood, Source: RSS, 2025

The flood was not related to rainfall. Satellite images and meteorological data confirmed that there had been no unusual precipitation ([NOAA, 2025](#); [ECMWF, 2025](#)). However, the water level in the upper Bhotekoshi region suddenly rose by 3 - 4 meters, which is typically a sign of a glacial lake outburst. Research indicates that the flood (GLOF - Glacial Lake Outburst Flood) was triggered by the bursting of a supraglacial lake formed in the Puruogangri Glacier in Tibet. Due to abnormal temperatures, the lake had expanded rapidly in 2024 - 25 and eventually burst on July 8 ([ICIMOD, 2025](#)).
