# THE FLOOD AND CHALLENGES OF RASUWAGADHI, KERUNG BORDER

Sujan Paudyal

B.Sc. 4<sup>th</sup> Year (Geology), Tri-Chandra Multiple Campus, Tribhuvan University

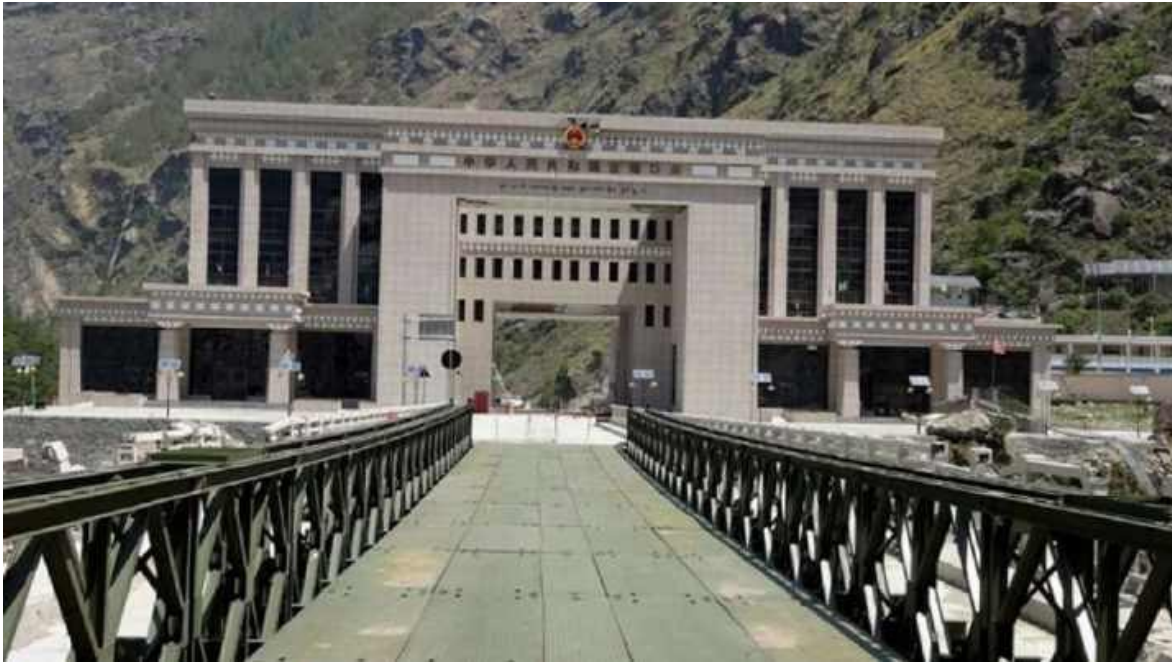
As Nepal's second official border checkpoint with China, this location carries both economic and geopolitical importance (Figure I shows this border before the devastating flood). The Lhunde and Kerung rivers of Tibet are the main sources shaping the Bhotekoshi Valley. Since these Himalayan rivers flow with great force, the risk is ever-present.

Figure 1: Kerung Border before flood, Source: *(RSS, Rastriya Samachar Samiti, 2023)*

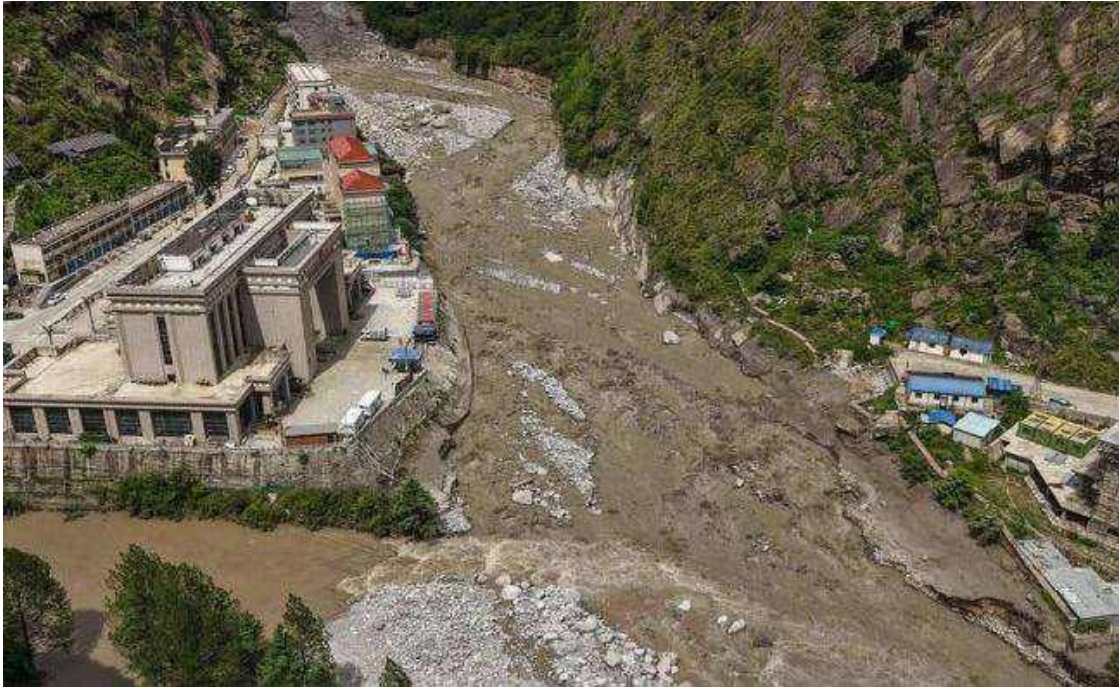
Around 3:15 a.m. on July 8, 2025, a sudden and massive flood struck on the Bhotekoshi River. The flood destroyed the Nepal - China Friendship Bridge, swept away customs infrastructure, damaged roads, and caused severe losses to hydropower projects. Hundreds of trucks, electric vehicles, and heavy machinery were reported to have been carried away by the river. Storage warehouses were destroyed, and commercial activities came to a halt (Figure 2 illustrates the Kerung border after the flood).

*Figure 2: Kerung Border after flood, Source: (RSS, Rastriya Samachar Samiti, 2025)*
