# Tropical Storm Arthur - Storm Report

## 1 Observations of The Regulus Project

**Focus:** Historical Audit: 2026-06-15 00:00:00 to 2026-06-20 0:59:59

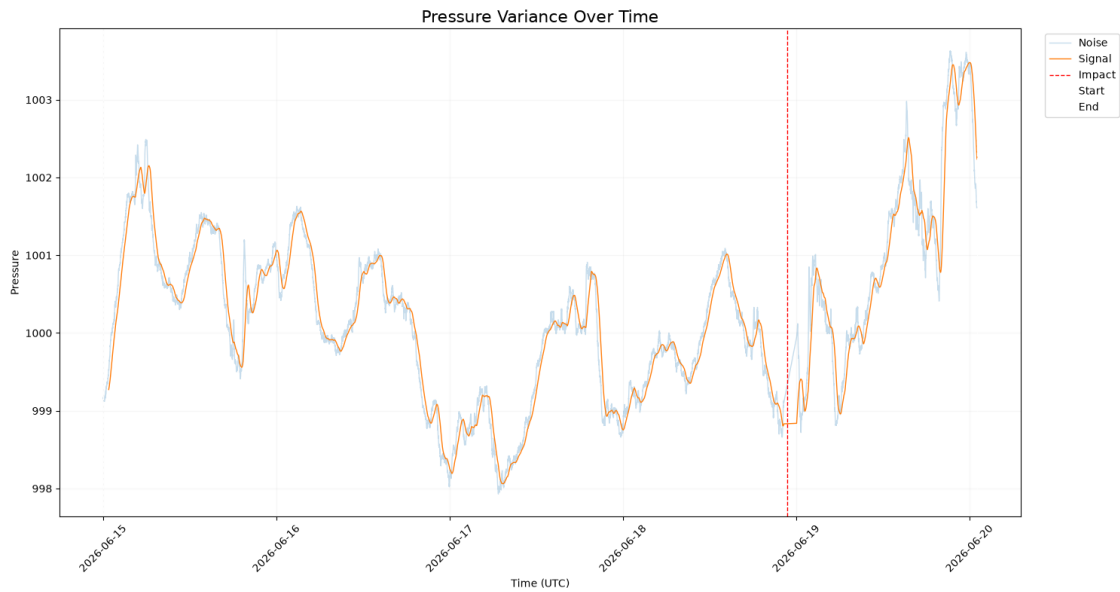
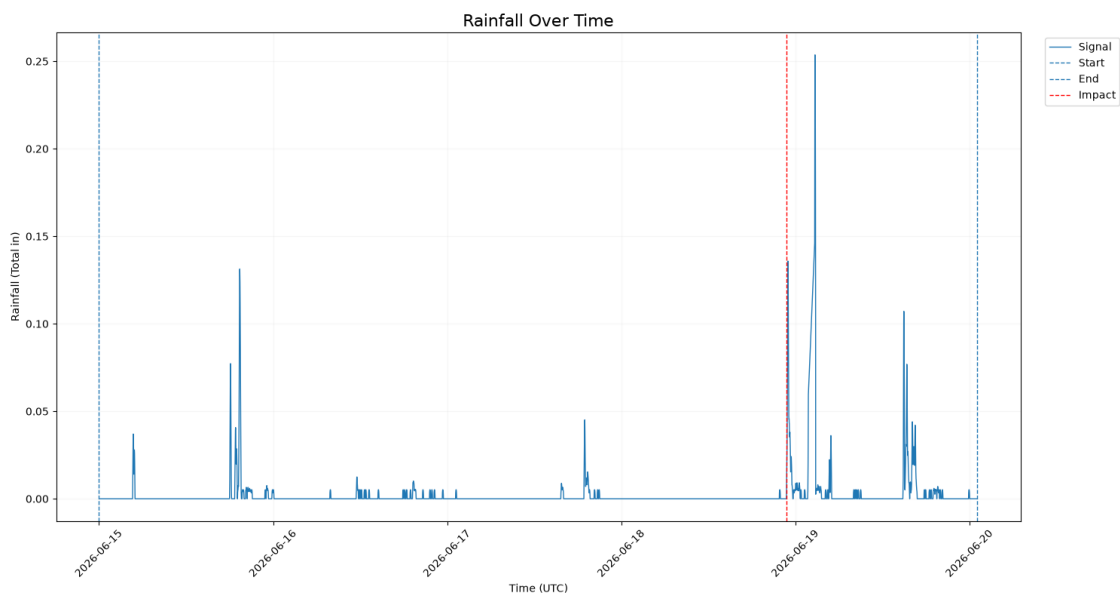
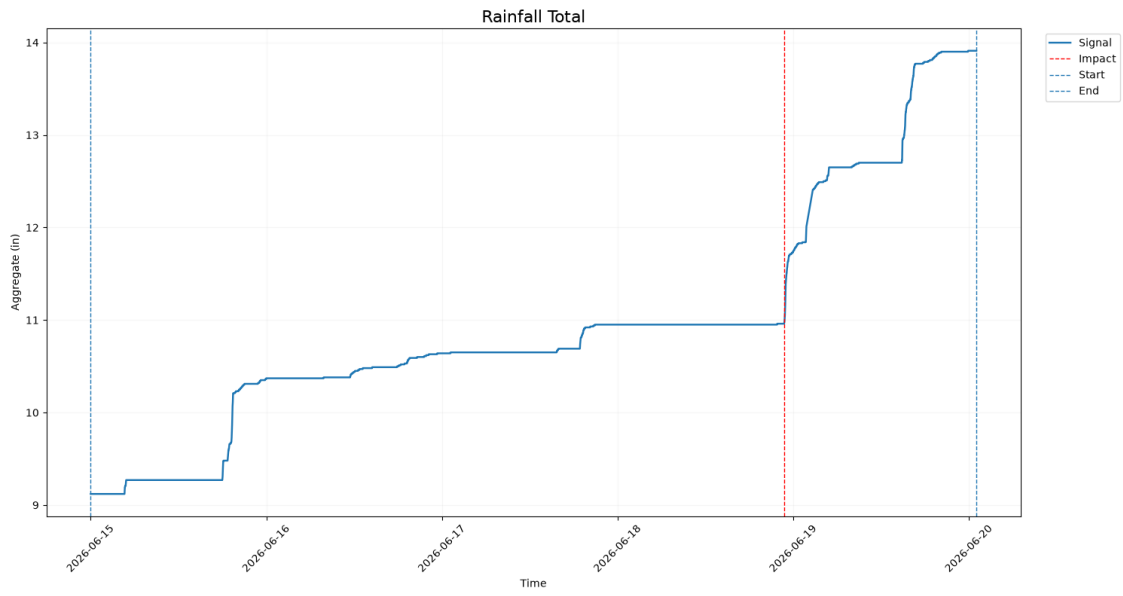
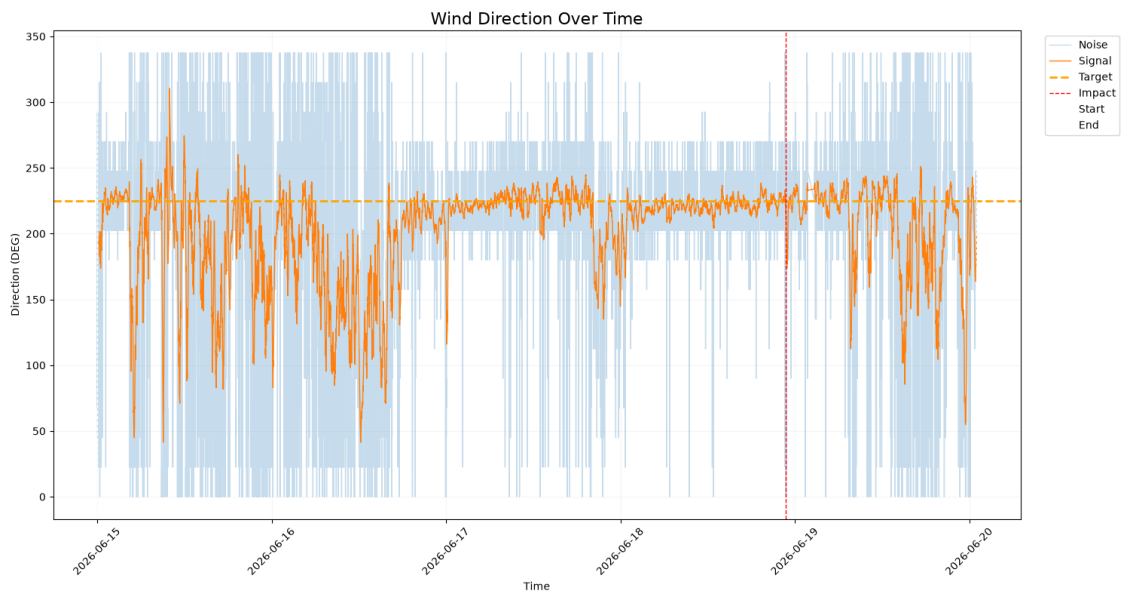
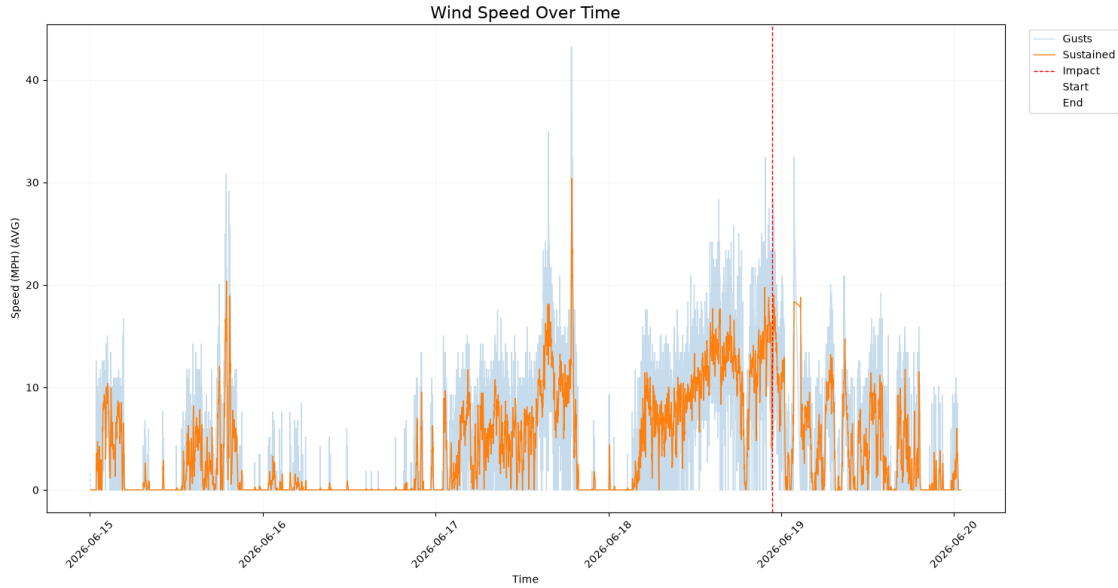
Arthur began impacting the air column surrounding the facility on 6-15-2026 while it was still a developing storm off in the gulf. On 6-17-2026, atmospheric degradation was at its peak. Diurnal cycles were clearly disrupted late on the evening of the 15th. As the rain fell, there was an obvious elevation in pressure for the duration of the rainfall.

*Note: Barometric Pressure data is not comprehensive. It includes data around the gaps. (End of day on 6-18-2026 was not captured. This was when the storm actually hit the envelope. The outage in station monitoring was not related to the storm.)*
