# Engine Acoustic Diagnostic Report

| Vehicle: | 2006 Vauxhall Corsa 1.4 petrol (56 plate) |
| Engine: | Z14XEP - 1.4 litre, 4-cylinder, naturally aspirated petrol |
| Recording: | 25 May 2026 · 122 seconds total · 44.1 kHz mono |

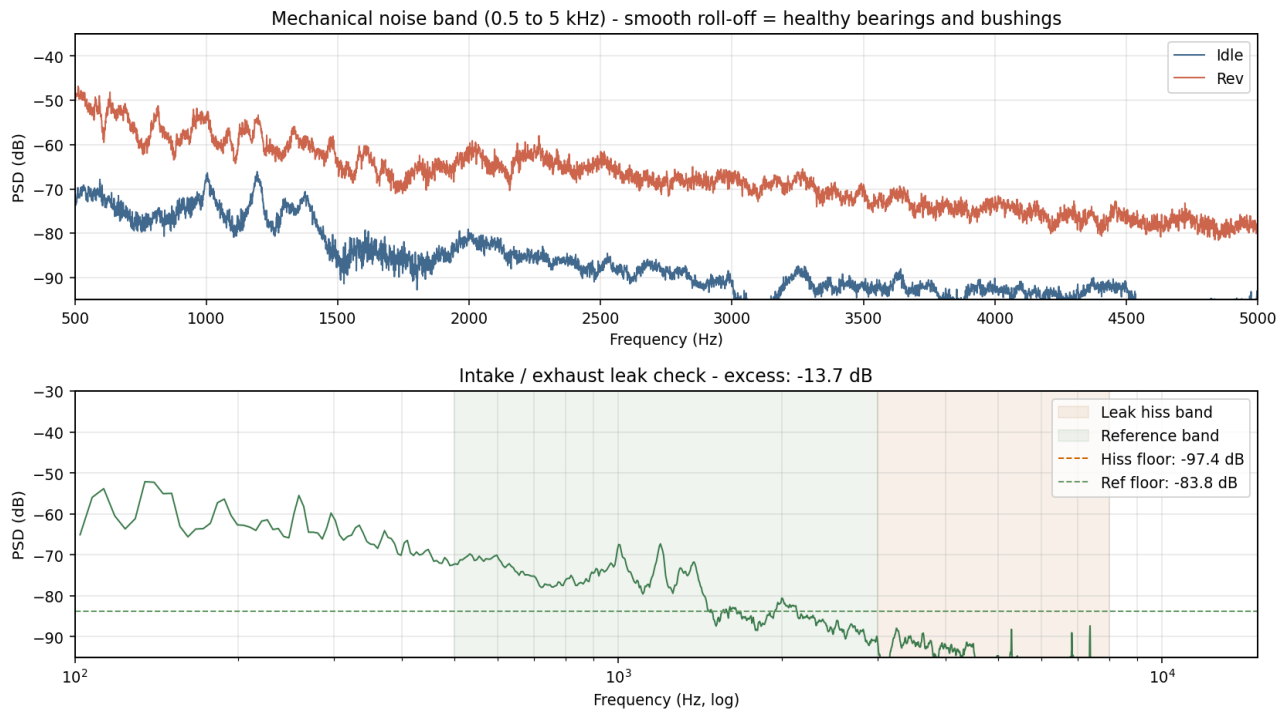
Smooth roll-off through the 0.5-5 kHz mechanical band. No broadband noise humps that would indicate bearing wear. Rev/idle differential is moderate - consistent with normal mechanical noise rising with engine load.

**CLEAN.** No abnormal broadband hiss. Vacuum and exhaust system appear sealed. The 3-8 kHz noise floor sits 13.7 dB *below* the 500-3000 Hz reference floor - **no abnormal broadband hiss**. Vacuum hoses, exhaust manifold seals, and intake gaskets are acoustically intact.
