Vancouver Green Infrastructure Performance Monitoring Report 2021-2023

City of Vancouver, Engineering Department, Green Infrastructure Implementation Branch

Published: January 2024

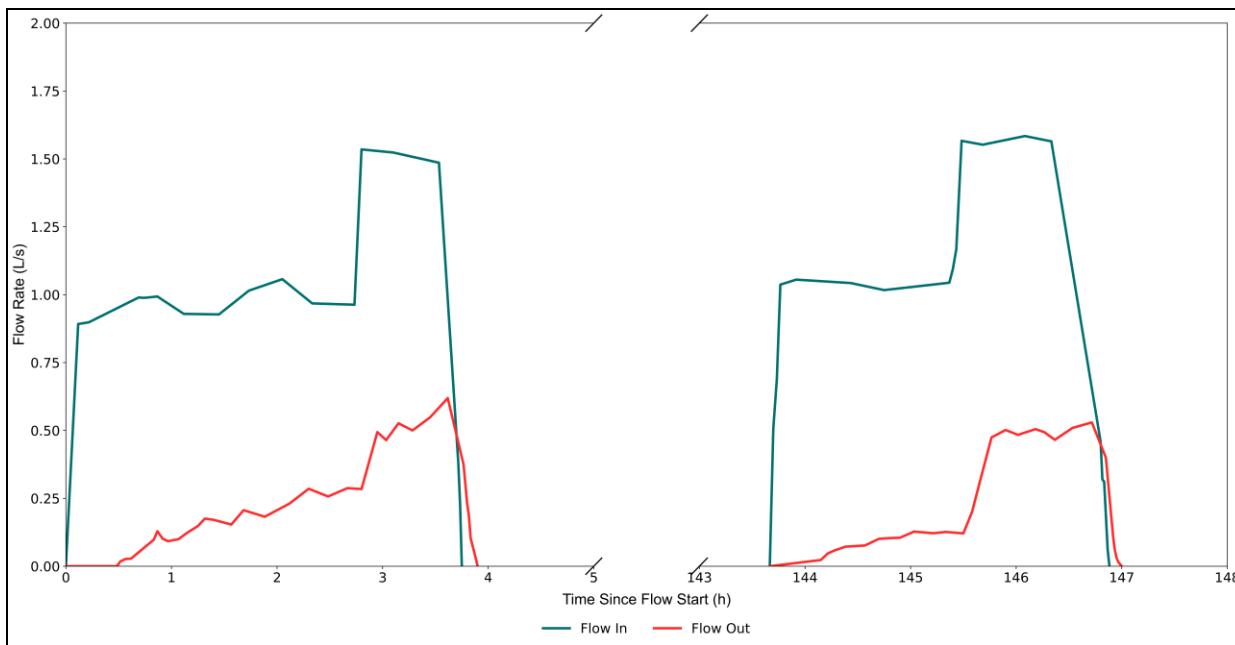
In 2022, we conducted another synthetic runoff test to assess the volume managed portion of our active systems. We arranged a water truck to inject 14,172 L of clean water into our system, and we measured the rate of flow at the inlet and at the underdrain outlet with the bucket-timer method. This volume was equivalent to a 21 mm event across the 676 m² catchment area for the Pine St. and 8th Ave. bioretention system. Figure 26 shows the hydrograph at the inlet and

underdrain outlet for this test. A total of 3,366 L were estimated to flow out of the underdrain outlet, meaning that 76% of water was retained in the bioretention system.

Figure 26 Hydrograph at the inlet and outlet of Pine St. and 8th Ave. synthetic run-off test, July 2022

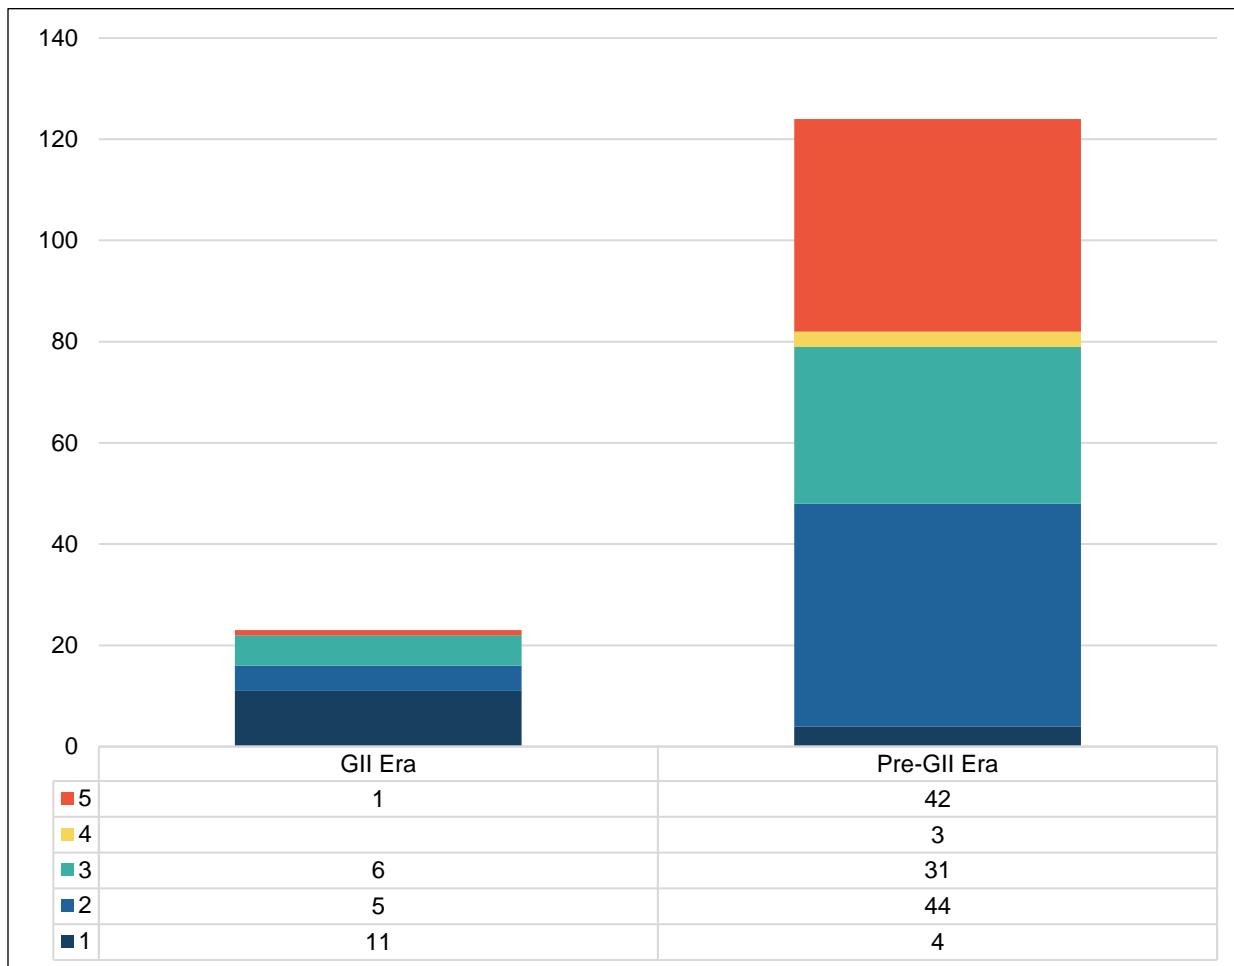
Figure 27 Bioretention condition scores (1-5) for assets constructed prior to the GI branch being formed (pre-GII era), and for assets designed and delivered by our branch (GII Era)

5 - Very Poor	Replace / Rehab / Redesign	Asset has failed and is not functional. Immediate action maybe required.

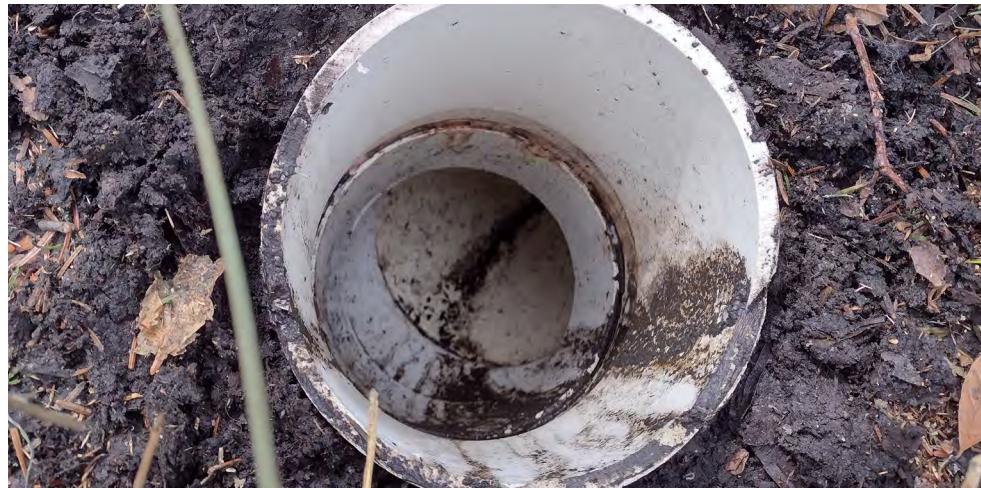
Example of a monitoring well with minimal sediment and no damage.
Condition score: 1

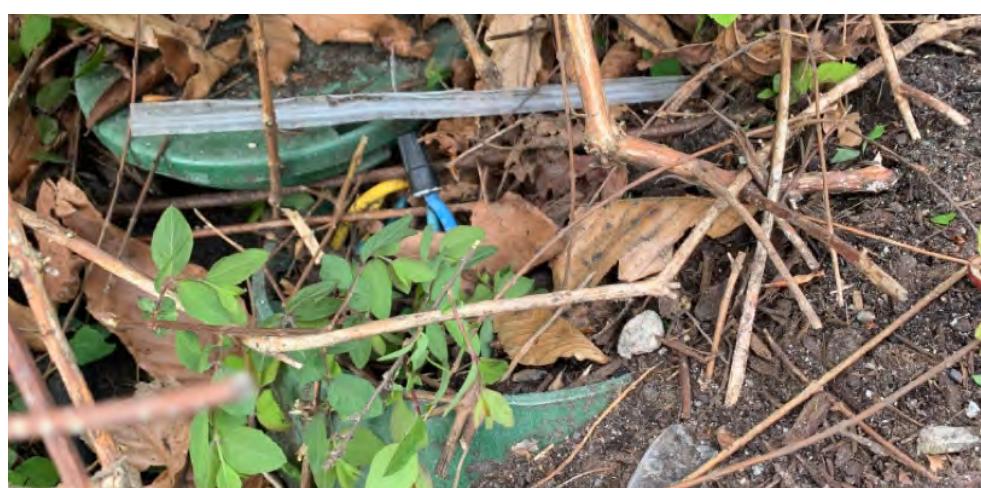
Example of a monitoring well extensive build up of debris and is non-functional.
Condition score: 5

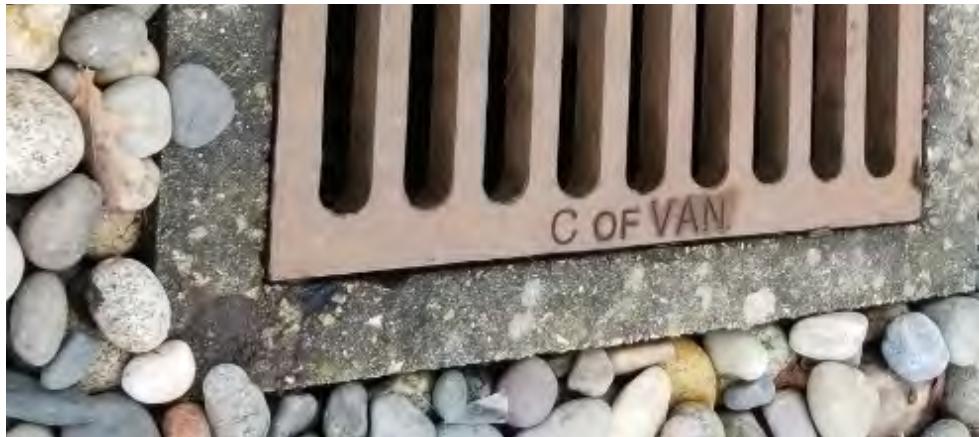
CB with minimal spalling on exterior
Condition score: 2

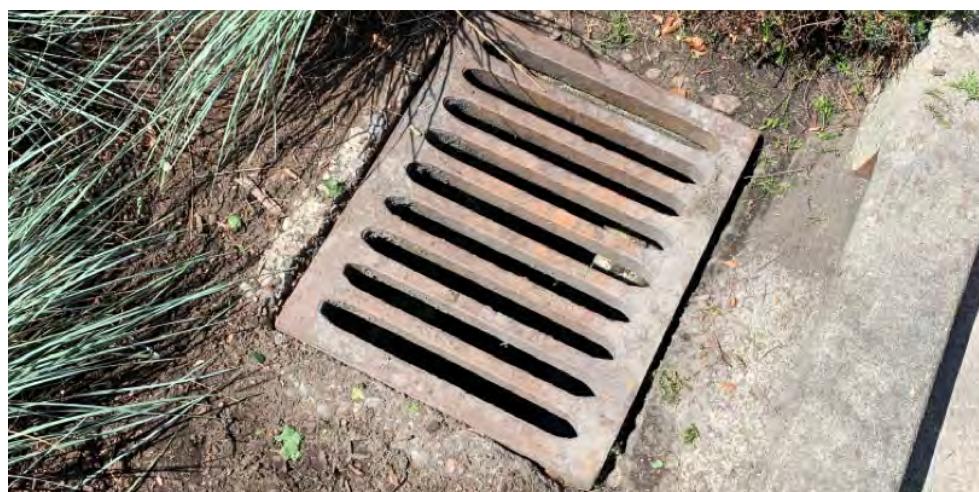
Moderate damage to concrete around CB, could be sign of water leakage.
Condition score: 3

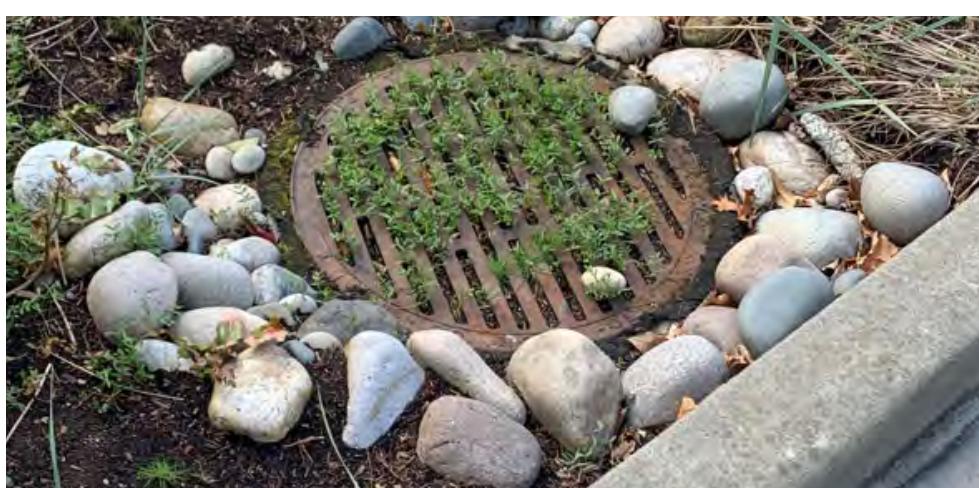
CB is filled with debris and non-functional. Could cause backups that create community risk.
Condition score: 5

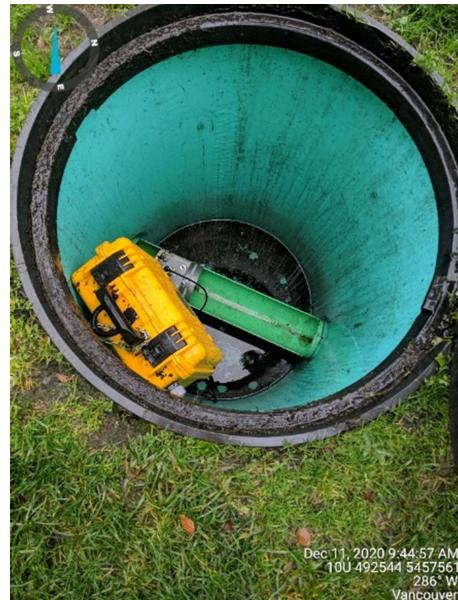
Bioswale #2 has a perforated 100 mm PVC underdrain that is laid at 0% gradient across the length of the swale. The perforated underdrain connects to a solid 150 mm PVC pipe, laid at 1% gradient, that discharges to the stormwater sewer. A monitoring manhole installed between the practice and the stormwater sewer discharge point allows for monitoring of outlet flows and water quality. A 0.6 m × 0.08 m opening has been cut in the top of the 150 mm PVC pipe to facilitate flow monitoring and sample collection. The monitoring manhole, with flow monitoring equipment installed by the City, is shown in Photo 2-1.

Photo 2-1: Monitoring Manhole at Bioswale #2 on Quebec Street

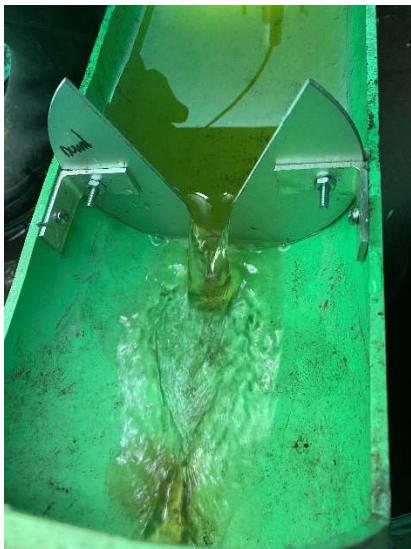
Photo 2-2: 45-degree V-notch Weir Installed to Facilitate Level Logging in the Underdrain of Bioswale #2

Bioswale #2 has a functional monitoring manhole, but existing flow monitoring equipment was not operating and needed to be reconfigured or replaced.

The original setup at the monitoring manhole used an Onset Hobo Energy datalogger to record voltage output from a Senix Toughsonic ultrasonic level transducer. For the duration of the injection test, KWL installed a 45-degree V-notch weir to the monitoring manhole, which increased the level response and thus the resolution of the flow calculation (Photo 2-2). The existing Senix Toughsonic transducer was re-programmed and reused; the existing datalogger was not functional so a Telog datalogger was used instead. Ultrasonic level data was recorded at one-minute intervals.

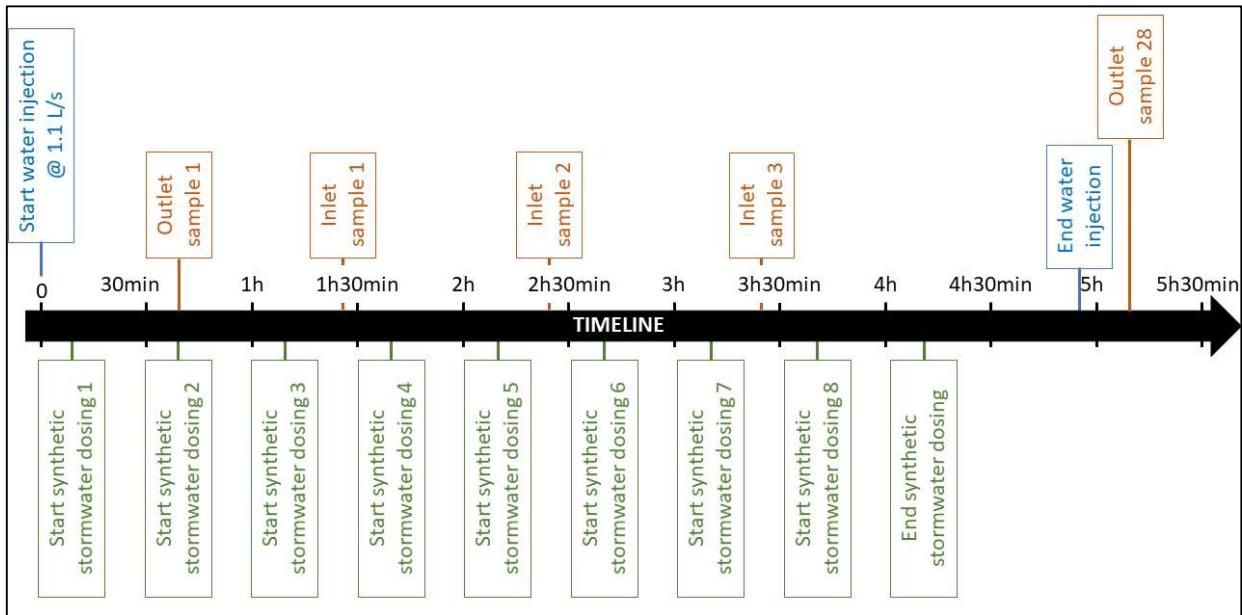
Each 20 L batch of synthetic stormwater concentrate was applied to the bioswale over a period of 30 min and a total of 8 batches were applied during the injection test. Tap water injection was ended when all synthetic stormwater was assumed to have infiltrated, approximately 45 min after the last batch of synthetic stormwater concentrate was applied and approximately 5 h after the start of the tap water injection. Inlet (synthetic stormwater) and outlet (from the underdrain) water samples were collected on several occasions during the injection procedure, further described in Section 2.5. The approximate timeline of the test, with tap water injection start and end, dosing of the synthetic stormwater concentrate, and collection of inlet and outlet samples, is shown in Figure 2-1.

Figure 2-1: Approximate Timeline of Synthetic Stormwater Injection Test Actions

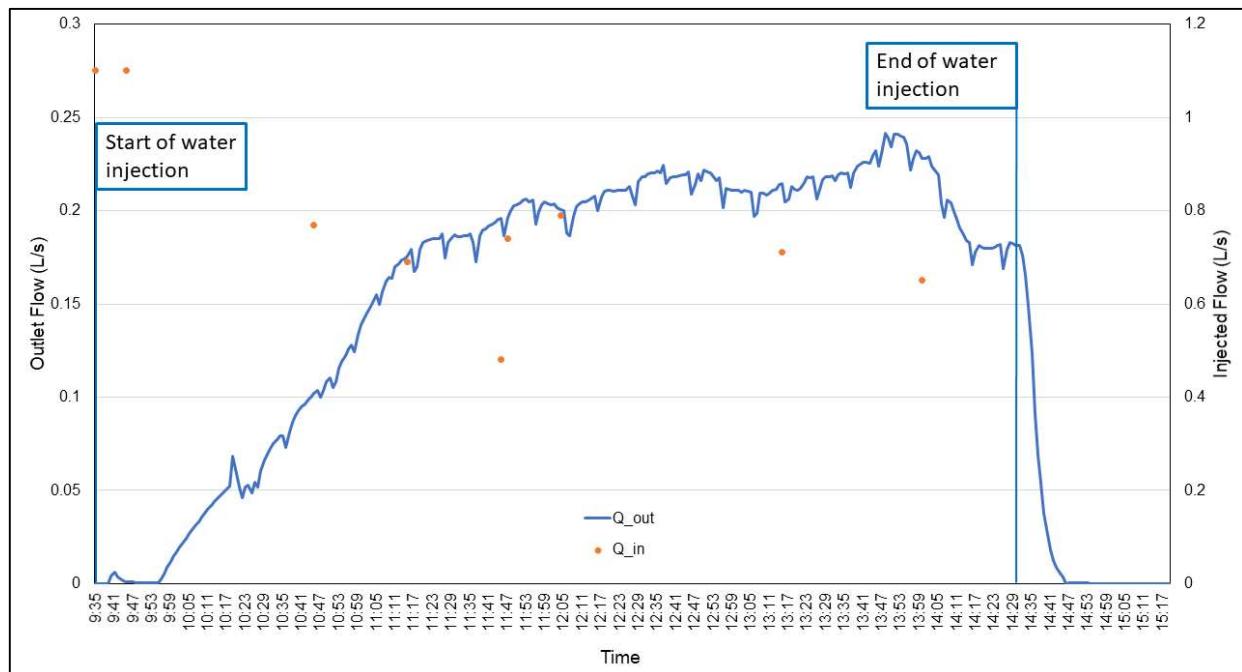
- The flow continues to increase, but at a lower rate, until it reaches its peak at 0.24 L/s (13:50), 3 h after the flow started to increase and 3 h and 20 min after the water injection started. The peak flow is reached before the water injection has ended.

- When the water injection is stopped (14:30), the outlet flow decreases drastically and reaches negligible levels in less than 15 min.
- Between the start (09:35) and the end (15:10) of the water level logging, the total volume of water passed through the underdrain is estimated to 2,890 L.

Figure 3-1: Hydrograph of Injected (●) and Outlet (—) Flows (L/s) During the Synthetic Stormwater Injection Test

The sharp increase in flow after 20 min of water injection (Figure 3-1) suggests that the infiltration lag time was shorter during the synthetic stormwater injection test compared to the pre-test, when water was observed in the underdrain after 30 min. The shortened lag time is likely a result of more saturated soils at the beginning of the synthetic stormwater injection test because of the shorter antecedent dry period; 40 h dry period prior to the pre-test vs. 20 h dry period prior to the synthetic stormwater injection test.

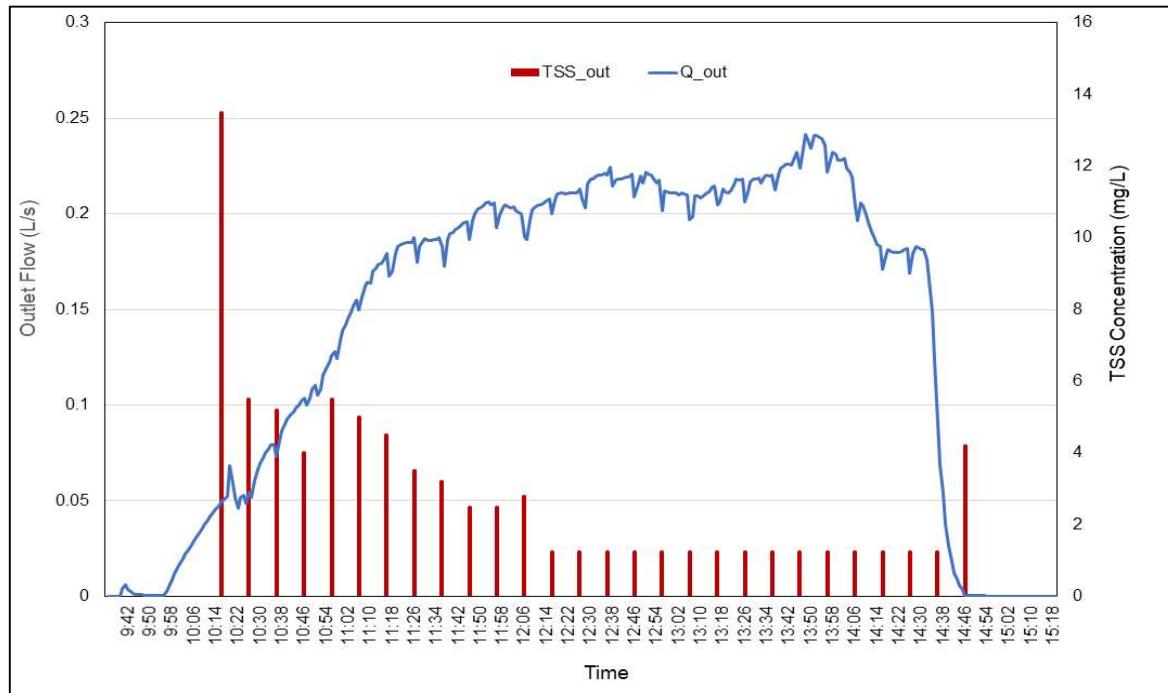
Figure 3-2: Pollutograph Showing Outlet Flows (—, L/s) and TSS Concentrations (█, mg/L) During the Synthetic Stormwater Injection Test. TSS Concentrations Below Detection Limit (2.5 mg/L) have been Replaced with ½ Detection Limit.

Figure 3-2 shows that the outlet TSS concentration reached its peak at an early stage of the injection test. The outlet TSS concentration decreased considerably within short time, likely because of increasing flows diluting the TSS concentration, and approximately 2 h 30 min after the first injection of synthetic stormwater (12:16), outlet TSS was reduced to concentrations below detection limit (<2.5 mg/L, replaced with ½ detection limit in Figure 3-2), except for an increase in TSS in the final Outlet Sample 28. The TSS concentration in outlet sample 28 may have been affected by bottom sediments in the outlet pipe as water level was very low at the time of sampling.
