**PHASE II ENVIRONMENTAL SITE ASSESSMENT  
FOR  
HITCHING POST INN  
1600 WEST LINCOLNWAY  
CHEYENNE, LARAMIE COUNTY, WYOMING**

| Date Prepared | March 2018 |
| TDD No. | 0003/1711-13 |

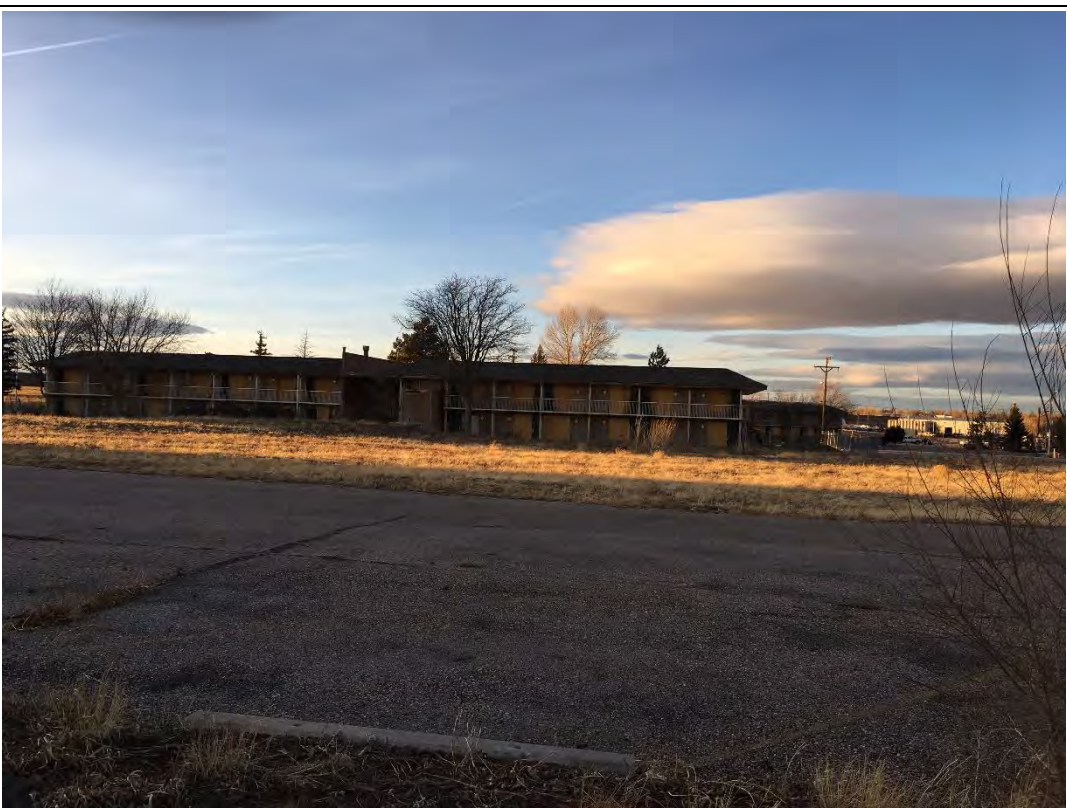
| <table> <tr> <td><b>Photo No.</b><br/><b>1</b></td><td><b>Date:</b><br/>02/07/2018</td></tr> <tr> <td colspan="2"><b>Photo Coordinates</b></td></tr> <tr> <td><b>Lat</b></td><td>41.125764</td></tr> <tr> <td><b>Long</b></td><td>-104.834144</td></tr> <tr> <td colspan="2"><b>Direction Photo Taken:</b><br/>357.368932038835</td></tr> <tr> <td colspan="2"> <b>Description:</b><br/><br/> Looking at the site of the former burned down Main Building and current Buildings #1 and #2. </td></tr> </table> | <b>Photo No.</b><br><b>1</b> | <b>Date:</b><br>02/07/2018 | <b>Photo Coordinates</b> | | <b>Lat</b> | 41.125764 | <b>Long</b> | -104.834144 | <b>Direction Photo Taken:</b><br>357.368932038835 | | <b>Description:</b><br><br>Looking at the site of the former burned down Main Building and current Buildings #1 and #2. | | |

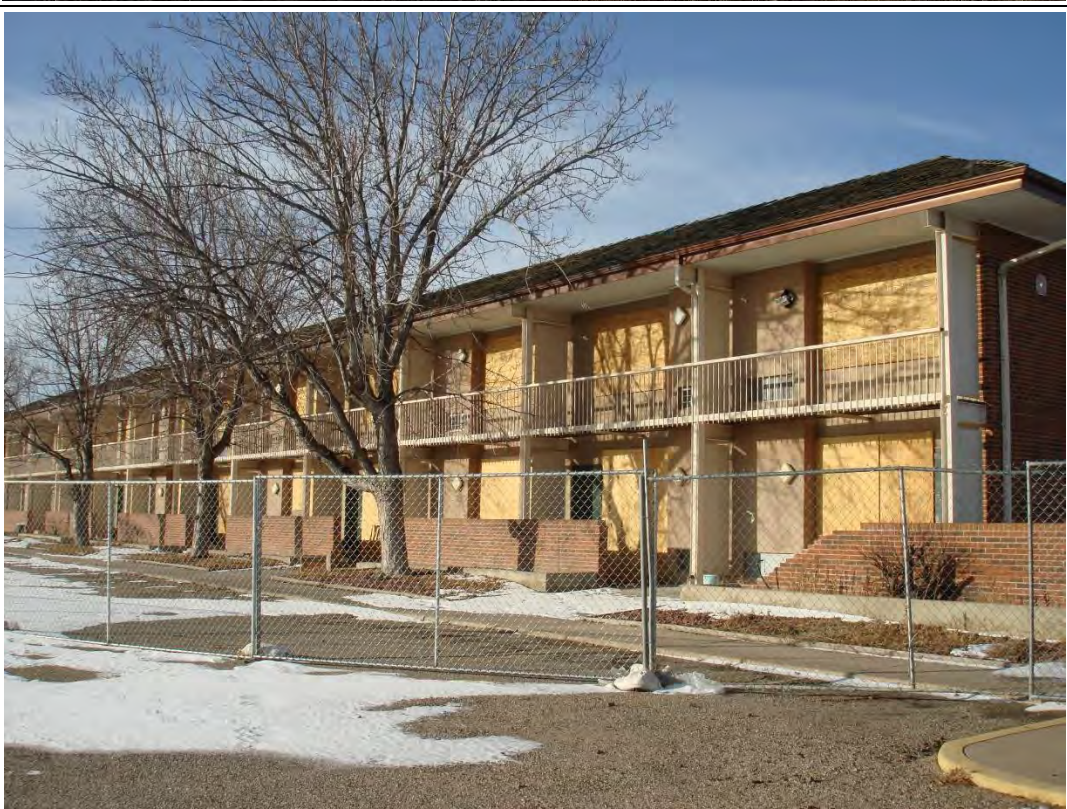
| <b>Description:</b><br><br>Looking at the exterior of Building #4 with LBP on I-beams. | | | | | | | | | | | | | |

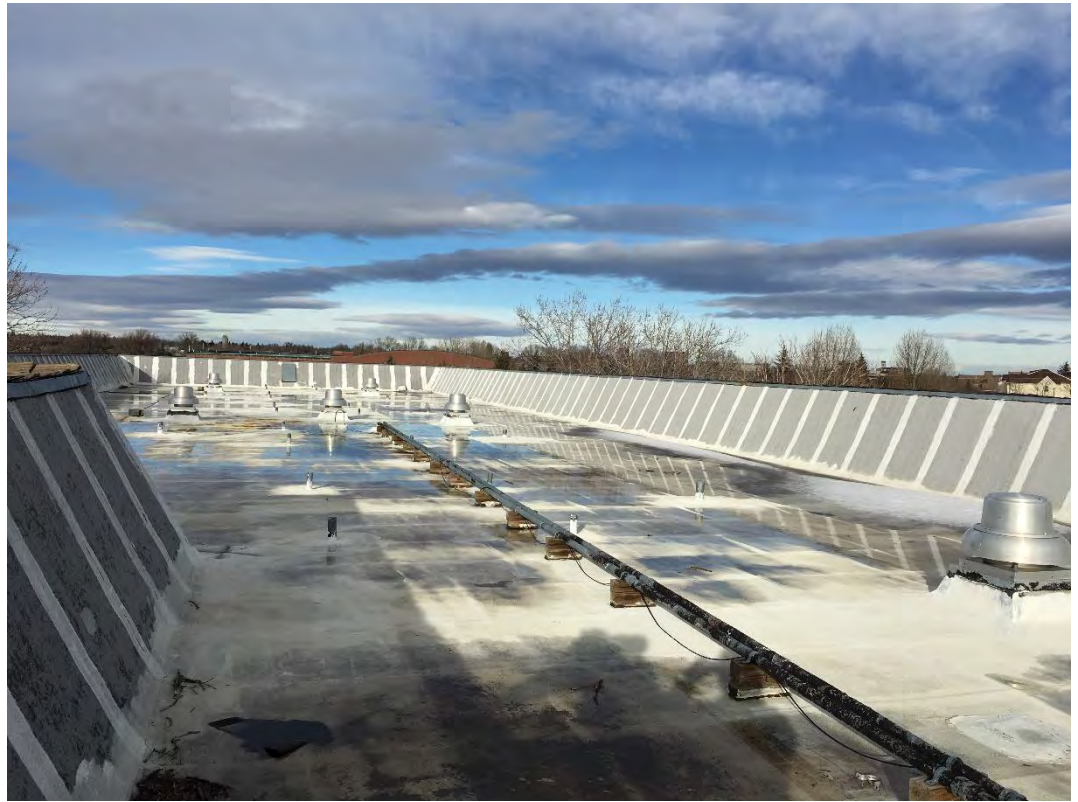
| <b>Description:</b><br><br>Roof of Building #4.<br>Assumed all roofs are homogeneous based on aerial photographs. | |

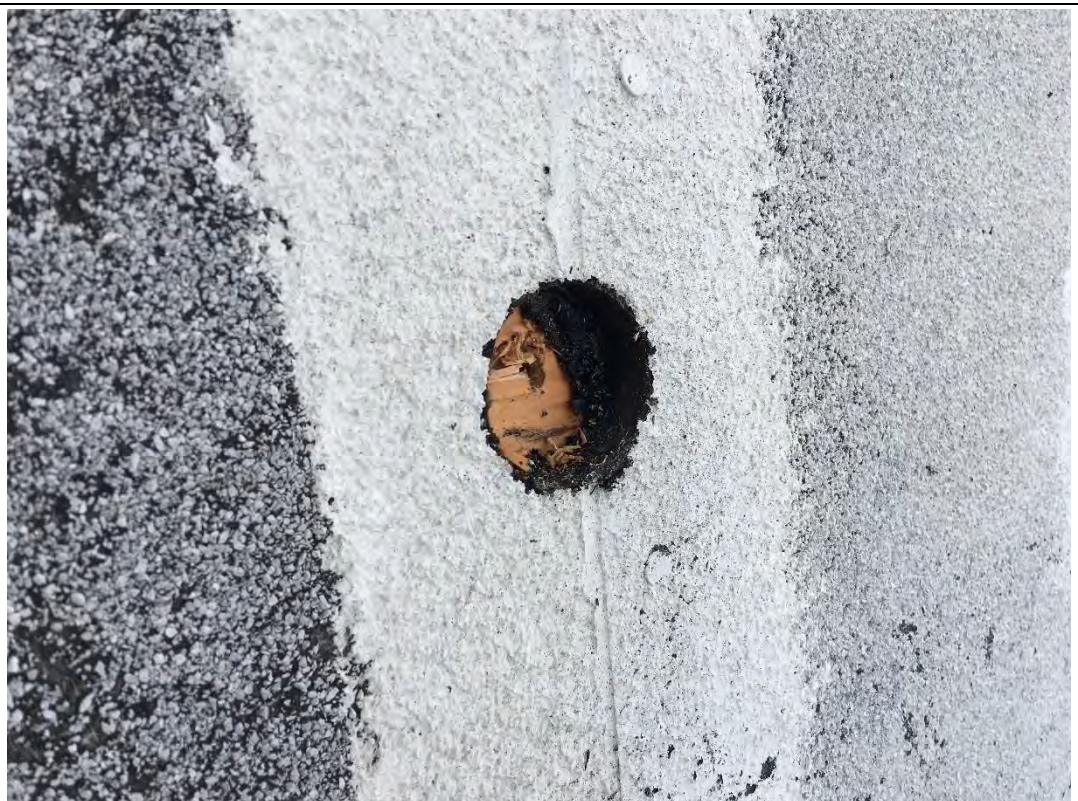
| <b>Photo No.</b><br><b>4</b> | <b>Date:</b><br>02/07/2018 |

| <b>Description:</b><br><br>Hole saw was used to collect ACM sample HP4-R-RM01-189. | |

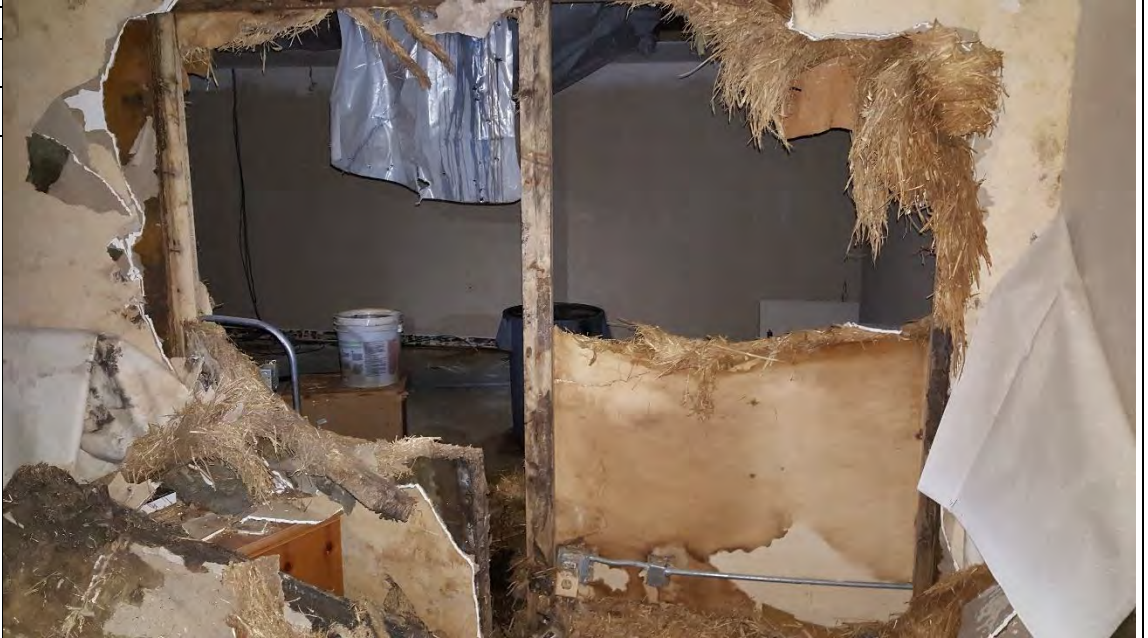
| <table> <tr> <td><b>Photo No.</b><br/><b>5</b></td><td><b>Date:</b><br/>02/05/2018</td></tr> <tr> <td colspan="2"><b>Photo Coordinates</b></td></tr> <tr> <td><b>Lat</b></td><td>41.129722</td></tr> <tr> <td><b>Long</b></td><td>-104.830556</td></tr> <tr> <td colspan="2"> <b>Description:</b><br/><br/> Straw wall insulation observed in Building #3. </td></tr> </table> | <b>Photo No.</b><br><b>5</b> | <b>Date:</b><br>02/05/2018 | <b>Photo Coordinates</b> | | <b>Lat</b> | 41.129722 | <b>Long</b> | -104.830556 | <b>Description:</b><br><br>Straw wall insulation observed in Building #3. | | |

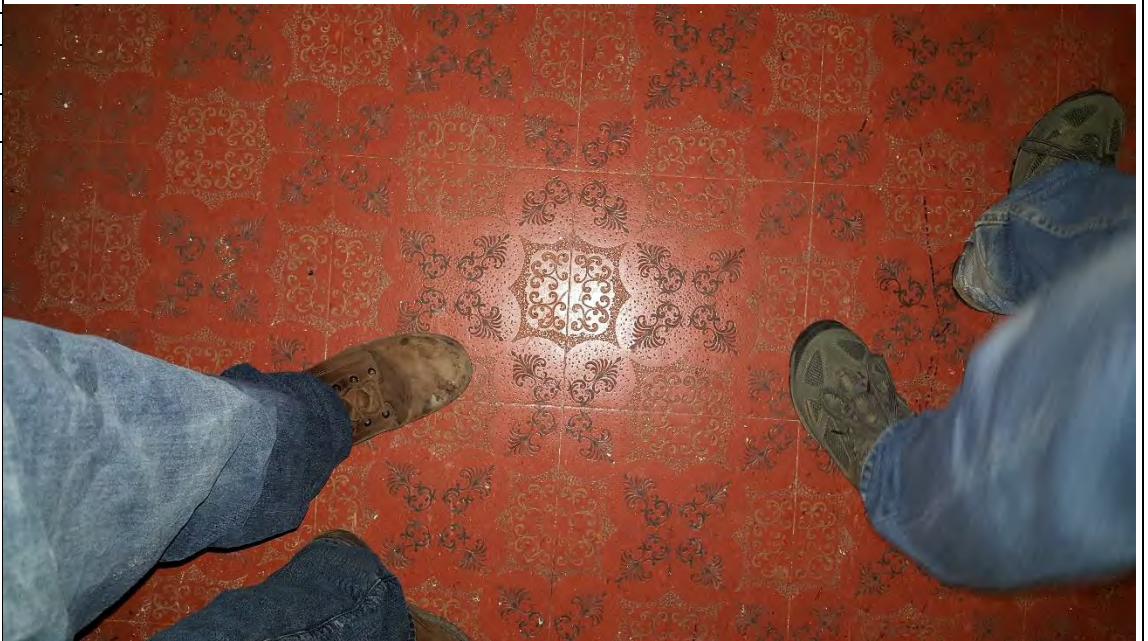
| <table> <tr> <td><b>Photo No.</b><br/><b>6</b></td><td><b>Date:</b><br/>02/05/2018</td></tr> <tr> <td colspan="2"><b>Photo Coordinates</b></td></tr> <tr> <td><b>Lat</b></td><td>41.129722</td></tr> <tr> <td><b>Long</b></td><td>-104.830556</td></tr> <tr> <td colspan="2"> <b>Description:</b><br/><br/> ACM floor tile observed on the 3<sup>rd</sup> floor of Building #5 and location of sample HP5-3-FT04-430. </td></tr> </table> | <b>Photo No.</b><br><b>6</b> | <b>Date:</b><br>02/05/2018 | <b>Photo Coordinates</b> | | <b>Lat</b> | 41.129722 | <b>Long</b> | -104.830556 | <b>Description:</b><br><br>ACM floor tile observed on the 3 <sup>rd</sup> floor of Building #5 and location of sample HP5-3-FT04-430. | | |

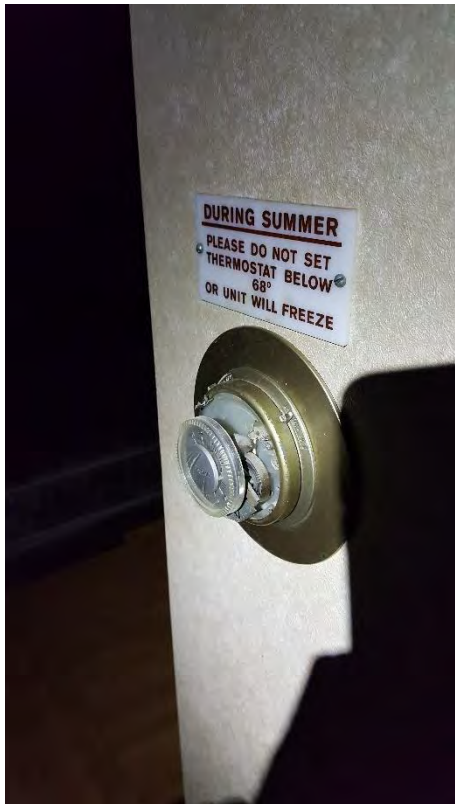
| <b>Photo No.</b><br><b>7</b> | <b>Date:</b><br>02/06/2018 |

| <b>Description:</b><br><br>Example of a mercury thermostat switch observed throughout the buildings. | |

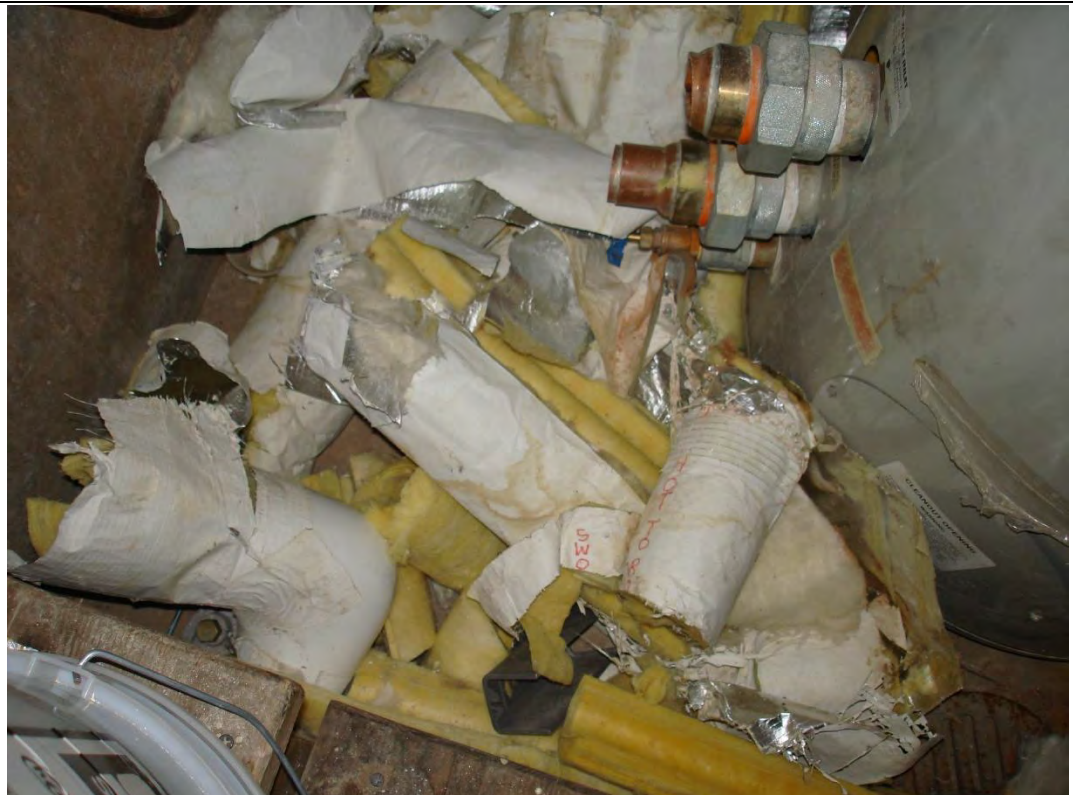
| <b>Photo No.</b><br><b>8</b> | <b>Date:</b><br>01/03/2018 | |

| <b>Description:</b><br><br>Primarily fiberglass insulation was observed in the buildings. | | |

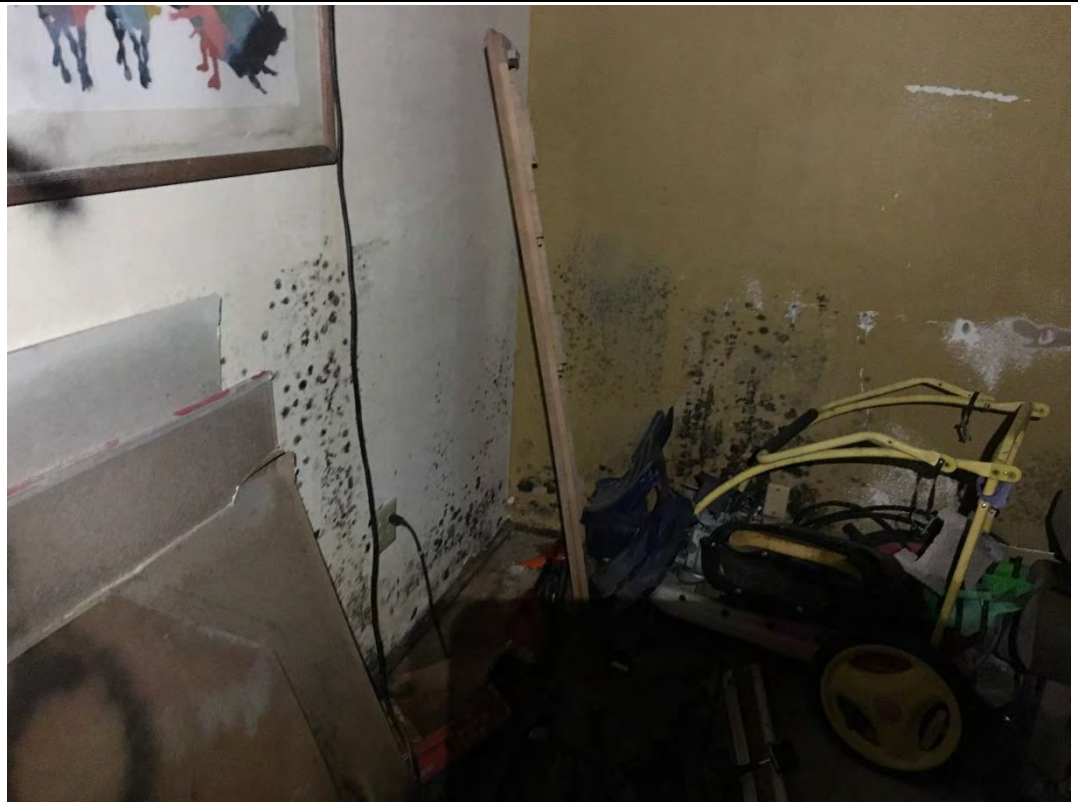
| <b>Description:</b><br><br>Black mold observed in one of the hotel rooms. | |

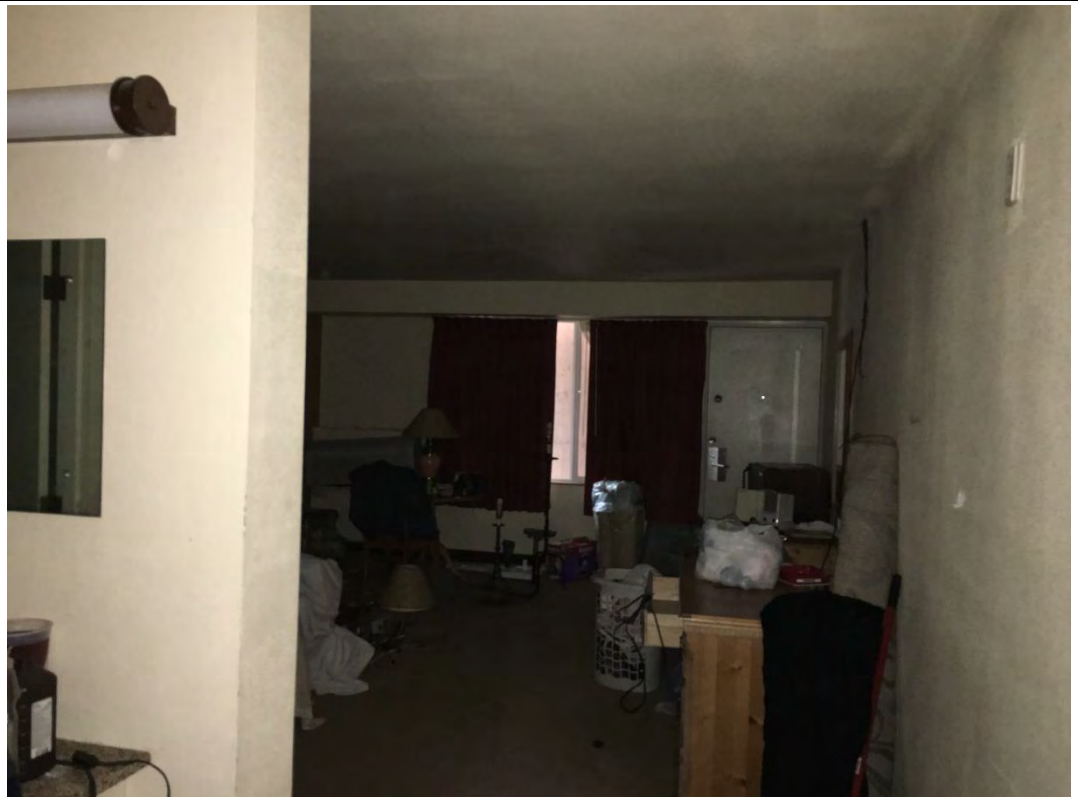
| <b>Photo No.</b><br><b>12</b> | <b>Date:</b><br>02/05/2018 |

| <b>Description:</b><br><br>Typical hotel room with ACM compounds on walls and ceilings. | |

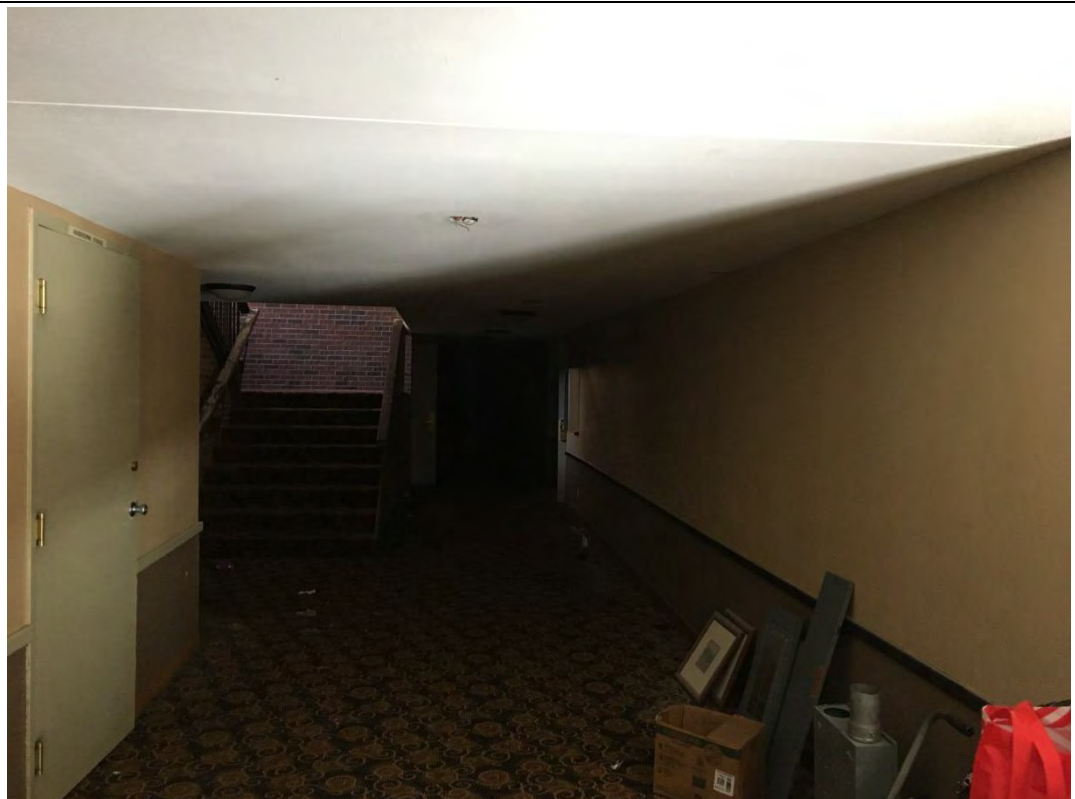
| <b>Photo No.</b><br><b>14</b> | <b>Date:</b><br>02/06/2018 |

| <b>Description:</b><br><br>Looking down the hallway of Building #4. All walls and ceilings have ACM drywall compounds present. | |

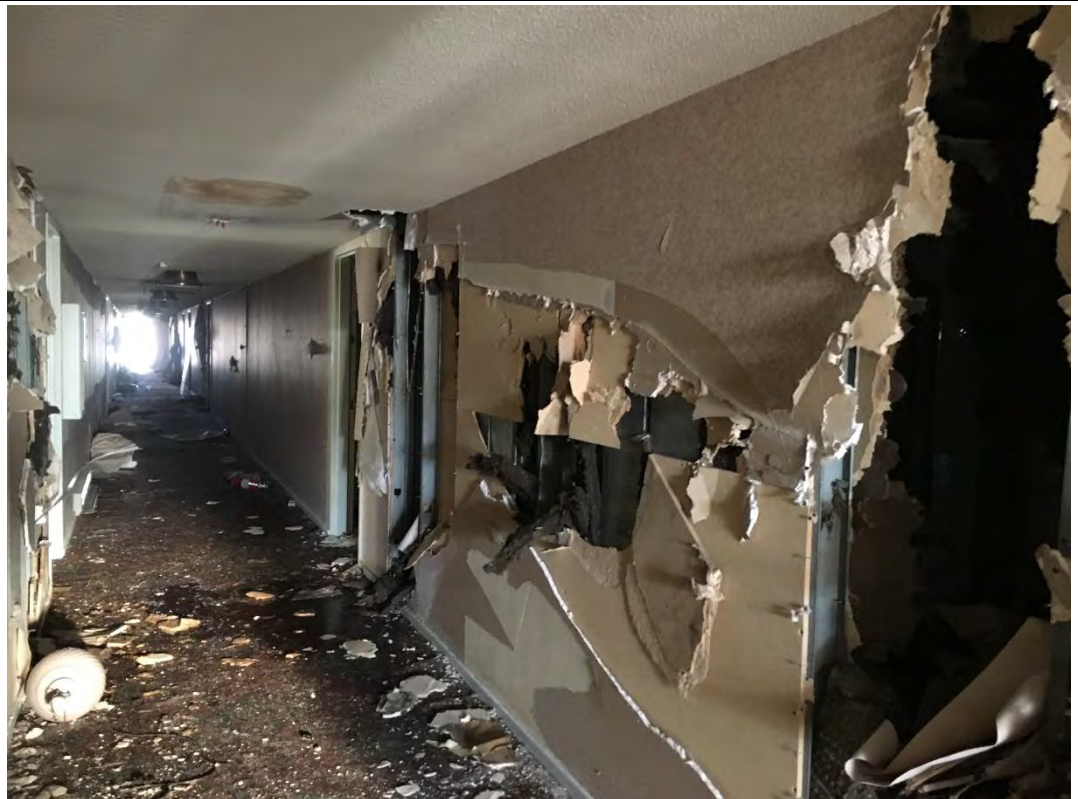
| <b>Photo No.</b><br><b>18</b> | <b>Date:</b><br>02/07/2018 |

| <b>Description:</b><br><br>Damaged conditions present in Building #5. All walls and popcorn ceilings have ACM compounds. | |
