# Conditions of Blight

## City of Cheyenne

Exhibit A: Produced to support the Initiative Resolution

Produced Spring 2021  
Planning and Development Department  
Mark Christensen, Planner II

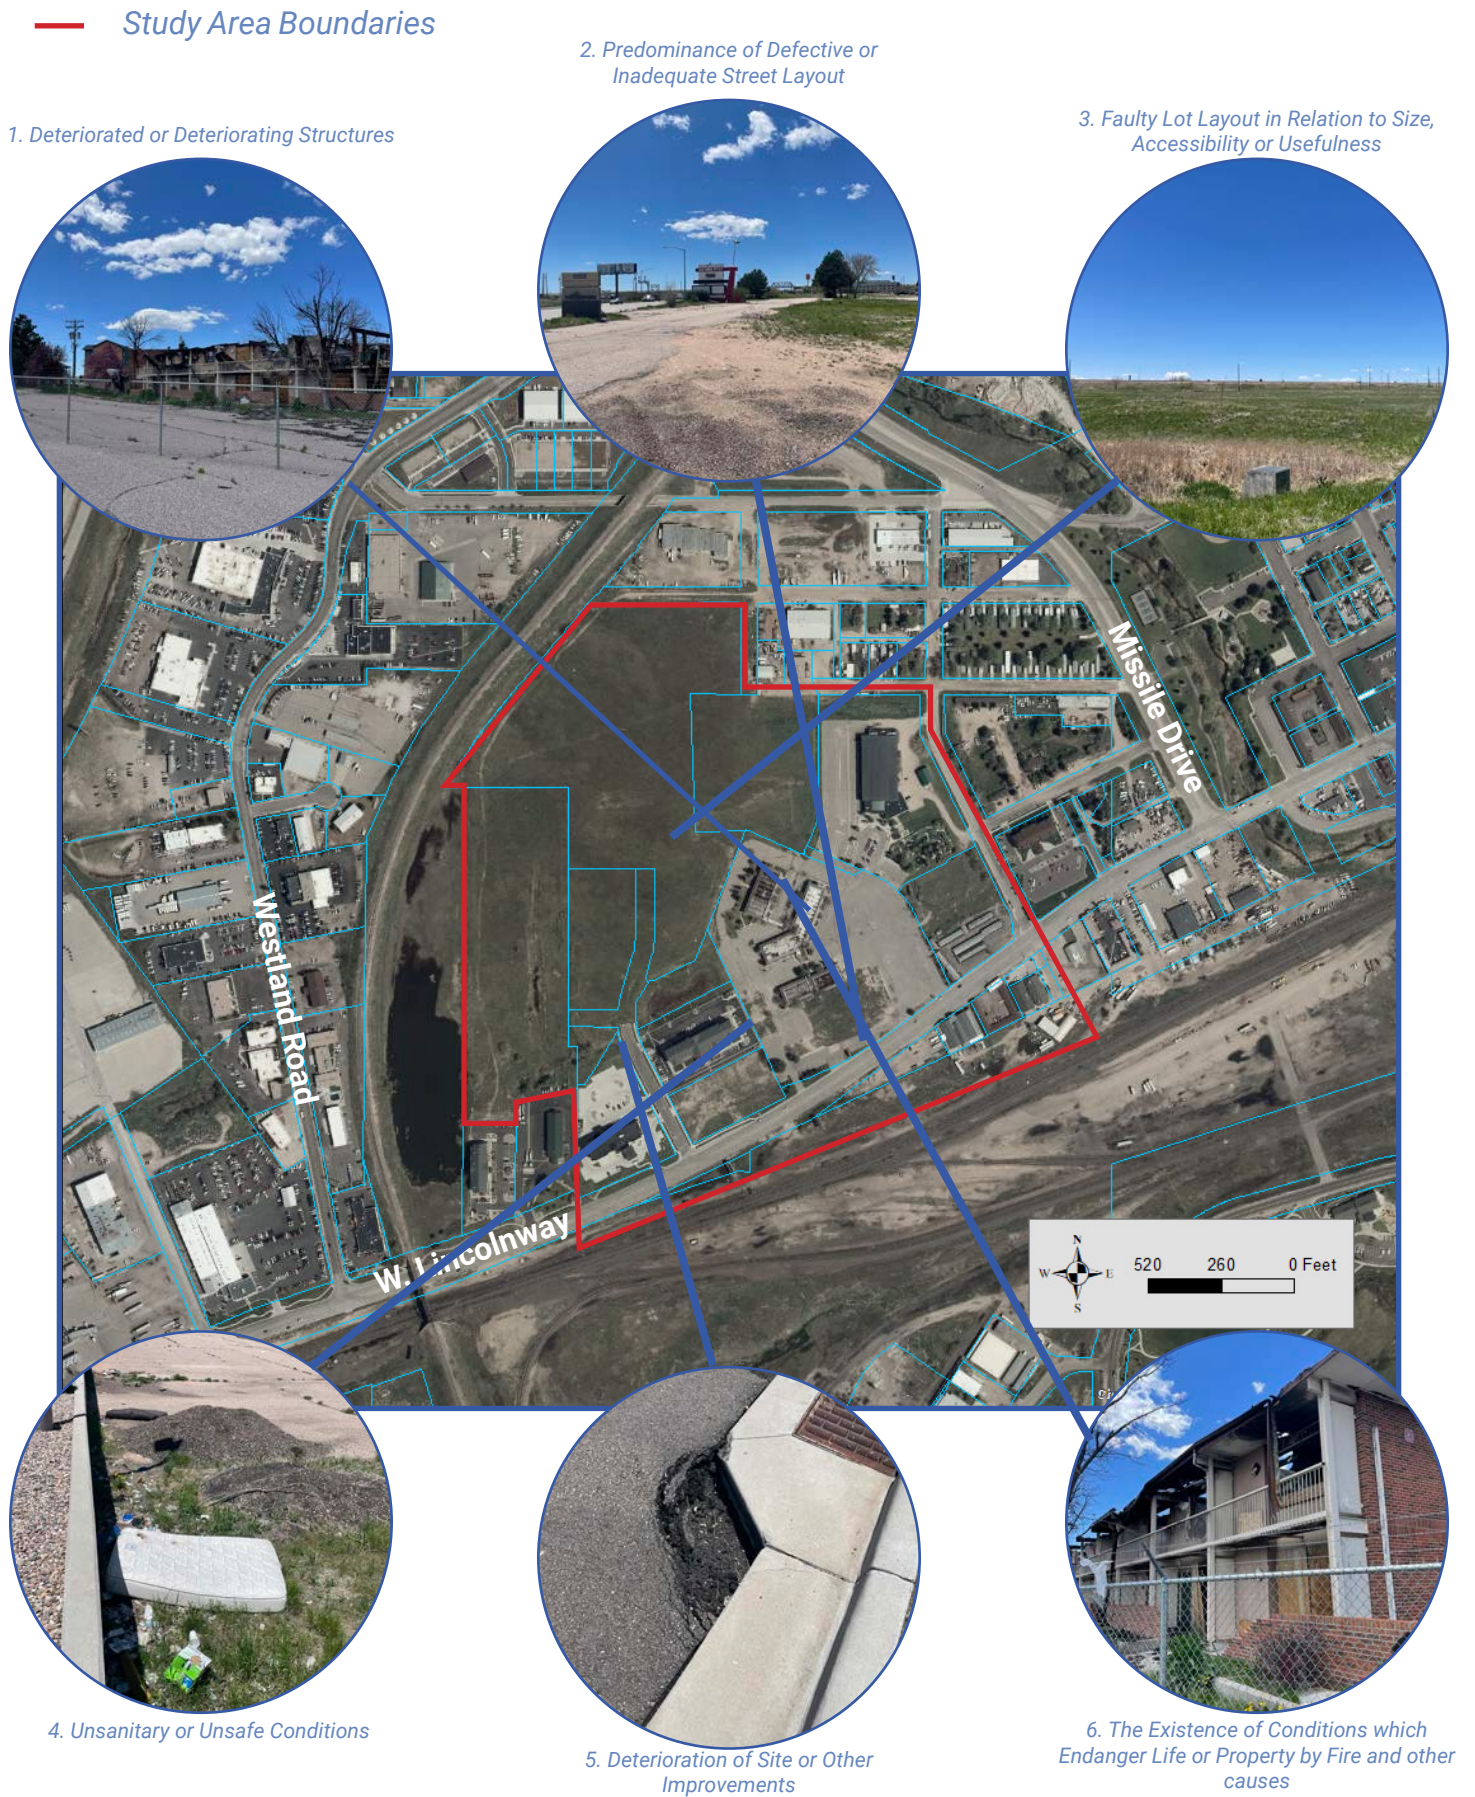
**Figure 1: Hitching Post Study Area**

The Hitching Post study area is shown in Figure 1. The study area includes the Hitching Post property and several surrounding properties, including several across Lincolnway. The site contained six (6) of the nine (9) conditions of blight identified on the survey, demonstrating one area of blight in the community.

The Hitching Post study area contains several examples of deteriorated or deteriorating structures, as shown in the photo on the previous page. Most of the buildings on the Hitching Post property are either boarded-up or burned, and the walkway between two of the buildings has partially collapsed. In addition to the buildings on the Hitching Post site, other buildings in the area show evidence of deterioration. The prevalence of deteriorating buildings as depicted in the supporting photographs in Appendix A fulfills this condition of blight.

Several of the parcels in the Hitching Post property are large with no lot frontage or direct right of way access. One of these is shown in Figure 1 with the Back 40 subdivision. Again, the lack of internal connections through the site lead to accessibility issues and a lack of pedestrian connections. The study area is designated as a Community/Regional Activity Center in PlanCheyenne, yielding a maximum block size with a 2000' perimeter and 600' maximum on any one block face per Unified Development Code Table 4-6. Currently, the site has approximately 1500' of frontage on one block face and an incomplete block structure due to lack of connections; though, if one were to complete the block, it would be approximately 5250' of perimeter. The size of the blocks, lack of pedestrian routes, and lack of internal connections yield a faulty lot layout in relation to size, accessibility and usefulness; thus, meeting this condition of blight.

Staff noted several conditions of deterioration of site improvements at the Hitching Post study area. The deterioration included curb, gutter, sidewalk, and areas around a storm sewer drain (Figure 1). In addition to these conditions of deterioration, staff also noted a downed light pole on the Hitching Post property. The deterioration of site conditions is illustrative of blight in the study area.

The two main indicators of the site that meet these conditions include the fire-damaged building (Figure 1) and the presence of environmental contamination. A recent Phase I Environmental Site Assessment documented several conditions that are recognized as hazardous by the Environmental Protection Agency. The existence of fire-damaged building also leads to a concern, as the buildings have become unstable and possibly life endangering.

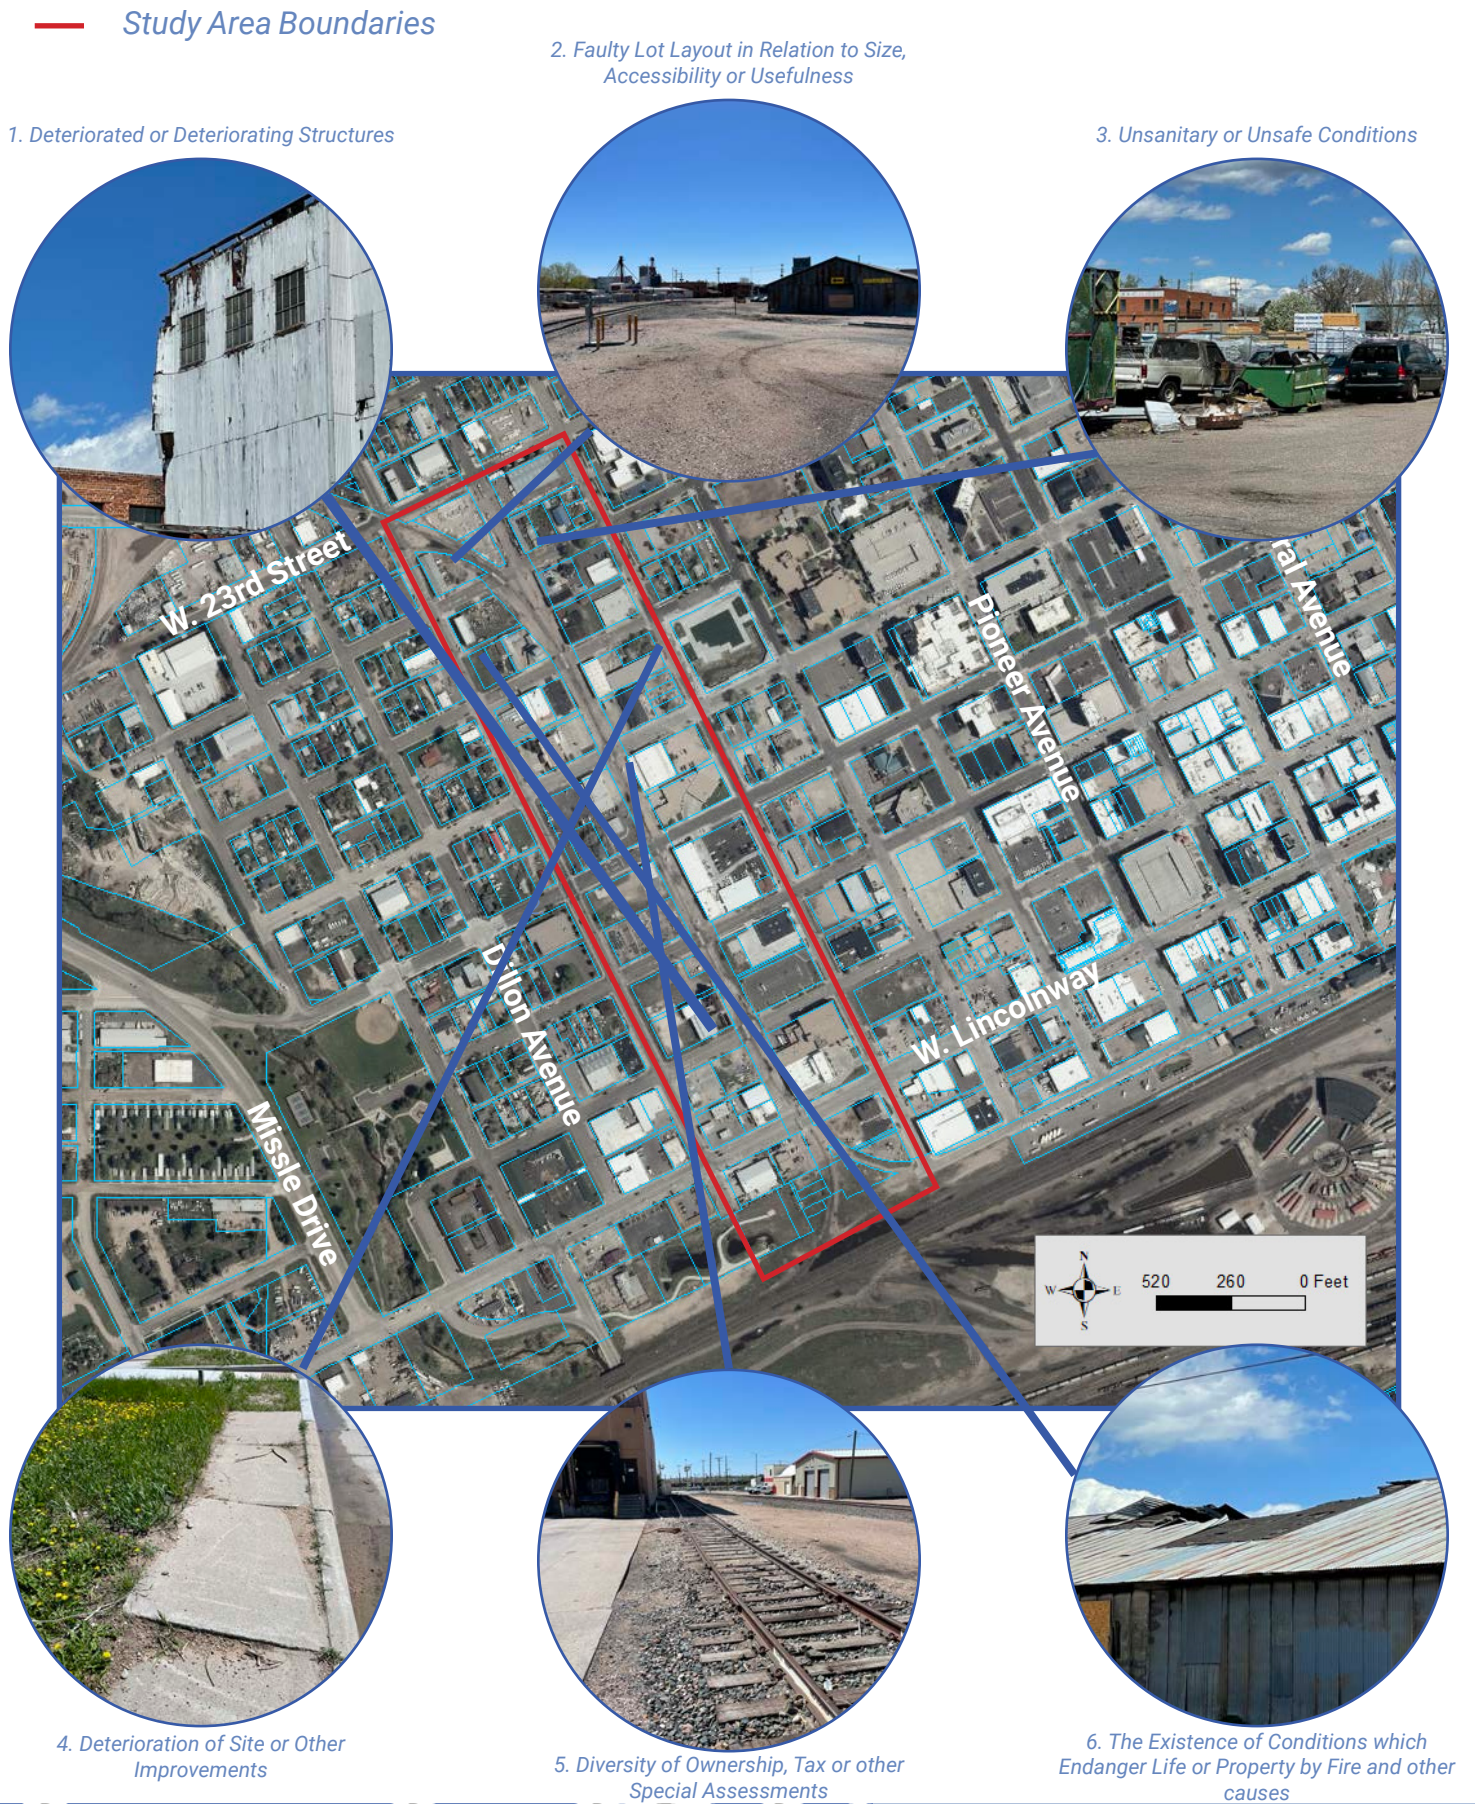
**Figure 2: Reed Avenue Rail Corridor Study Area**

The Reed Avenue Rail Corridor is shown in Figure 2. The study area includes the blocks between Bent Avenue and Snyder Avenue from east to west and between W 23rd Street and the Union Pacific Railroad from north to south. The study area included six (6) of the nine (9) conditions of blight identified in the survey, demonstrating a second area of blight in the community.

Staff noted several deteriorating buildings in the Reed Avenue Rail Corridor. Examples include 800 W 17th Street (Figure 2) and 820 W 22nd Street; though several other buildings appear to be deteriorating and may be more so on the interior. Indicators of deterioration witnessed include evidence of fire, boarded-up buildings, and faulty building siding. The photo on the previous page and those in Appendix B illustrate the study area meets this condition of blight.

Many blocks in the study area contain platted alleys while others have been vacated. This leads to confusion and lack of usable area for development purposes. Supplemental to this evidence of blight, many lots have not been platted since the Original City subdivision. Staff has difficulty interpreting the Original City subdivision and the legal descriptions are often a source of confusion. The inconsistency in alley vacation and age of the subdivision lead to faulty lot layout in relation to size, accessibility, and usefulness. The photo in Figure 2 for this criteria depicts a lot with a faulty layout.

The Reed Rail study area contained litter and a lack of connections over the rail tracks, meeting unsanitary conditions and unsafe conditions respectively. Furthermore, the prevalence of industrial businesses (Figure 2), and the age

The Reed Avenue Rail Corridor has deteriorated curb, gutter, and sidewalk in various locations (Figure 2). The deteriorated site conditions have exacerbated the pedestrian connections along the Reed Avenue Rail Corridor, which is a critical project for the City of Cheyenne. The photos in Appendix B show several locations of deteriorated site conditions and infrastructure.

The building located at 820 W 22nd Street shows evidence of fire damage (Figure 2). Furthermore, many of the vehicles adjacent to this site show evidence of fire. Again, the confirmed environmental contamination on some sites and probable contamination along the corridor yield another condition that may endanger life and property. The noted fire damage and environmental contamination fulfill this condition of blight.

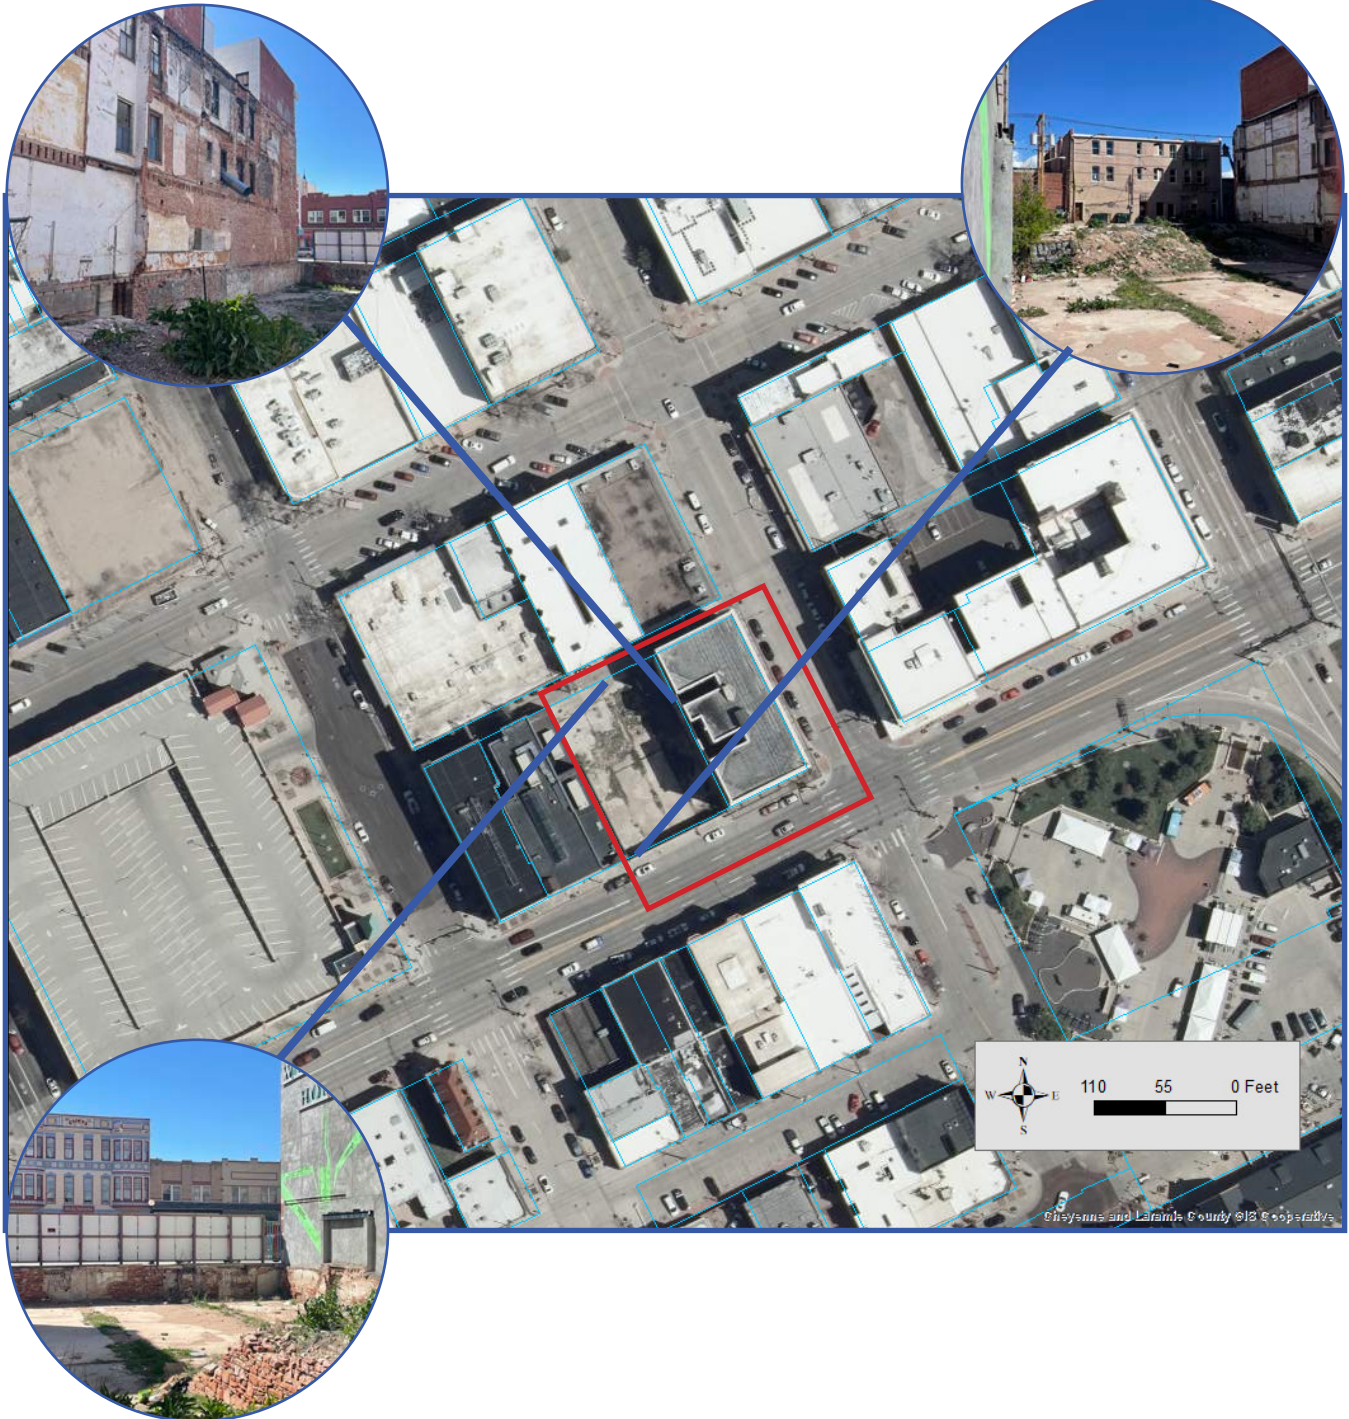
**Figure 3: The Hynds and the Hole Study Area**

The Hynds and the Hole study area is shown in Figure 3. The study area contains Lot 1, Block 1 of Cheyenne Leads Lincolnway Subdivision (the Hole) and Lot 8, Block 390 of the Original City Subdivision (the Hynds). The study area included three (3) of the nine (9) conditions of blight identified in the survey, demonstrating a third area of blight in the community.

The Hynds and Hole exhibit both a deteriorated and deteriorating structure (Figure 3). The building where the Hole is burned down in 2004 and the foundation that is still present shows evidence of deterioration. The Hynds building shows evidence of deterioration with rust and other loose and collapsing building materials.

The presence of the Hole represents an unsafe condition. Although the Hole is fenced off, if individuals are to enter over the fence or through the alley there is the possibility of injury.

The Hole was created by a fire that destroyed the building in 2004. The site has remained vacant ever since and represents a blighted area in the community (Figure 3).
