# Unit 14 visual

## A Inspection

MIDLAND COGEN

ESN/SY: 810893 | SY0048230

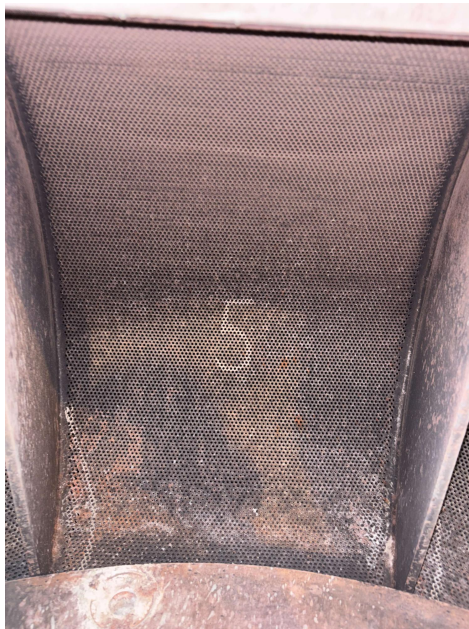
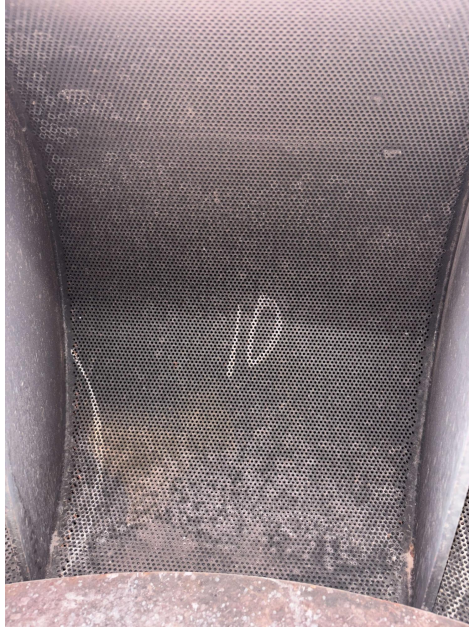
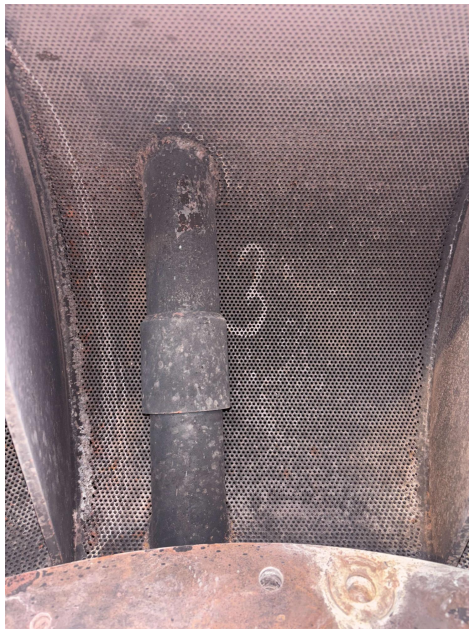
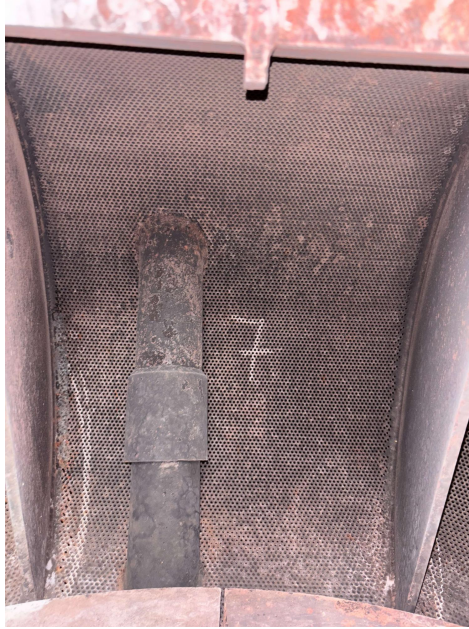
Strainer basket was found in acceptable condition.

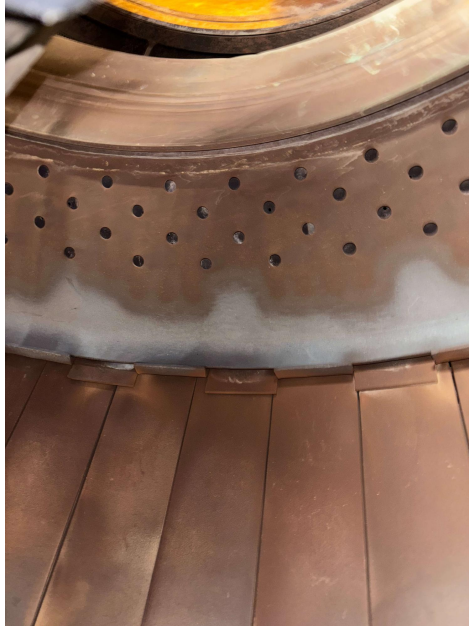
IMG 1995

Lower cone was found in acceptable condition.

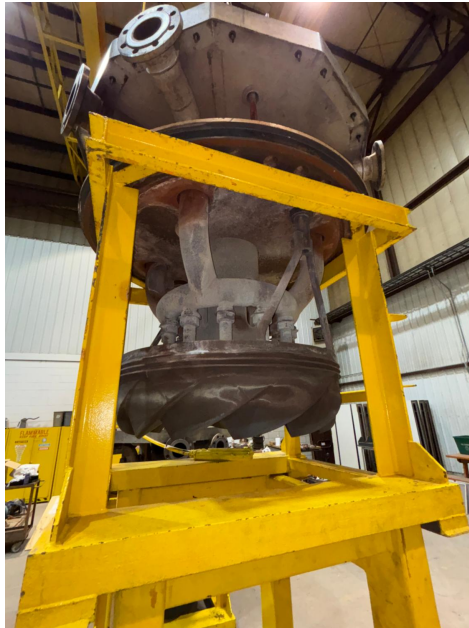
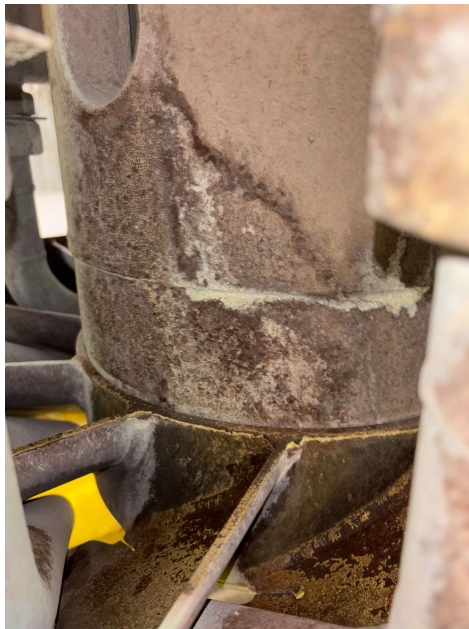
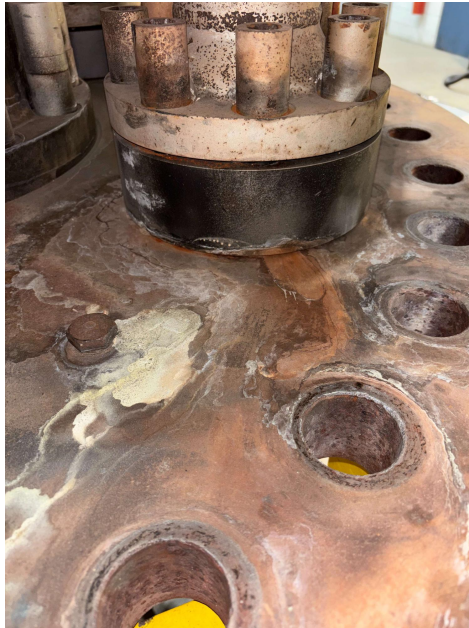
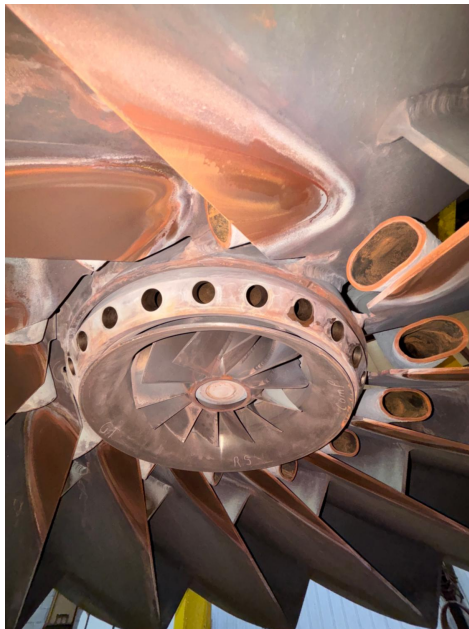
Burner was found with yellow deposits. Nozzle and swirler was in acceptable condition. A leak was found at one of the pipes on the cover that was repaired by the customer.

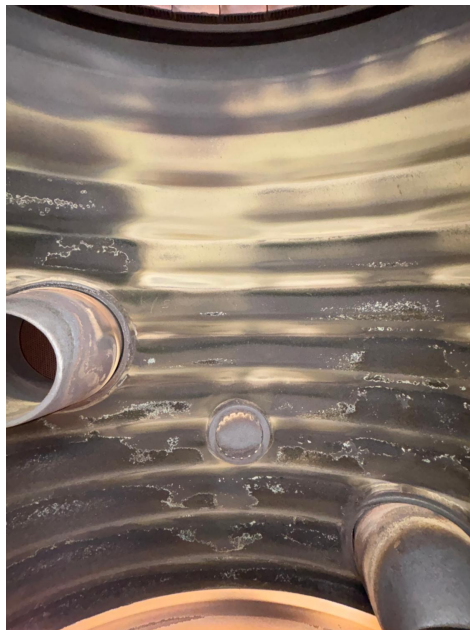
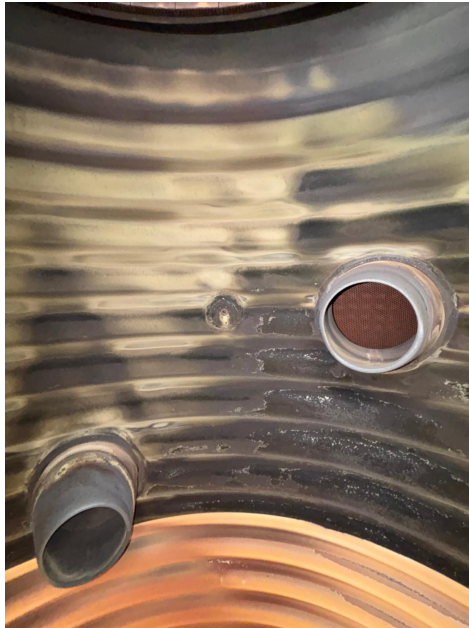
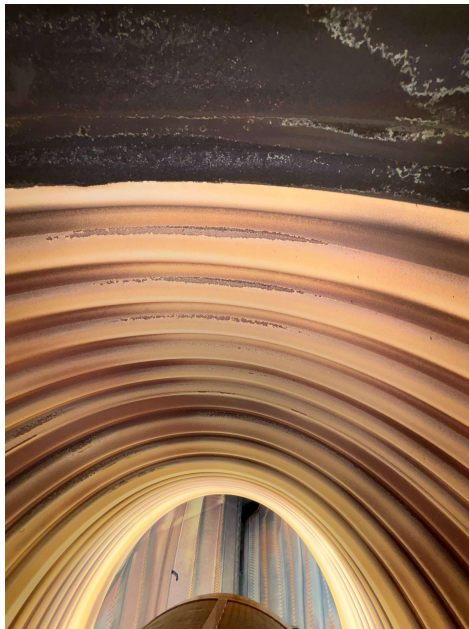
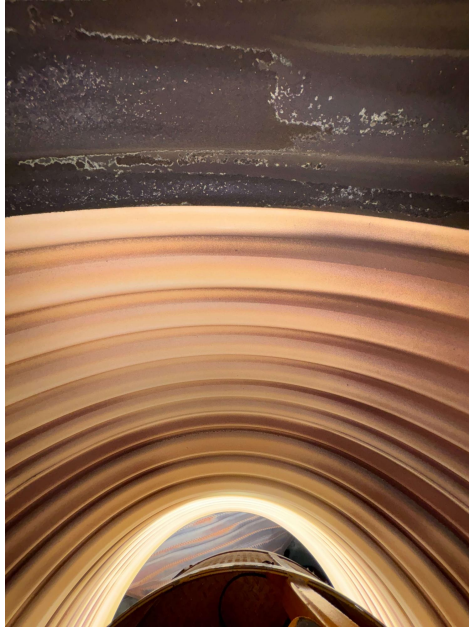
CIL was found with some erosion near secondary air nozzles and some erosion on the CIL near the secondary air nozzles.

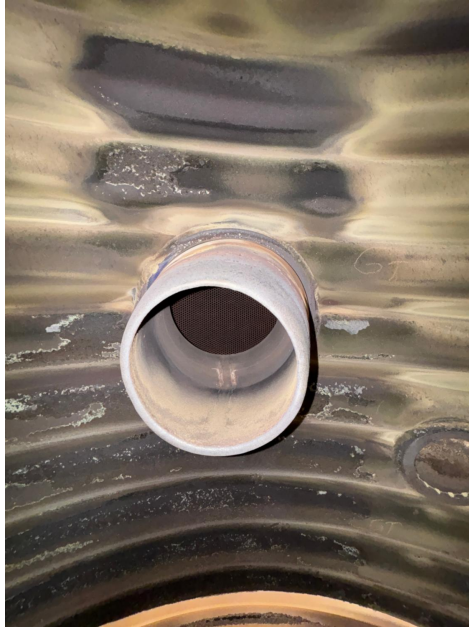
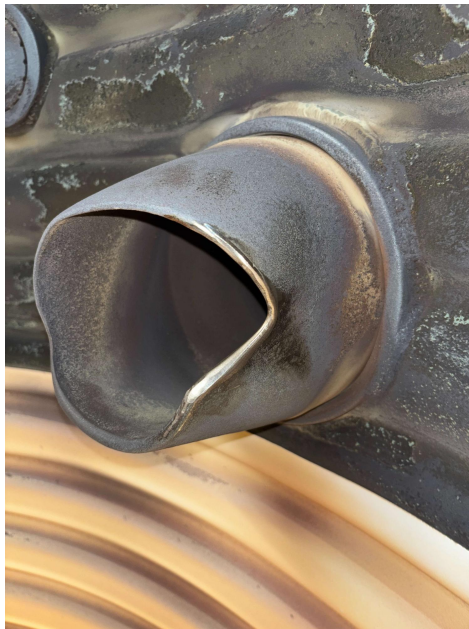
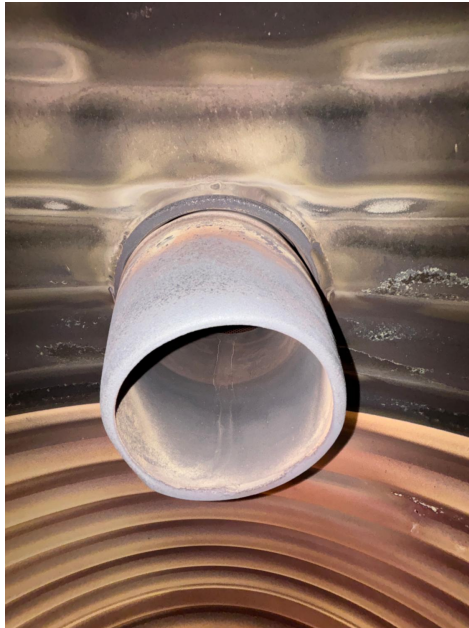
Medium erosion was found at the tips and the walls of the secondary air nozzles. One crack was found in the end of one and was blended out during inspection.

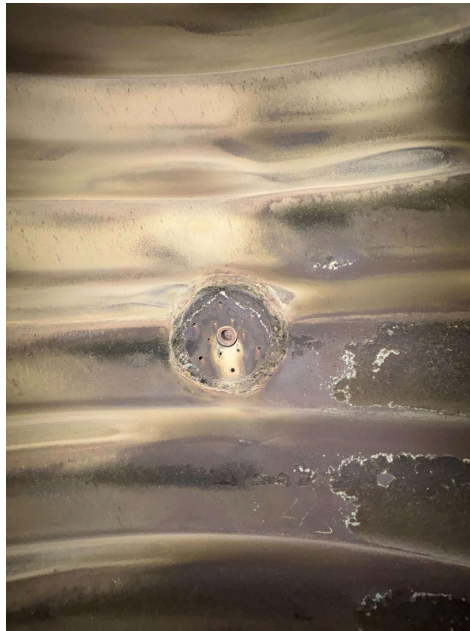
IMG 2006

Pulsation probe holder was found in acceptable condition.

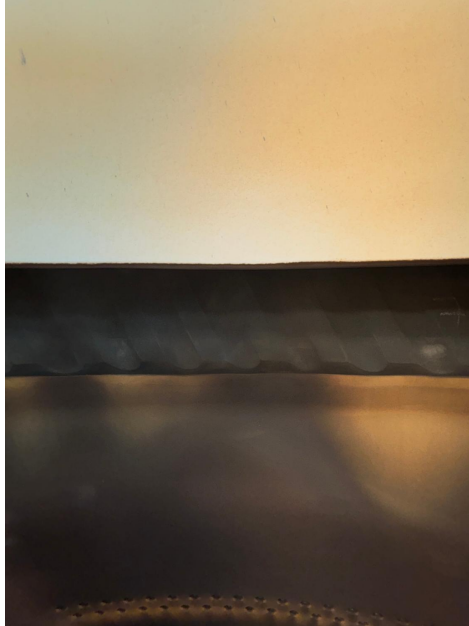
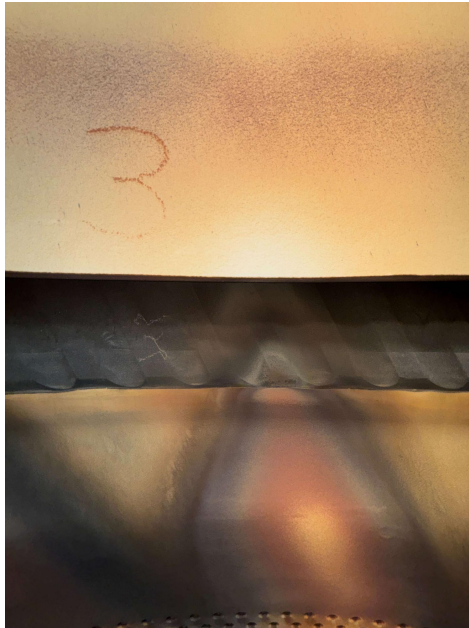
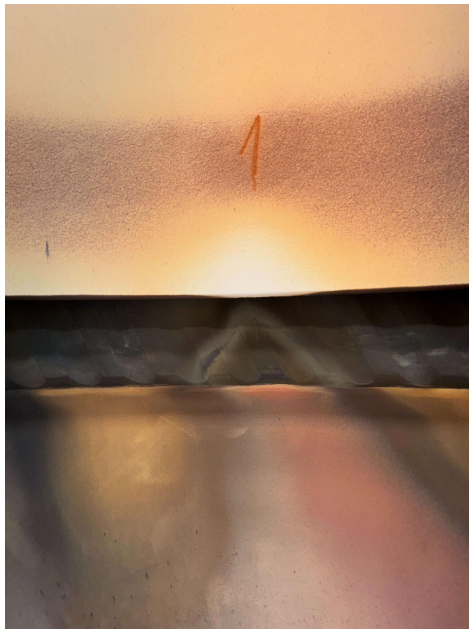
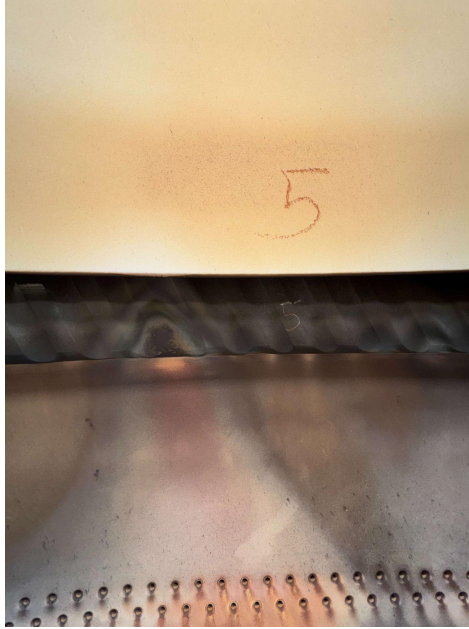
HGC collar was found with some minor erosion.

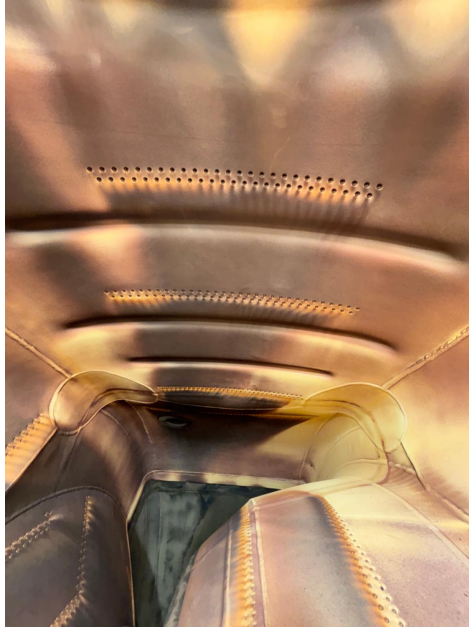
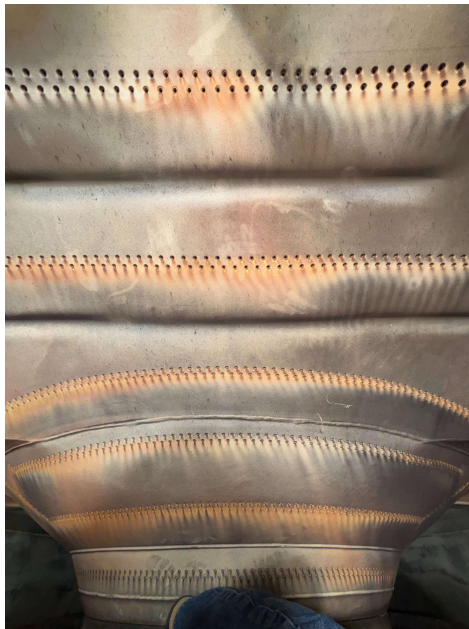
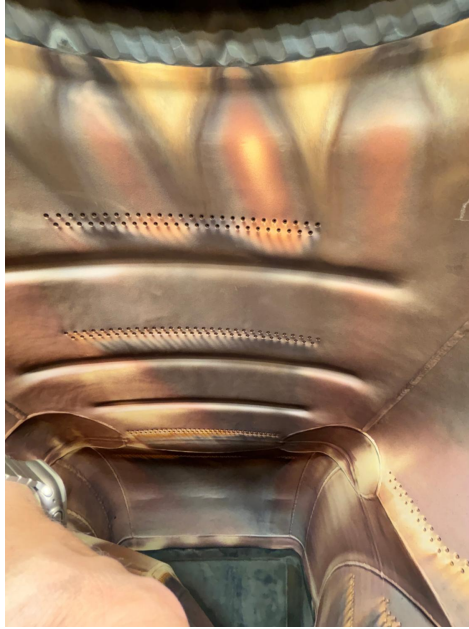
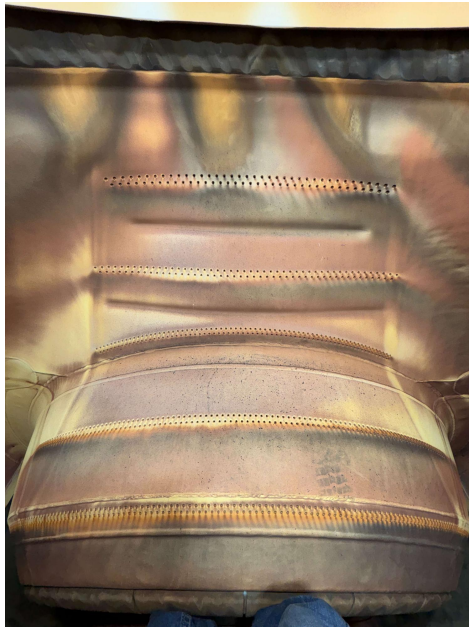
HGC was found with some coating loss. It is in overall acceptable condition.

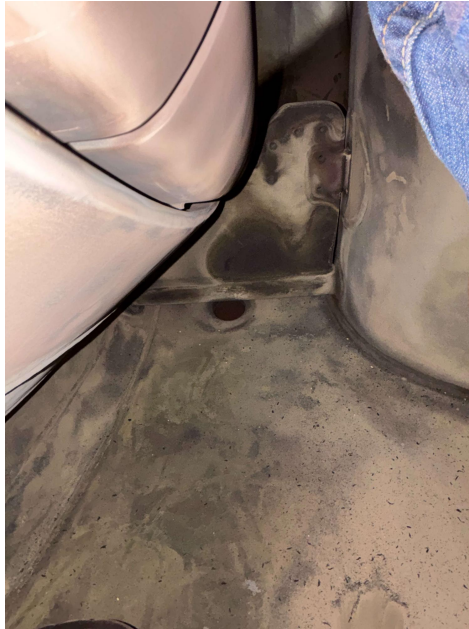
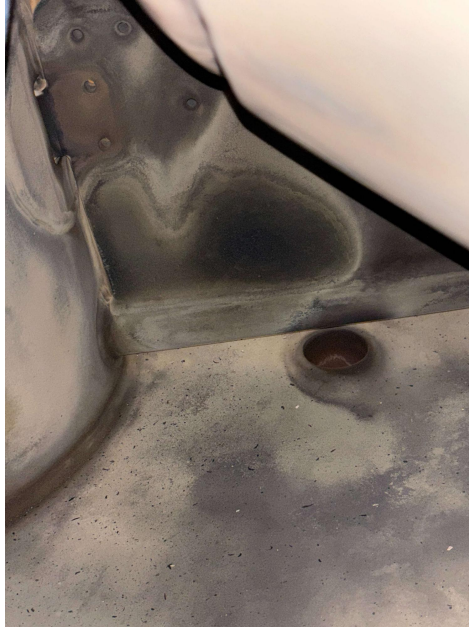
HGC flow strut separator was found in acceptable condition.

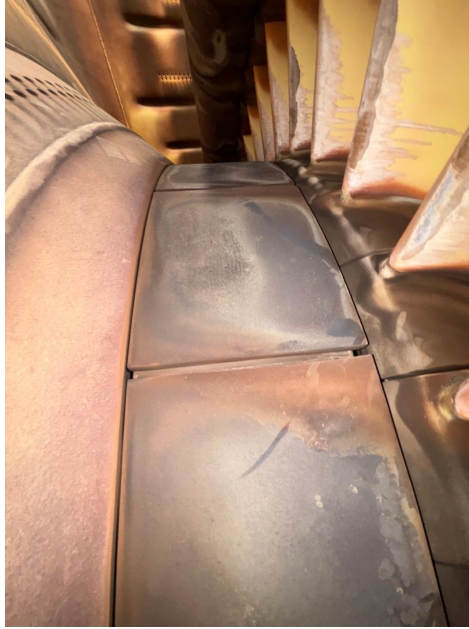
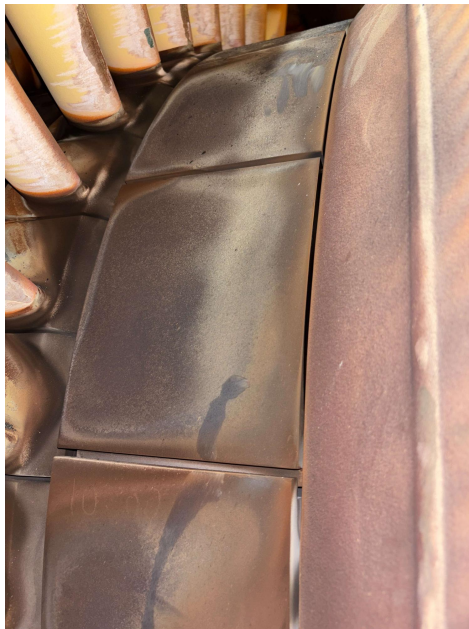
Entry segments were found with medium erosion.

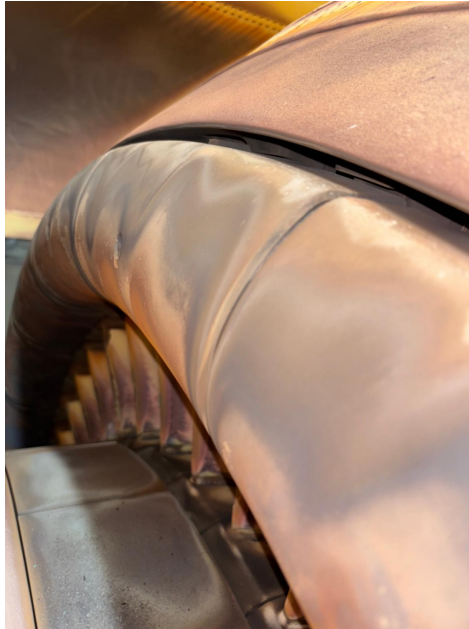
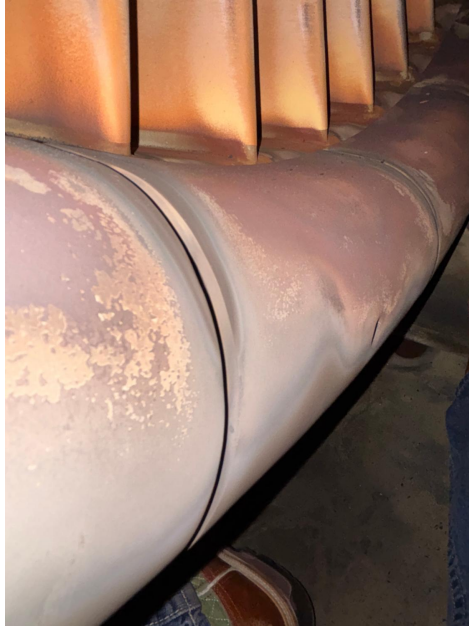
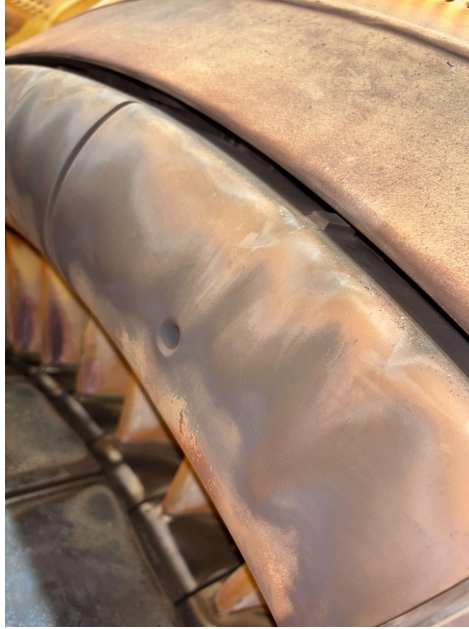
The C-Segments were found with medium erosion.

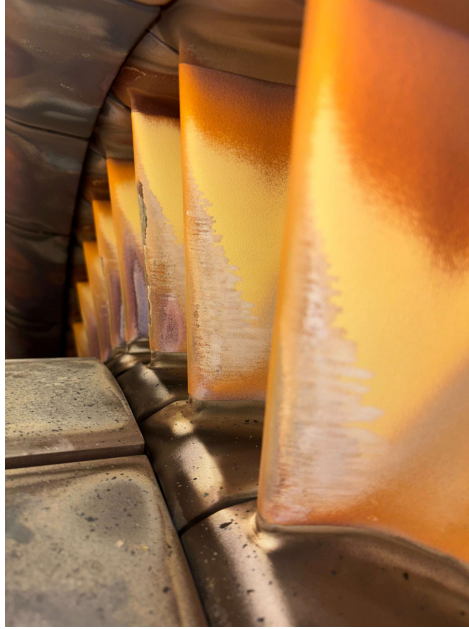
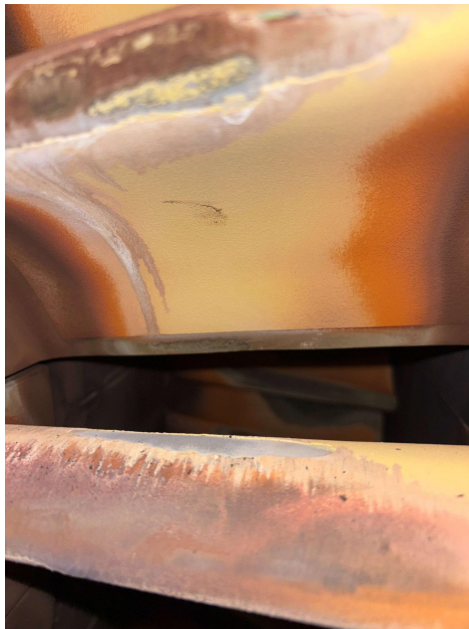
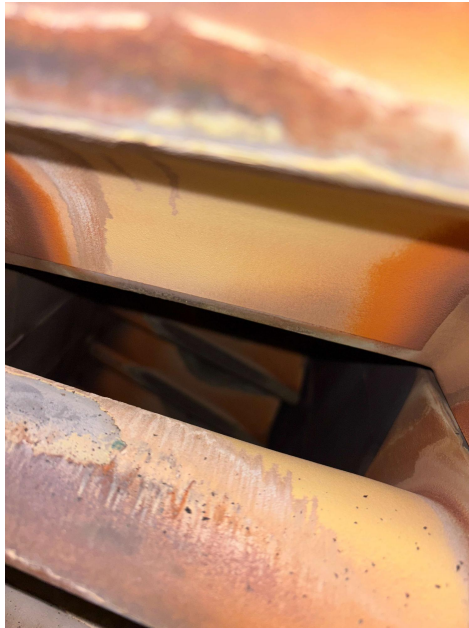
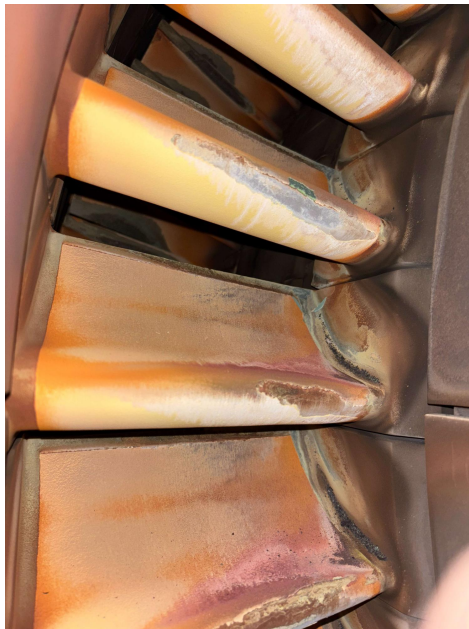
Row 1 vanes were found with erosion on both leading and trailing edges.

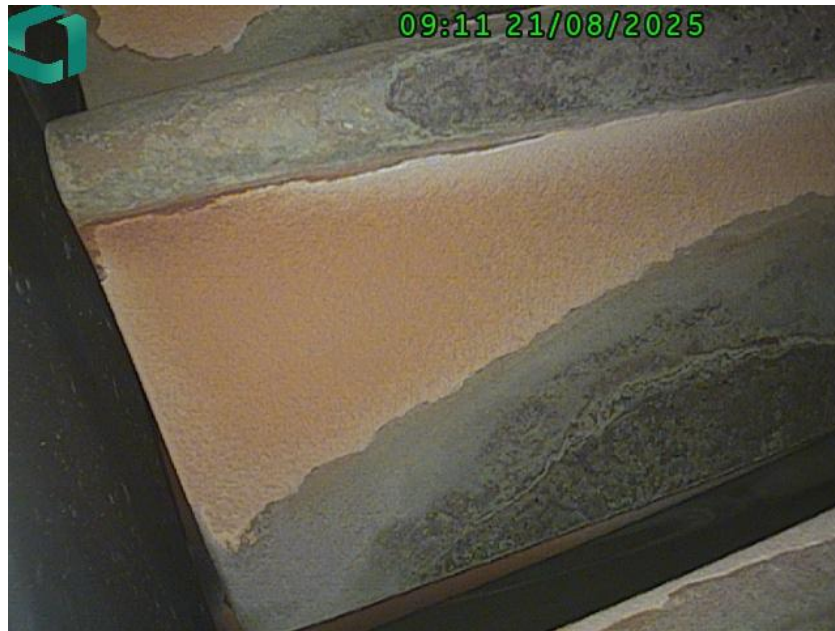
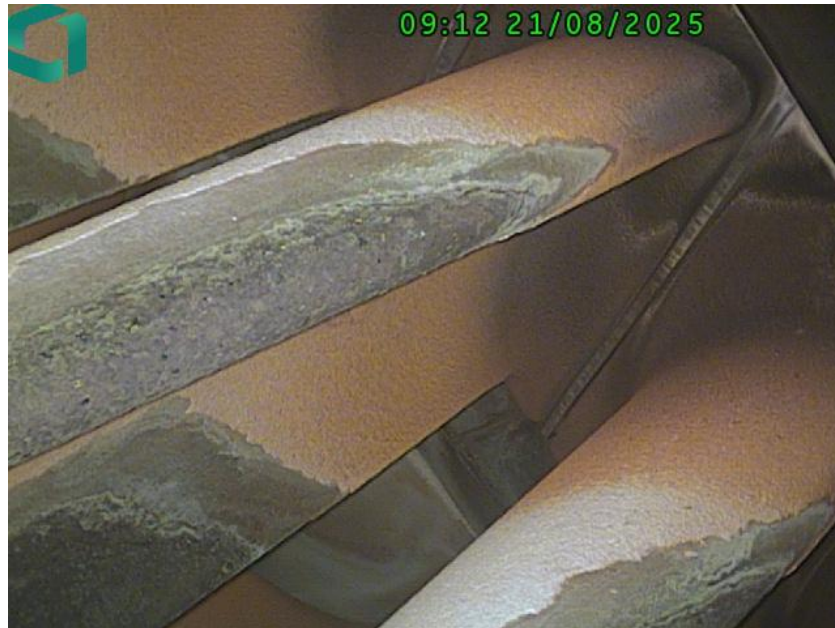
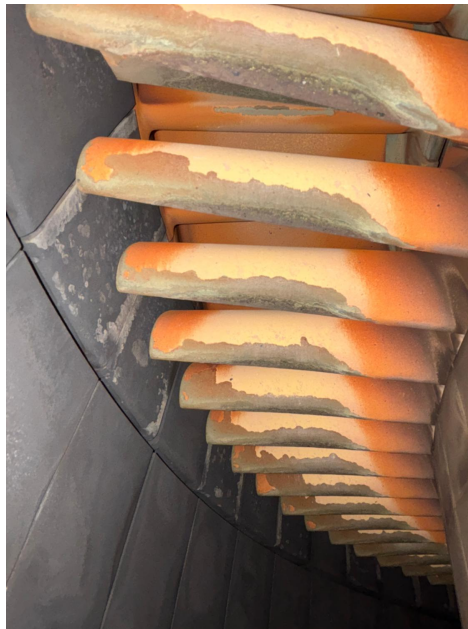
Row 1 blades were found with erosion on both leading and trailing edges.

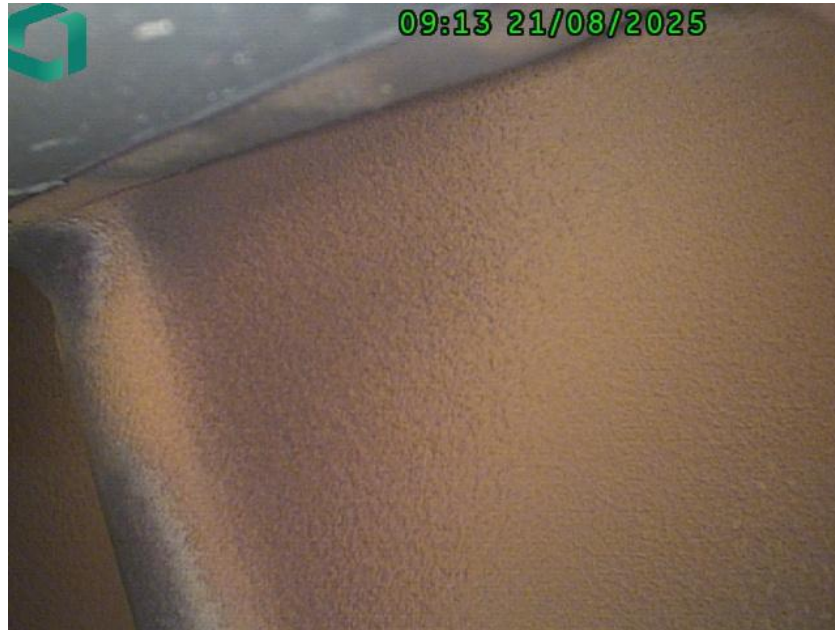
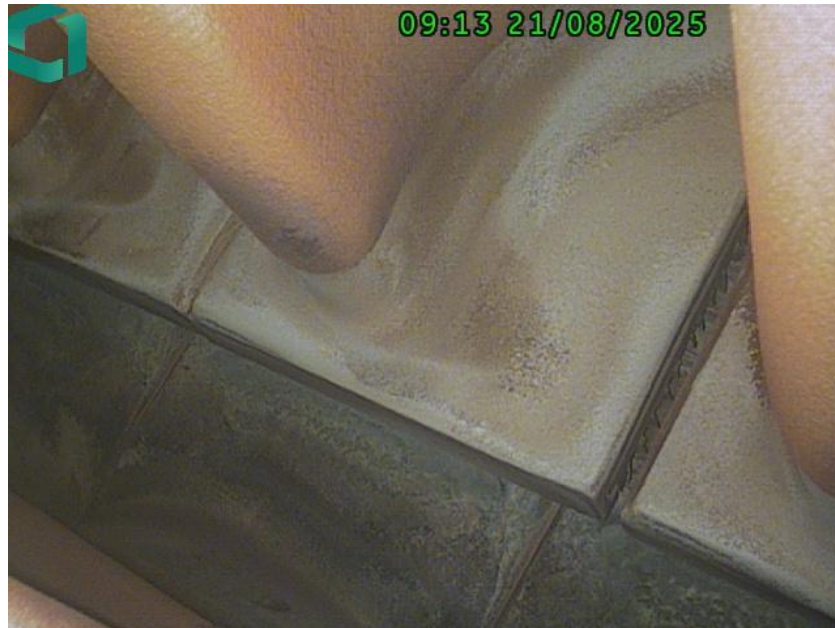
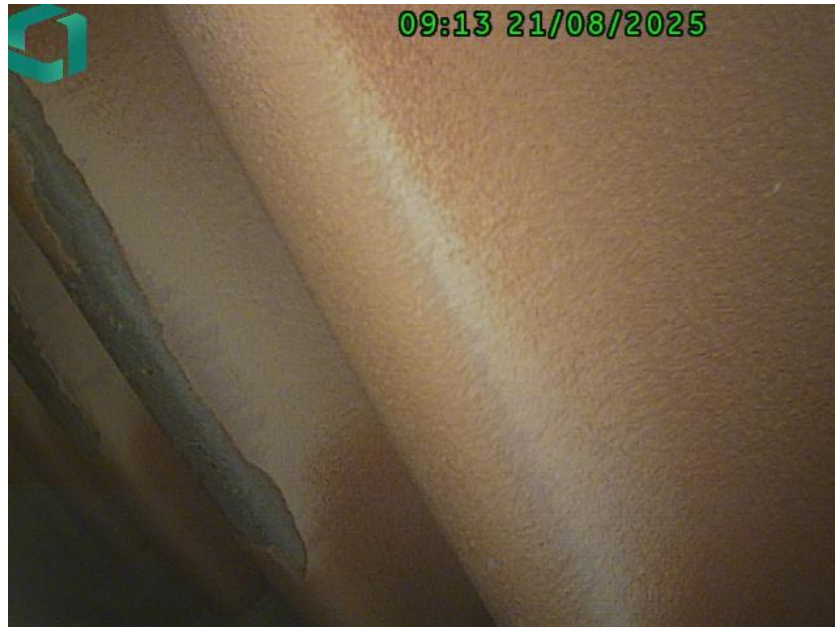
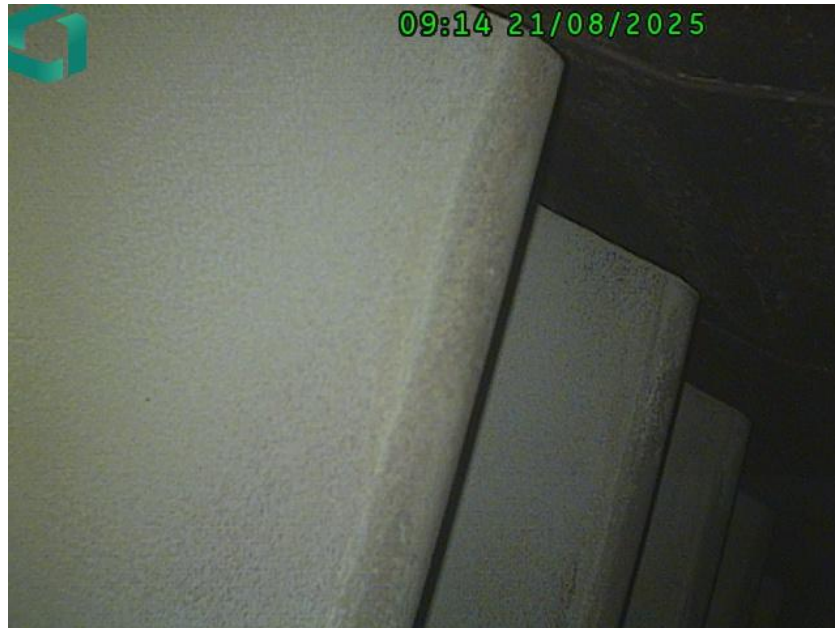
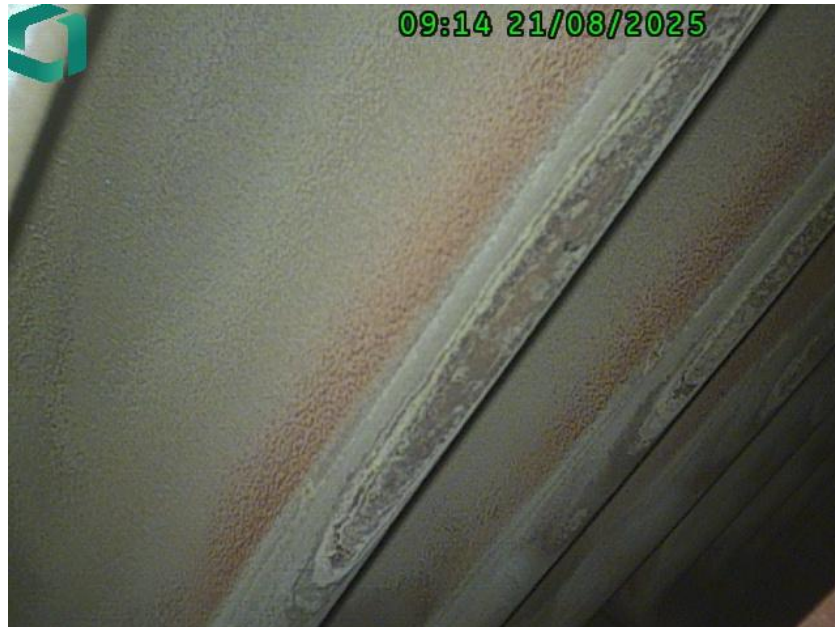
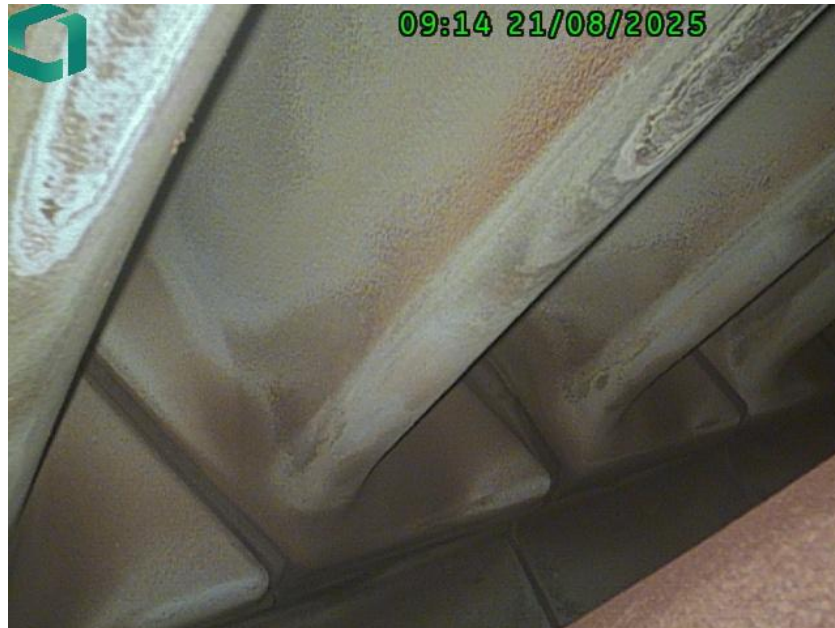
Row 2 blades and vanes had minor erosion. Rows 3 and 4 were founded in acceptable condition.

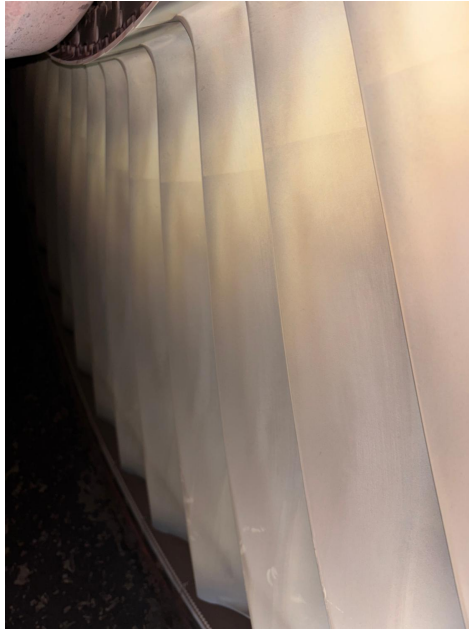
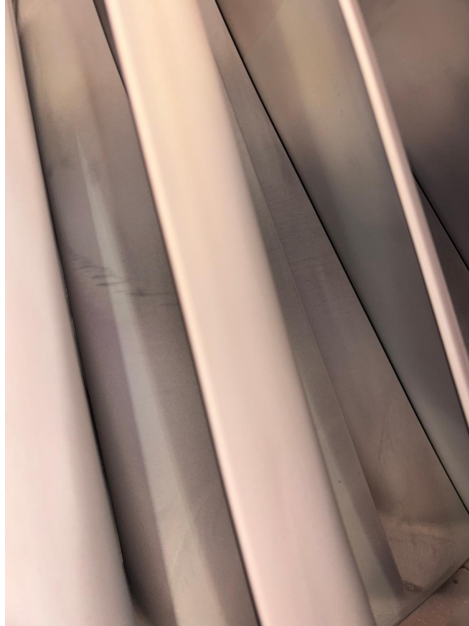
Blade and Vane row 5 was found in acceptable condition.

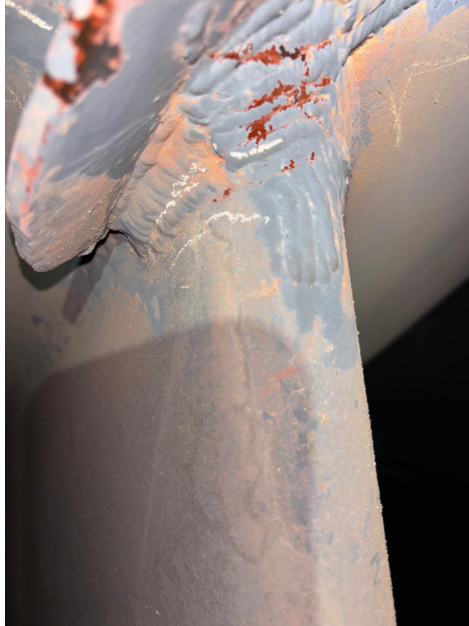
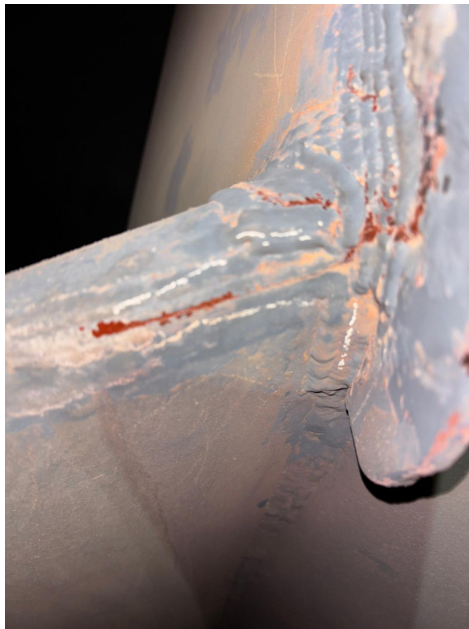
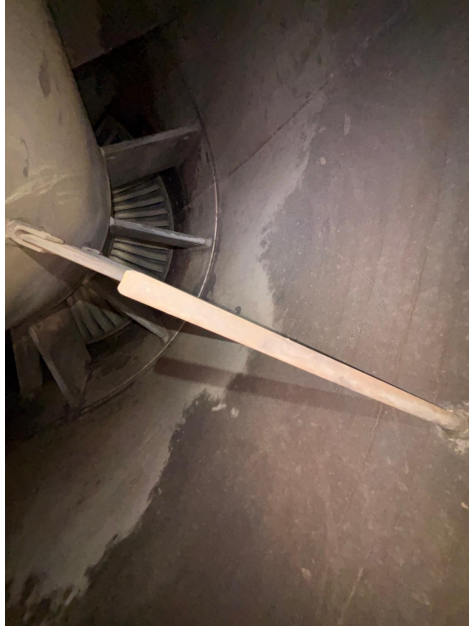
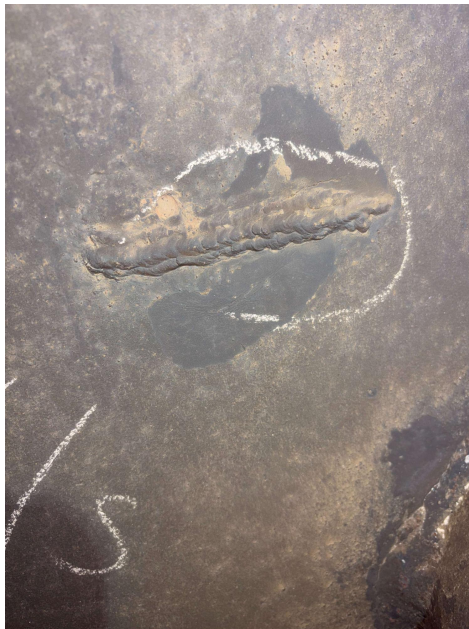
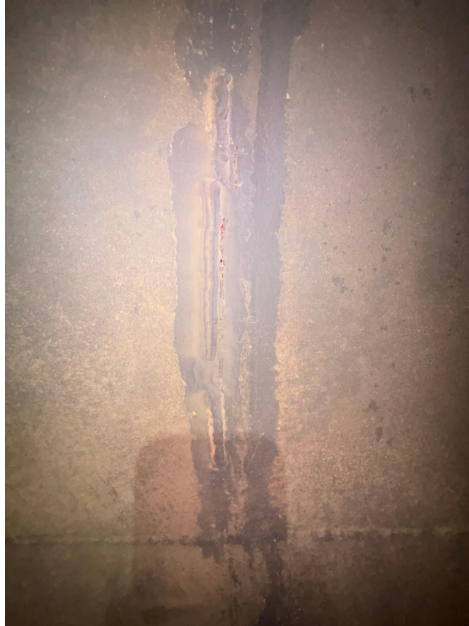
Some cracks were found at the H brackets as well as the diffusor.

Repair at next C inspection.
