# 26022 – Full Stave Tests & Beamline Tests

# Table Runs convention and How to

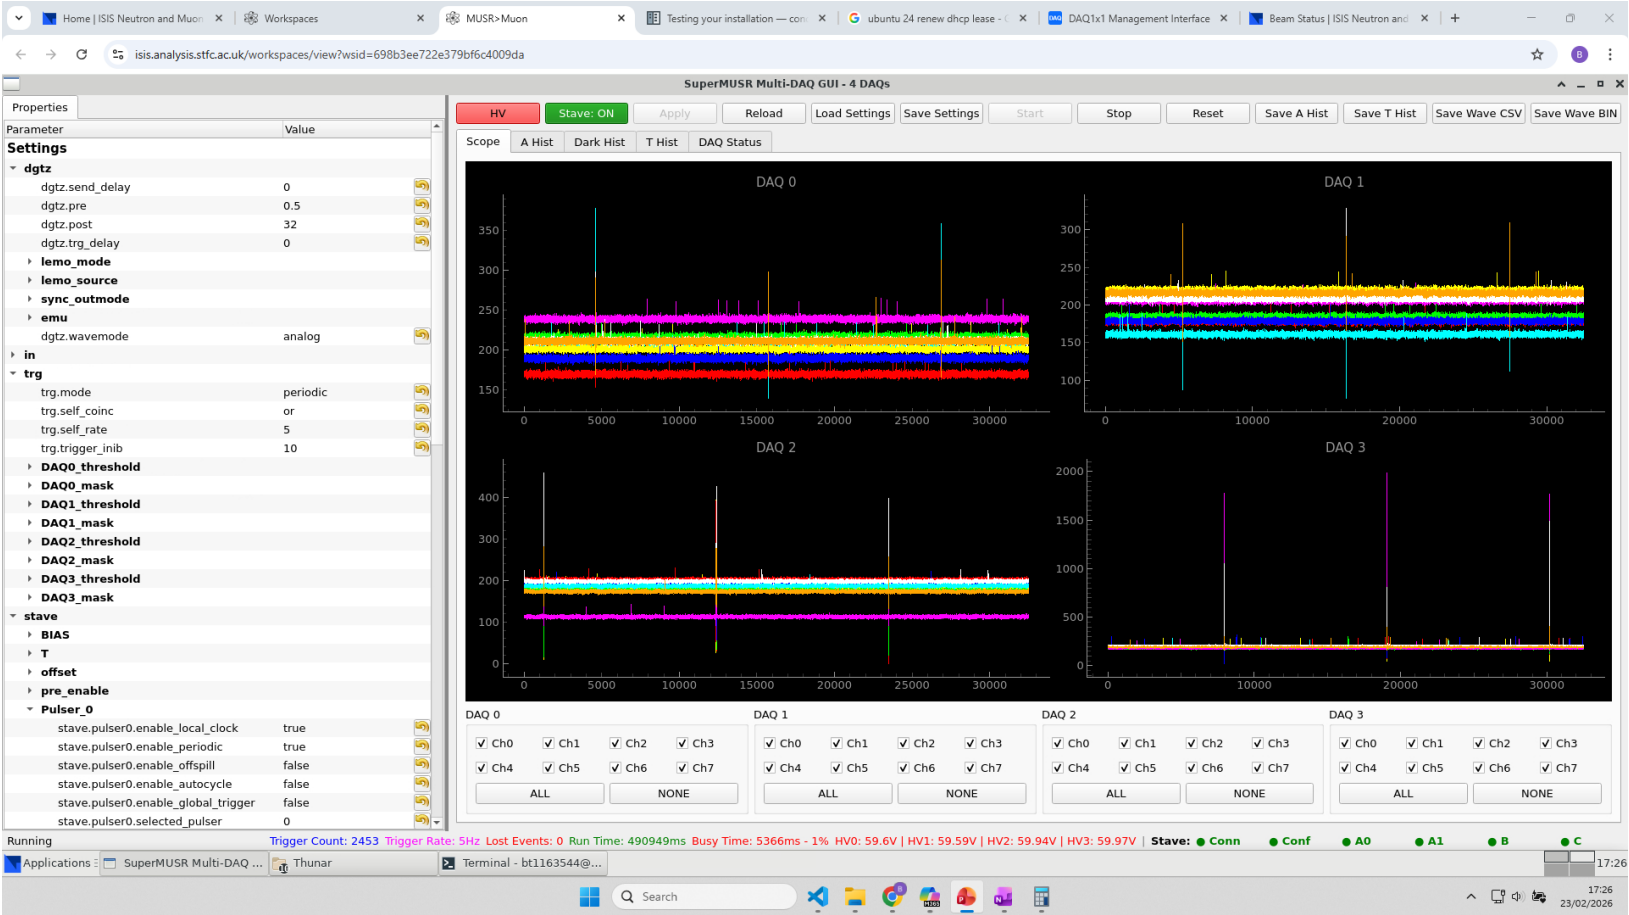
Stave PID: 20720

The issue with the broken DAQ was the infamous “stave\_configuration=1”. Must be set to 2 for ALL SEVERS AND DIGITISERS. Below is screenshot from pulser of all channels working.
