Suncor Energy; File Number: CL-63368

Formation: McMurray, Firebag; Well: 102/11-08-095-06W4/00

**Suncor Energy; CL-63368; McMurray Formation, Firebag
Elemental Maps of GR-002: Post Test Liner Coupon (Corrosion)**

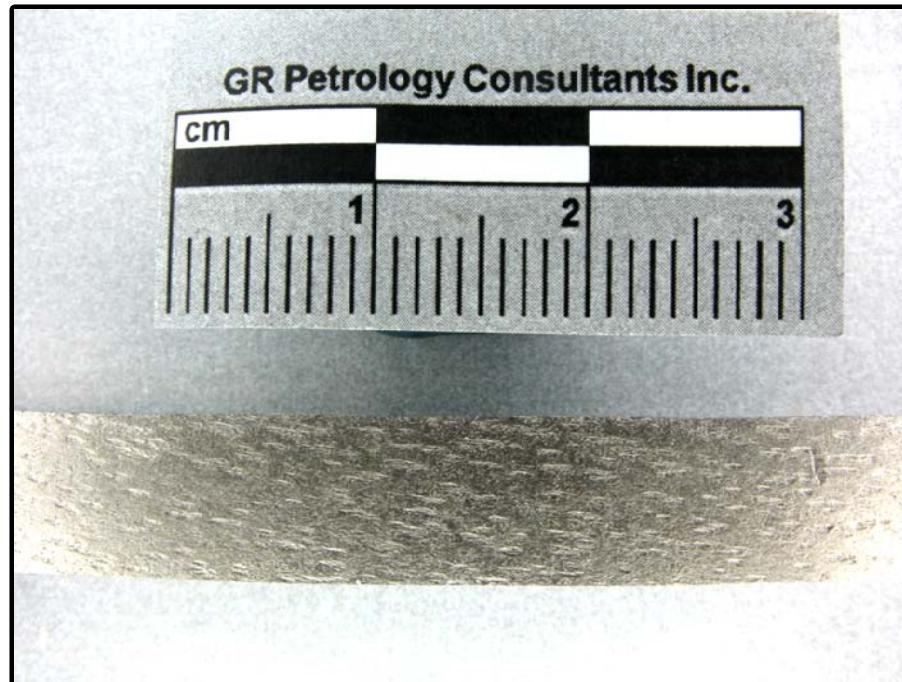
Sample ID: Pre test liner (coupon); corrosion

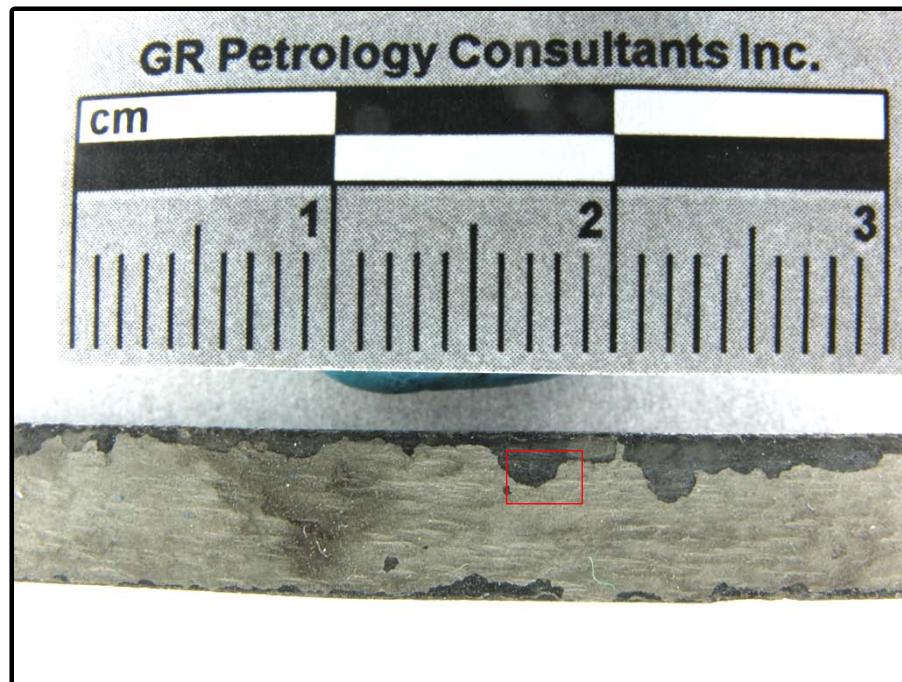
Sample ID: Post test liner (coupon); corrosion

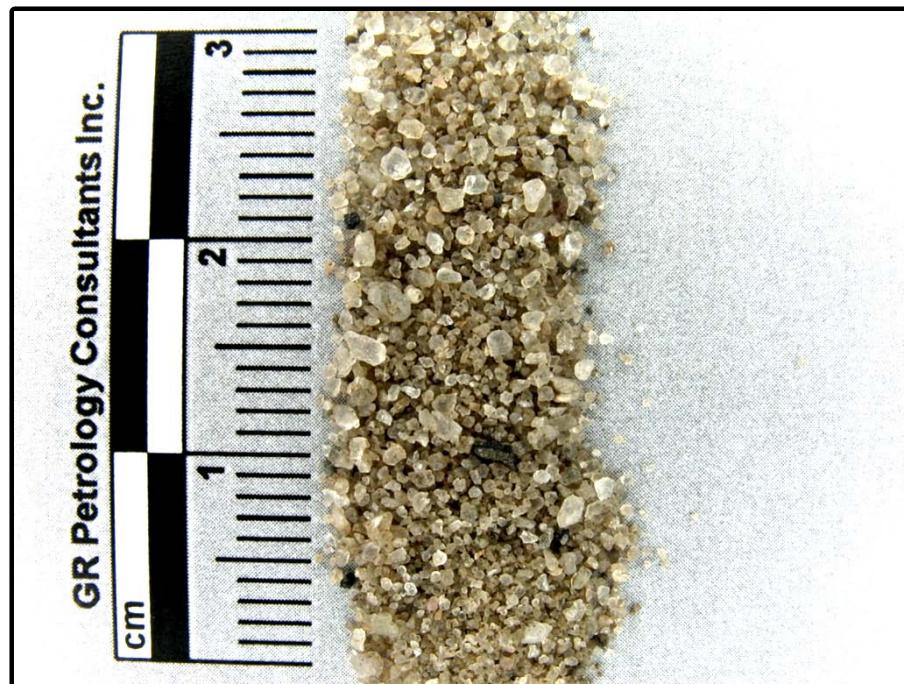
Sample ID: Post test sand; corrosion

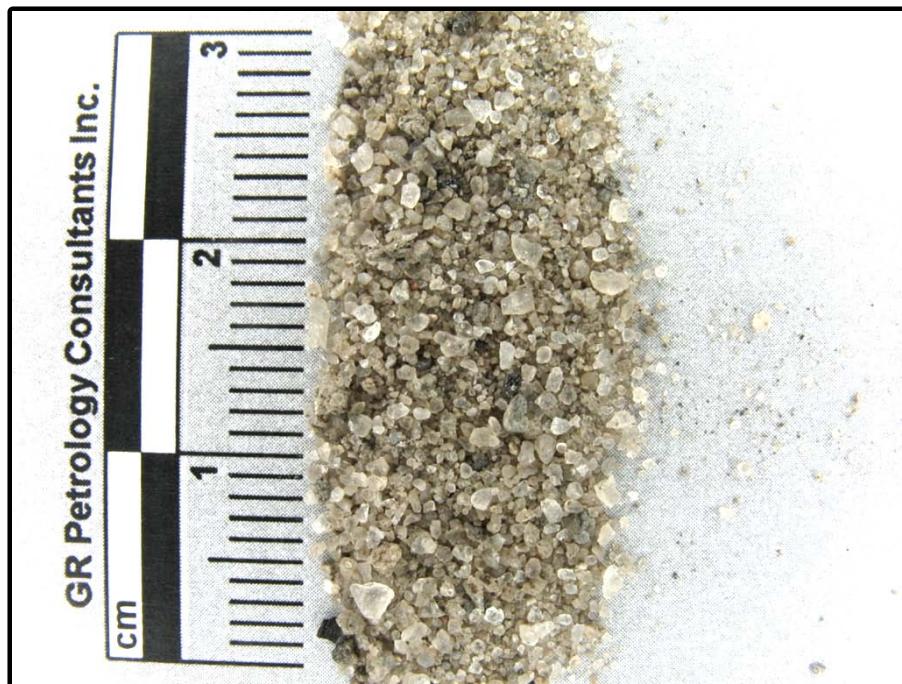
Sample ID: Pre test sand; aquathermolysis

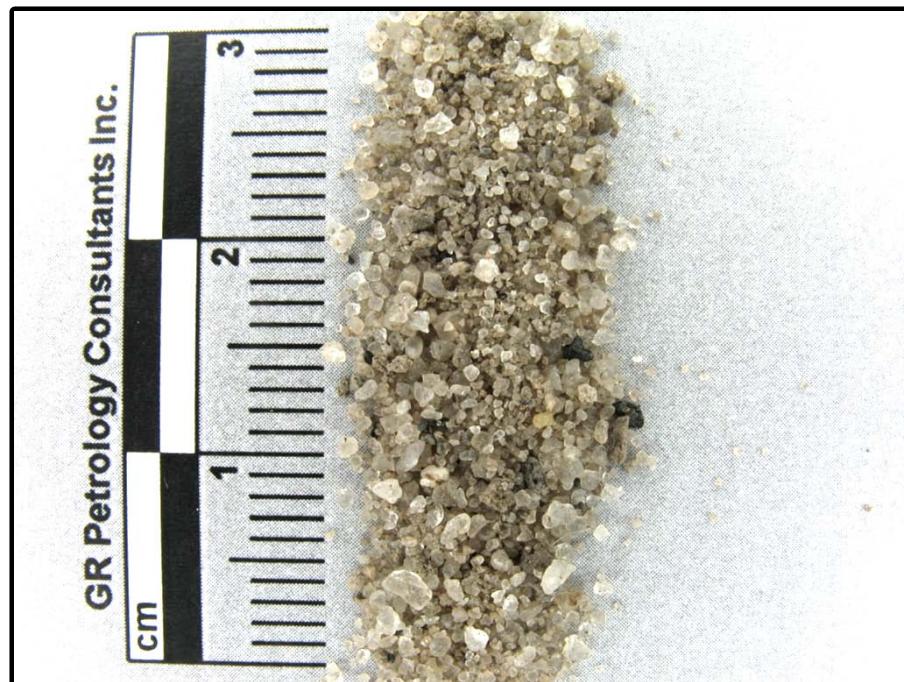
Sample ID: Post test sand; aquathermolysis
