# HVAC and VOC Forensic Analysis

Unit 806 · 315 N 12th Street · Philadelphia PA 19107

Goldtex Apartments · Greystar Real Estate Partners

| <b>Document date:</b> | Sunday, May 17, 2026 (evening edition) |

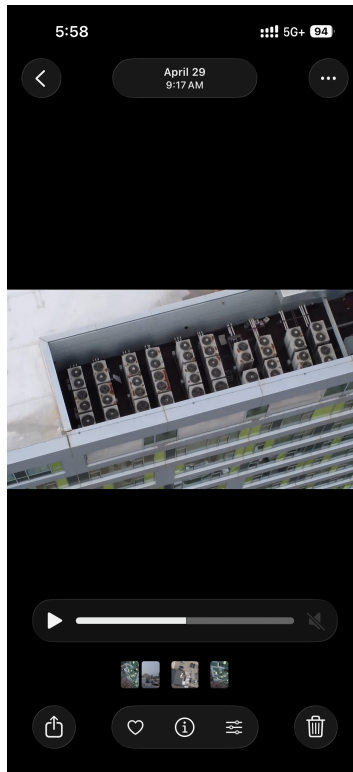
*Drone photograph, April 29, 2026 9:17 AM EDT. Building rooftop mechanical well showing stacked per-unit outdoor condensing units. Visible rust streaks and water staining on multiple cabinets indicate deferred maintenance.*

The per-unit architecture is significant for two reasons. First, AC failures in this building cannot be explained as a single shared central system being down for repair, because no such shared system exists — each unit has dedicated outdoor equipment. Second, restoring cooling to one unit specifically (rather than a building-wide system) requires targeted work on that unit's individual rooftop condenser. Such targeted work generates a discrete service record that should identify the technician, the refrigerant amount, leak test results, and EPA Section 608 certification of the technician performing refrigerant handling.
