Structural Impediments to Learning: Investigating Learning Environments Inside the Bahen Centre

Saif Abid, David Almond, and Hamid S. Timorabadi

University of Toronto Faculty of Applied Science

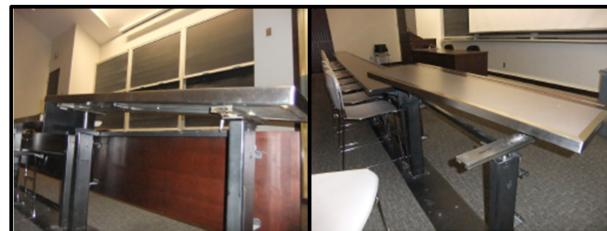
With regards to accessibility testing - Bahen Centre lecture halls require two wheelchair accessible stations, excepting the large lecture halls (which require three) and room 1160 (which requires four) [9]. All of the rooms meet this requirement, however numerous mechanical problems were noted with the accessibility stations (at the time of testing, July 2013). Of the 39 accessibility stations tested:

- 12 stations were completely functional.
- 9 stations were difficult to operate for a single seated user.
- 18 stations were either malfunctioning or damaged.

Fig. 2. Malfunctioning or damaged accessibility stations.

According to the University guidelines [9] the classroom accessibility for all the students is a primary concern. Many of the stations are currently in poor condition and require immediate repair. They are either difficult to operate (23%) or are damaged (46%). A lack of electrical outlets at the accessibility stations presents additional difficulties, as a cord must be run from a general maintenance outlet across a walkway, presenting another tripping hazard. According to guidelines, electrical outlets are to be provided at each accessibility station [9]. It should be noted that in rooms 1180 and 1190 the only seat in the first row that does not have an electrical outlet provided is the accessibility station.

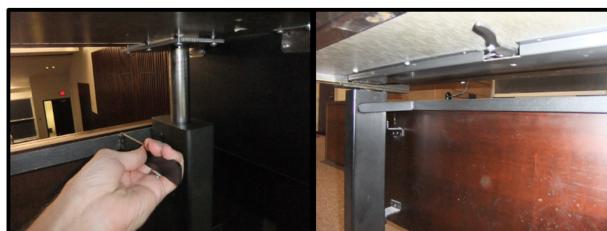
It is, furthermore, noted that the activation controls, as shown in Figure 3, were unmarked, difficult to locate, and confusing to operate. The source of these malfunctions could not be clearly identified, i.e. it was challenging to determine if the control had not been activated or if the piston itself had failed.

Fig. 3. Accessibility table operation.
