STRUCTURAL IMPEDIMENTS TO LEARNING: INVESTIGATING LEARNING ENVIRONMENTS INSIDE THE BAHEN CENTRE

University of Toronto Faculty of Applied Science

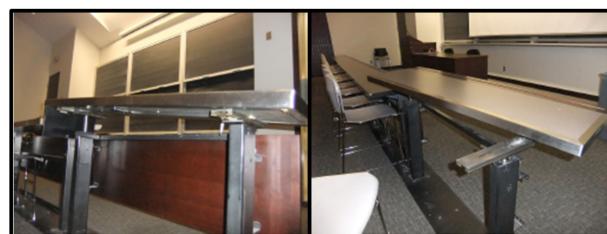
- Twelve (12) stations were fully functional.
- Nine (9) stations were difficult to operate for a single seated user.
- Eighteen (18) stations were defective or damaged. Figure 2 illustrates some examples of damaged stations.

Fig. 2. Malfunctioning or damaged accessibility stations.

According to the University guidelines [9], classroom accessibility for all the students is a primary concern. Many of the stations are currently in poor condition and require immediate repair. They are either difficult to operate (23%) or are damaged (46%).

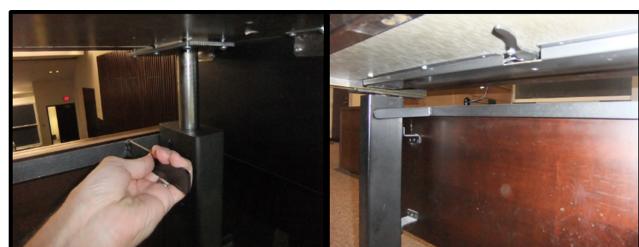
The activation controls for the accessibility stations (shown in Figure 3) were all unmarked, difficult to locate, and confusing to operate. The root cause for some of these malfunctions could not be clearly identified (i.e. it was challenging to determine if the control had not been activated or if the piston itself had failed).

Fig. 3. Accessibility table operation.

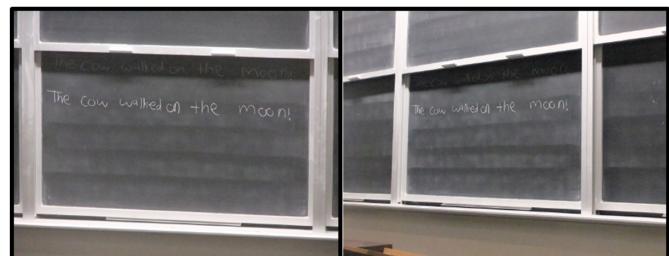
Due to various angles for overhead lighting for each size of lecture hall, the shadow height is different for each size of room. The shadow produces an illumination variance between 57 to 96 lux, affecting visibility of the chalkboard. Figure 5 provides an example of this effect.

Four percent of survey respondents addressed this issue in their additional comments of the survey. Table 3 quantifies the shadows sizes cast on the blackboards. Figure 5 illustrates the difficulty in attempting to read the two sentences on a blackboard, with one obscured by such a shadow. One potential solution to this problem could be installing light fixtures at the bottom corners of the blackboards such light shines upward, cancelling the shadow (though this might interfere with the lecturer). Another approach is to simply attached LED flashlights under the outer blackboards. This will also shine light on the shadowed area and eliminate it.

Fig. 5. Obstructive Chalkboard Shadowing.
