Gale Associates, Inc.

Re: 30% Schematic Design Submission  
Roof Replacement and Associated Work at the  
Amherst Regional Middle School  
170 Chestnut Street  
Amherst, MA 01002  
Gale JN 833180 P1

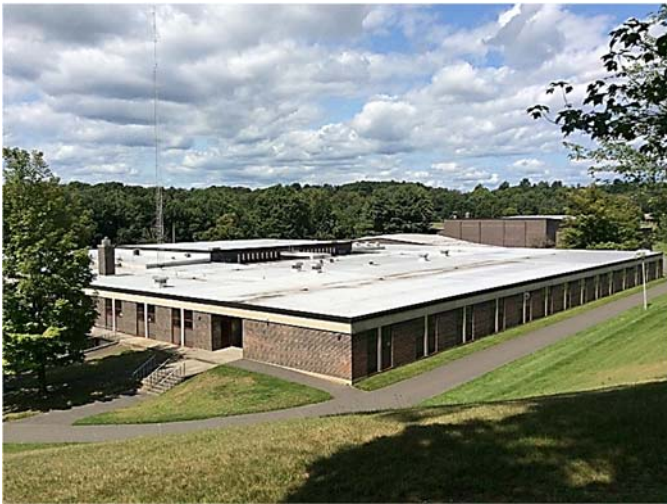
Photo 1 – Partial overall view of the Middle School Roof Areas (A-L).

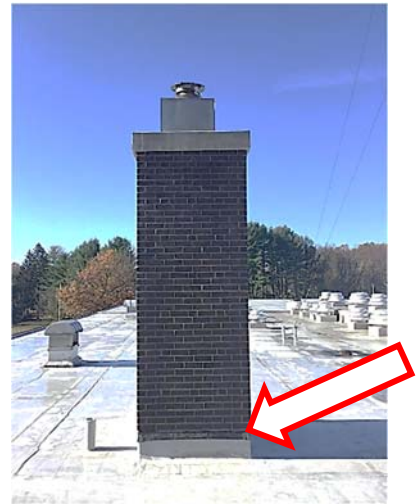
Photo 2 – Partial view of the recently rebuilt brick masonry chimney on Roof Area A.

3. Gale was informed by APRSD that the brick masonry chimney on Roof Area A had been recently rebuilt and should remain in place as part of these renovations. However, due to the anticipated new tapered insulation thickness, the existing roof flashing height at the base of the chimney would be less than the 8-inch recommended minimum industry design standard. Therefore, the existing throughwall flashing and brick masonry would require removal and replacement.

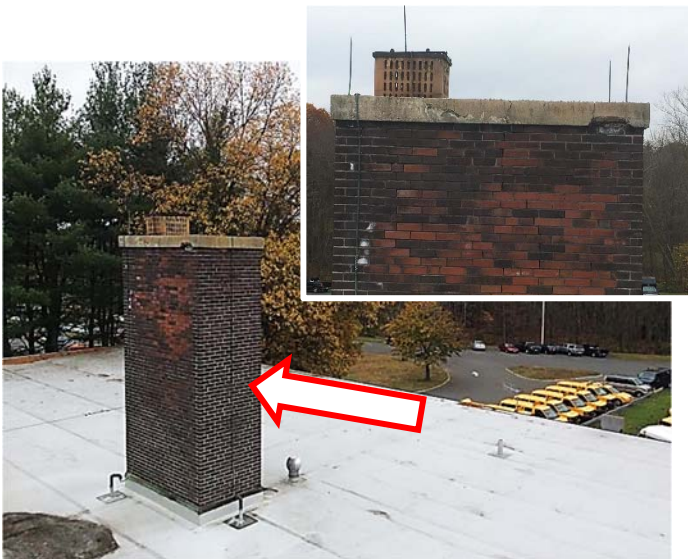
4. On Roof Area J, the existing brick masonry chimney appears to have failed mortar joints, step cracking, and is in overall poor condition. Since APRSD reported that the chimney is no longer in use, Gale recommends removing the chimney down below the roof deck and infilling the roof deck in this location. Further review of the chimney's construction below the deck and written confirmation from the APRSD indicating that the chimney is no longer in use will be required. Please note that the existing chimney currently has lightning protection mounted to the chimney cap. If the chimney is removed, the lightning protection will likely need to be re-located or removed. The assistance of a lightning protection consultant will be required should APRSD decide to upgrade their lightning protection systems. Should APRSD consider keeping the chimney, Gale recommends repointing 100% of the mortar joints and rebuilding more than 50% of the outer wythe of the brick. The cost to repair the chimney would be approximately \$20,000 - \$30,000.

Photo 3 – Overall view of the abandoned chimney on Roof Area J which appears to be in poor condition and is reportedly not used anymore.

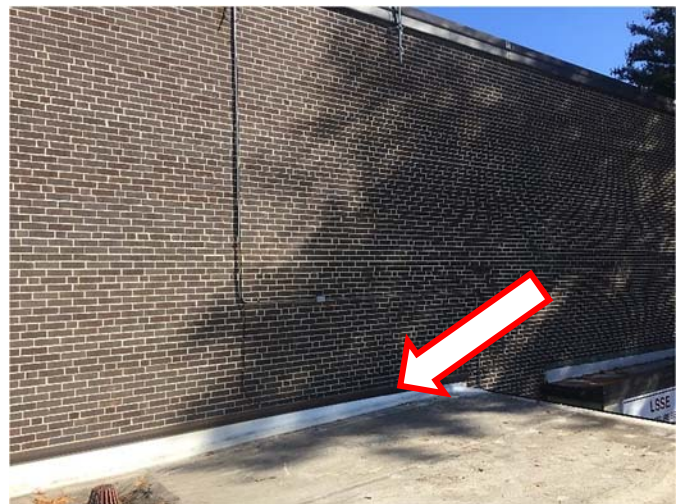
2. The throughwall flashing at the roof to wall transition on Roof Area K is currently low, and due to the anticipated new tapered insulation thickness, the existing roof flashing height at the base of the wall would be much less than the 8-inch recommended minimum industry design standard. Therefore, the existing throughwall flashing and brick masonry would require removal and replacement. The throughwall flashings on Roof Areas E, F, H, and J also appear that they will be low once the new roof system is installed. However, the flashing heights in these locations will not greatly differ from those which are existing. Therefore, unless otherwise requested, the existing throughwall flashings can remain in place at the rising walls on these Roof Areas. New throughwall flashing will also be required at four (4) locations at the parapet to rising wall transition on Roof Areas H and J. Similar conditions exist at four (4) small rising wall locations on Roof Area A where new throughwall flashings will also be required.

Photo 4 – View of the roof to wall transition that will require new throughwall flashing at Roof Area K.

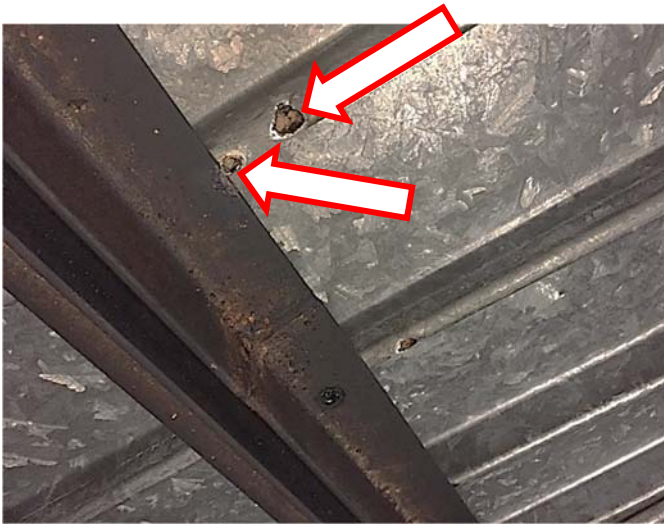
Gale performed a leak audit of the interior spaces below the various roof areas in an attempt to determine the cause of the moisture infiltration. Gale also took this opportunity to briefly observe any potentially damaged/corroded sections of the structural roof deck and structural framing members as a result of the moisture infiltration. It does not appear the steel deck has been corroded from moisture infiltration at the limited locations which were observed, however, in locations where stained ceiling tiles were present, small holes in the steel deck were noted. These holes appear to be a result of failed or missed puddle welds and were often noted throughout the steel deck.

Photo 5 – View of typical burned holes within the steel deck which may have been caused during the misalignment of puddle-welds connecting steel deck and joist.

8. It is recommended that any sections of the structural steel deck which appear to be loose or poorly connected to the structural framing be re-secured as part of this roof replacement project. Since the potential extent of unsecured decking is unknown at this time, it is recommended that the perimeters and corners of the roof be re-secured as part of the contract documents, and any missing fasteners/welds in the field of the roof will likely be covered by a unit cost, should this unforeseen condition be discovered during construction.

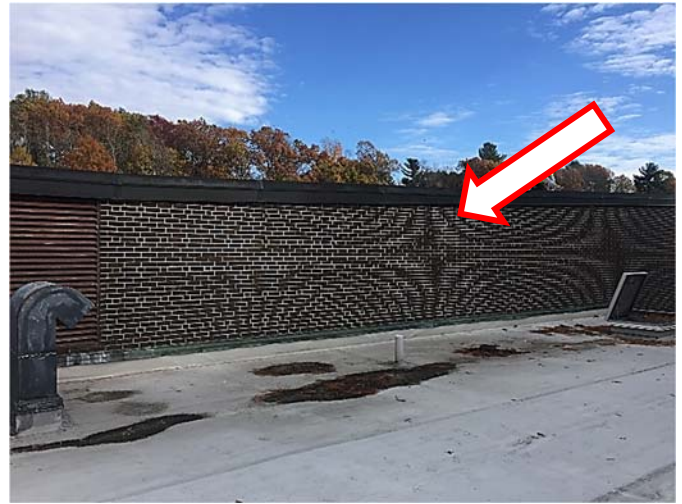
6. The masonry vertical expansion joints located at the brick masonry rising walls on Roof Areas H and J appear to have missing or failed mortar joints. It is recommended that these expansion joints be replaced with sealant under the scope of this project to reduce for the potential of moisture infiltration into the new roof system or into the building. These rising walls both contain a louver with failed perimeter sealants. These sealants should be removed and replaced.

Photo 6 – View of one (1) masonry control joint at the rising wall above Roof Area J. These joints typically are in failed condition.

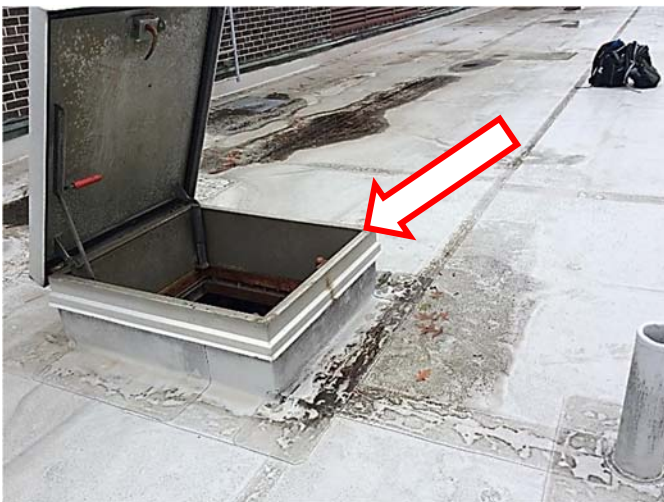
Photo 7 – View of the roof hatch on Roof Area H which will need to be replaced; similar to the ones on Roof Areas A and J.

10. Remove and replace the existing roof access hatches located on Roof Areas A, H and J, and remove and infill two (2) abandoned roof access hatches that were reported on Roof Area B.
11. Remove and replace the roof access ladders on Roof Areas E and H in order to meet code requirements with the new thickness of the proposed roof assembly. The ladder on Roof Area H currently has a weather antenna device mounted to it. If APRSD requires that this device stay, then it must be relocated.
12. Perform temporary disconnection/reconnection as required to raise the existing mechanical units set on curbs to properly flash and/or provide an 8-inch minimum flashing height to achieve the recommended industry design standards.
13. Provide perimeter guardrails along roof access points and around mechanical units within 15-feet of any roof edge.

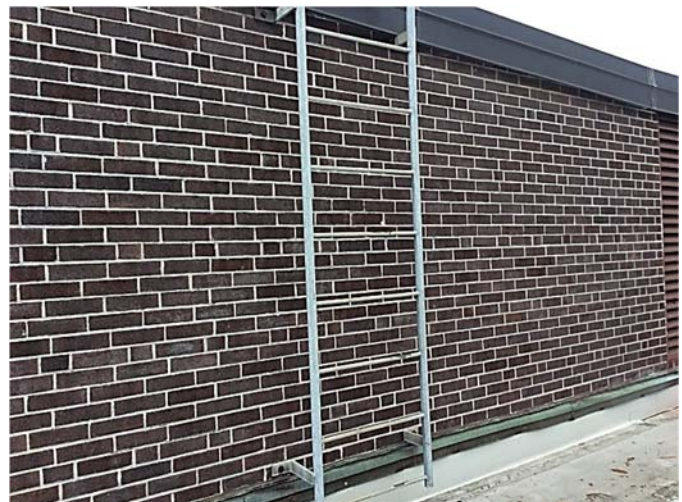
Photo 8 – View of the roof access ladder on Roof Area H which will need to be replaced.

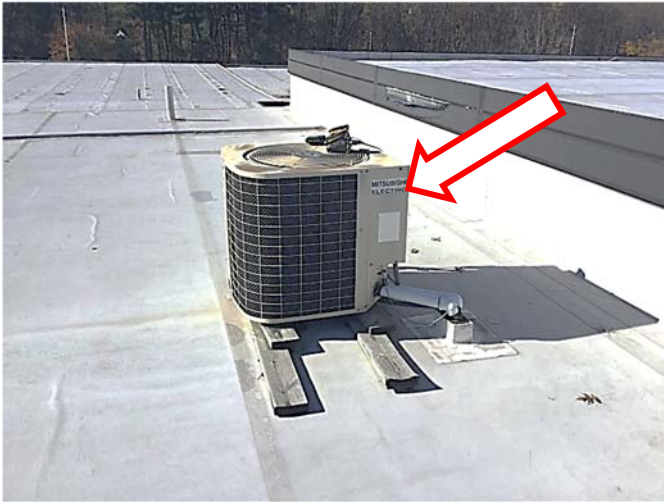
Photo 9 – Rooftop mechanical units will need to be disconnected, raised, and reconnected.

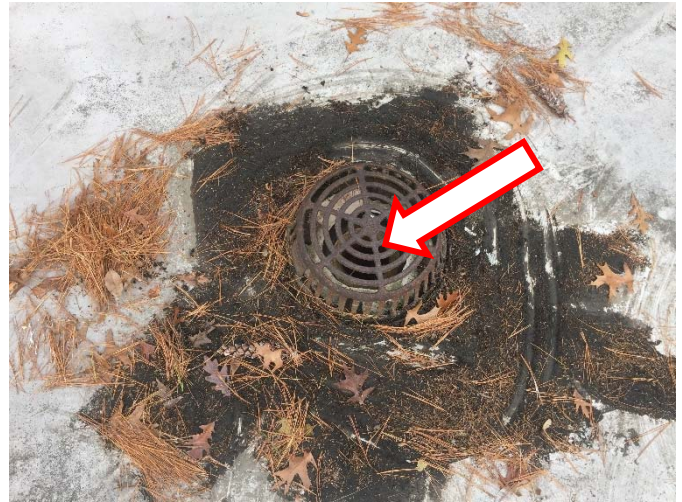
7. The majority of the existing cast iron drain bowls currently have copper sleeve inserts installed within the bowl and into the leader pipe. It appears these sleeves may have been installed with the new drains during the previous roof replacement as a substitute to extending the cast iron drain leaders. However, these configurations do not meet code and it is likely that the drain leaders will need to be extended with a no-hub connection below the roof deck. This will require the contractor to have interior access to the underside of each drain bowl. In addition, it is recommended that the existing roof drain bowls, clamping rings, hardware, and dome strainers be replaced. Install drain bowl collar extensions to accommodate the required minimum thickness of insulation. Provide roof crickets between roof drains with drain sumps to promote drainage and manage water.

Photo 10 – Roof drain bowls appear to have copper sleeve inserts.
